Technical Service Bulletin

20-01-015H

**2020 SONATA (DN8a) 16" TIRE SPECIFICATION LABEL AND
OWNER'S MANUAL (RECALL CAMPAIGN 190)**

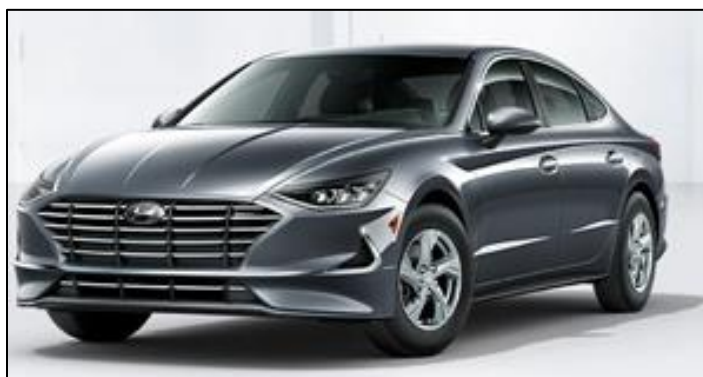
Description: Certain 2020 model year Sonata (DN8a) vehicles equipped with 205/65R16 (16") tires may indicate incorrect values for the tire sidewall aspect ratio on the Tire Specification Label and in the Owner's Manual. As such, these vehicles do not comply with Federal Motor Vehicle Safety Standards. Incorrect tire size specifications could lead to the installation of mismatched tires, increasing the risk of a crash. This bulletin describes the procedures to replace the Tire Specification Label and revise the Owner's Manual.
