RS20-004

VOLUNTARY SAFETY RECALL CAMPAIGN 2020 Q60 REAR SEAT BELT INSPECTION

CAMPAIGN ID #: R20A5
NHTSA #: 20V-145
APPLIED VEHICLES: 2020 Q60 (CV37)

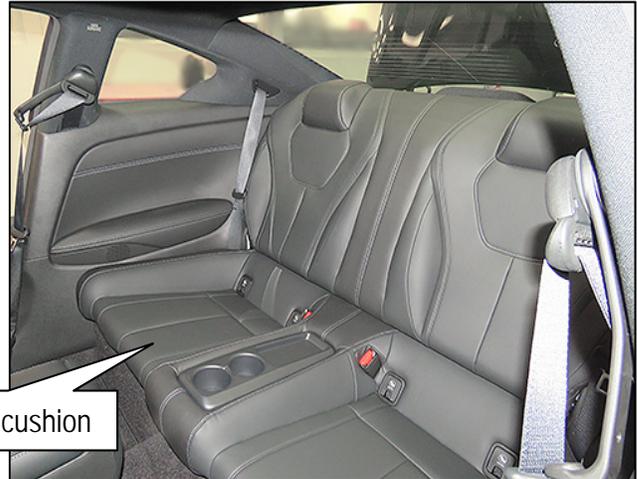
Figure 1

1. Remove the rear seat cushion.
 - For seat cushion removal, refer to the Electronic Service Manual (ESM): Section **REPAIR > BODY INTERIOR > SEAT > REMOVAL AND INSTALLATION > REAR SEAT CUSHION.**

Rear seat cushion

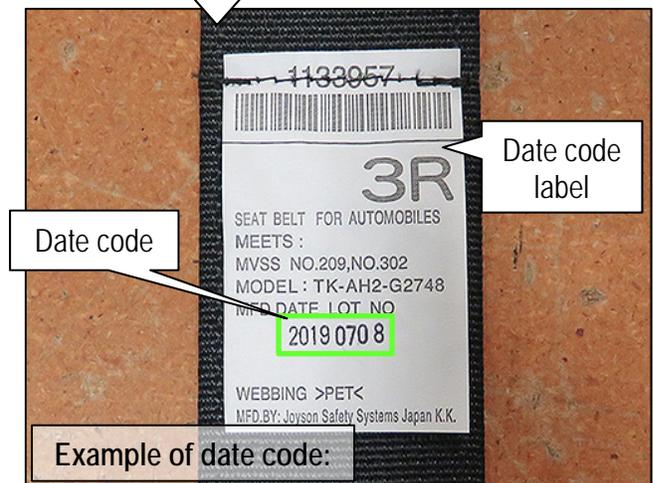
Figure 2

2. Locate the date codes on the driver side and the passenger side seat belts, and write them on the repair order.

HINT: The date code label is sewn onto the seat belt near the bolt anchor.

Rear seat belt

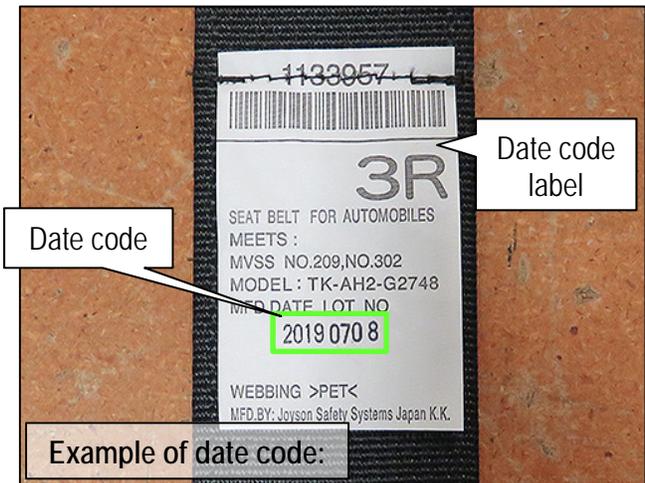
Figure 5

3. Confirm if the passenger side date code is in **Table A** (below) and, if so, circle the date code on the repair order.
4. Confirm if the driver side date code is in **Table A** (below) and, if so, circle the date code on the repair order.
5. If neither date code was circled in step 3 or step 4, skip to step 17, otherwise proceed to step 6.

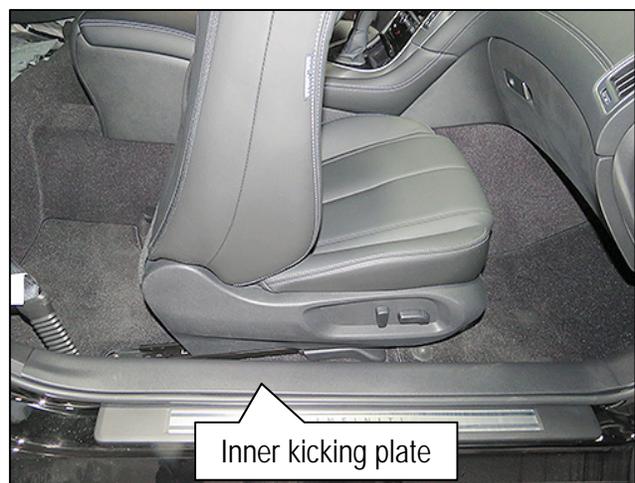
Figure 6

6. Remove the inner kicking plate.

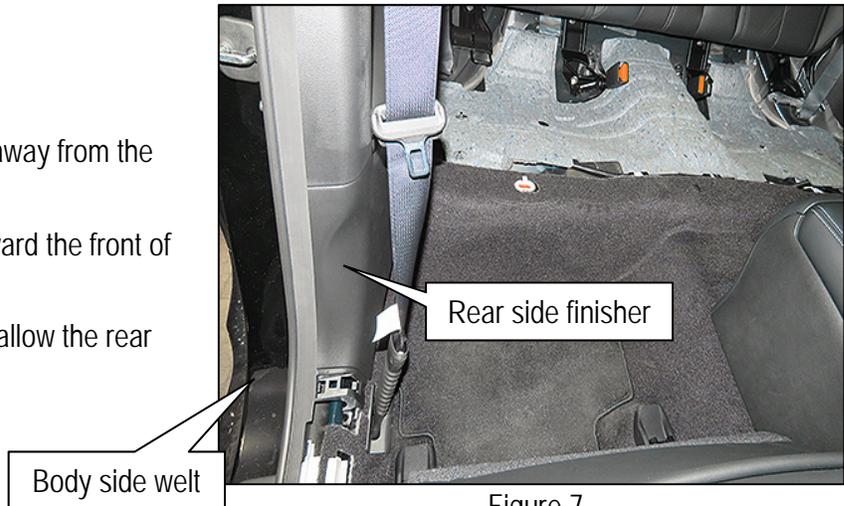
Figure 7

7. Gently pull the body side welt away from the rear side finisher.
- Pull the body side welt toward the front of the vehicle.
- HINT:** Remove just enough to allow the rear side finisher to be removed.

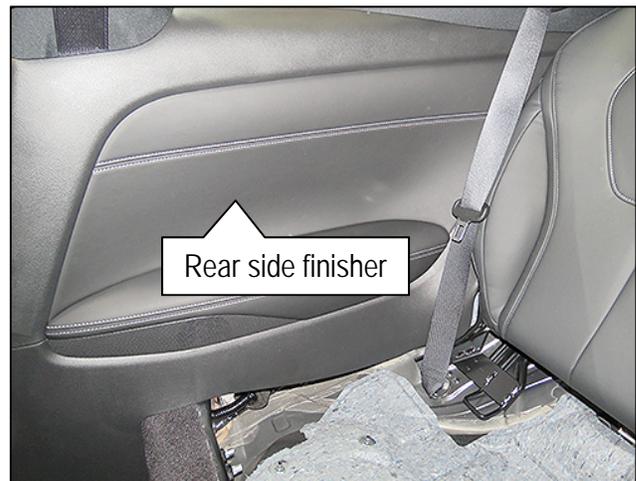
Figure 8

8. Remove the rear side finisher.
- For rear side finisher removal, refer to the ESM: Section **REPAIR > BODY INTERIOR > INTERIOR > REMOVAL AND INSTALLATION > REAR SIDE FINISHER**.
 - Do not remove the seat back.
- HINT:** The seat back will be folded down to allow the rear of the rear side finisher to be detached.

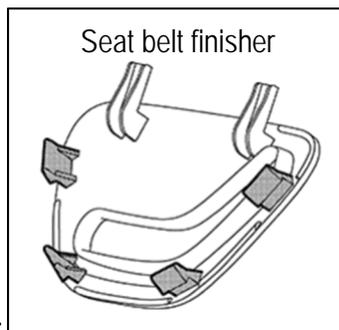
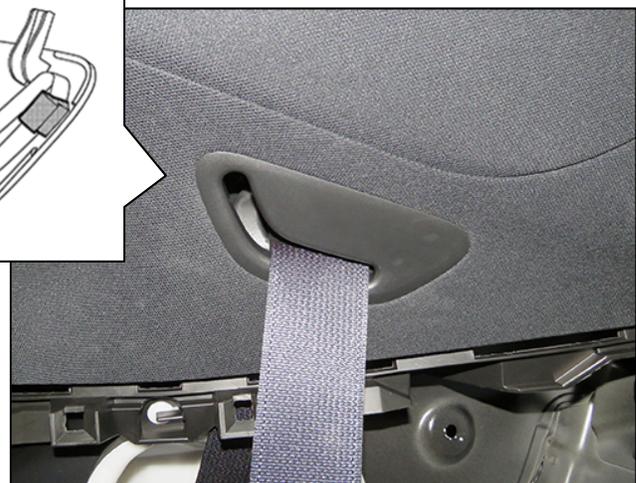
Figure 9

9. Remove the seat belt finisher.

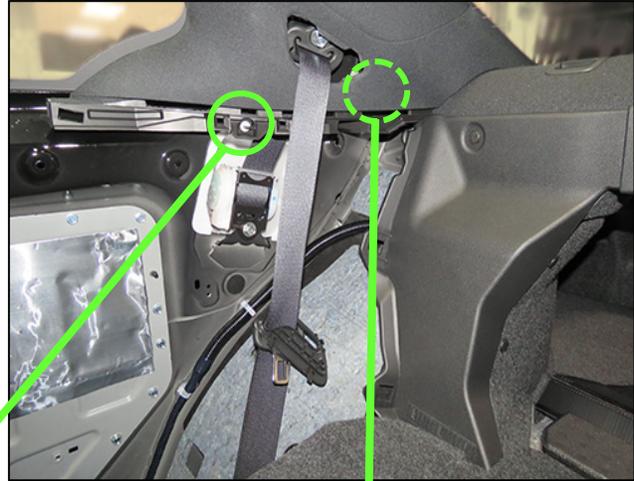
Figure 10

10. Detach the two (2) rear pillar finisher clips shown in Figure 11 and Figure 12.

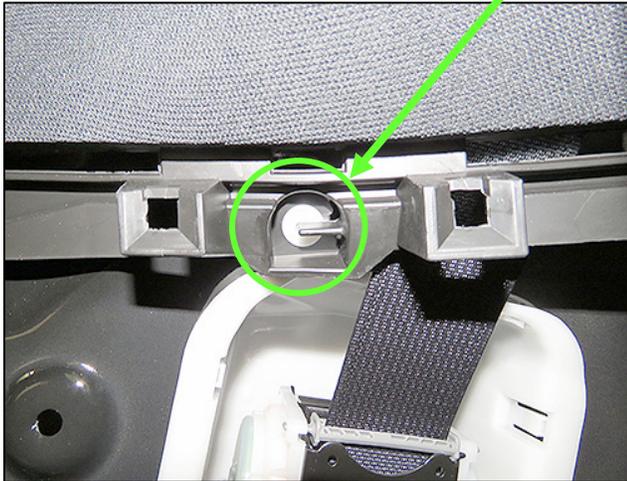
Figure 11

HINT: This will provide clearance to allow the seat belt to be removed.

IMPORTANT: Do Not remove the rear pillar finisher from the vehicle. If it is removed, it must be replaced, which is not included as part of the repair.

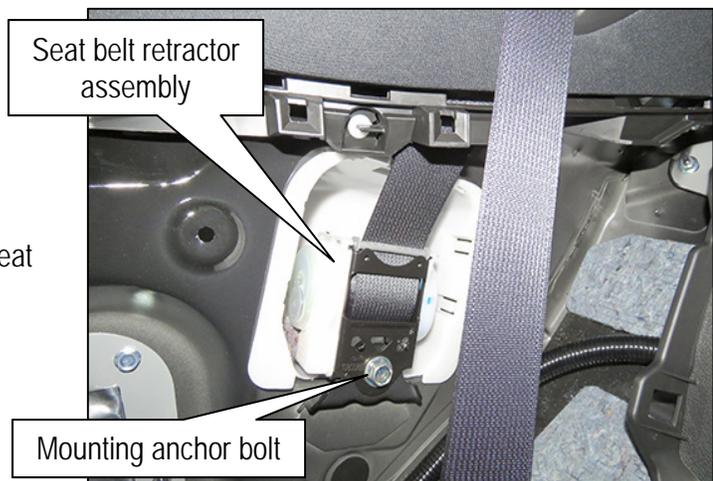
Figure 13

11. Remove the mounting anchor bolt of the seat belt retractor assembly.

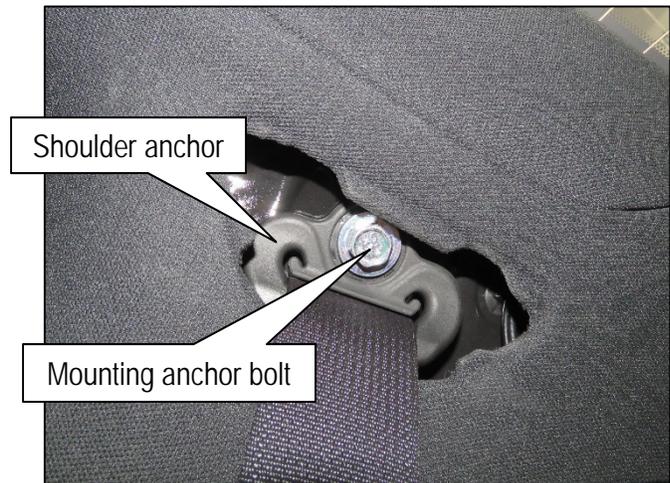
Figure 14

12. Remove the mounting anchor bolt of the shoulder anchor.

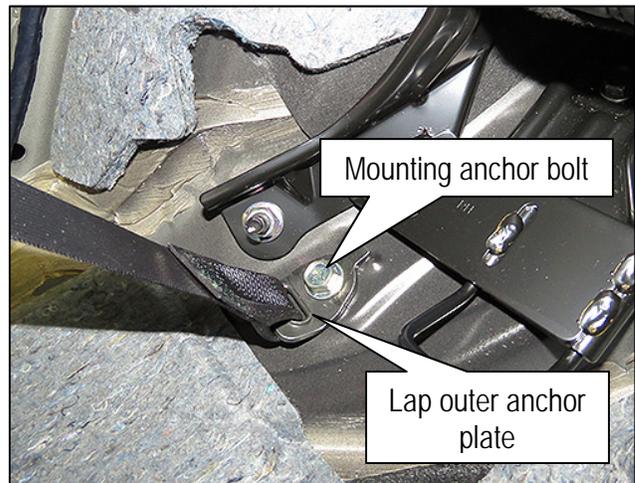
Figure 15

13. Remove the lap outer anchor plate mounting anchor bolt.

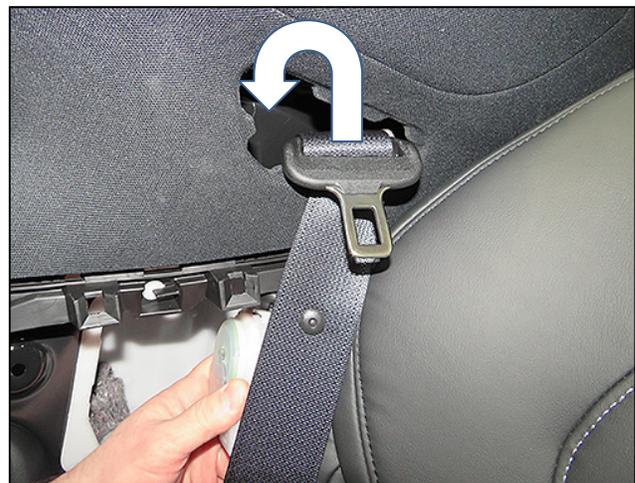
Figure 16

15. Install the new seat belt in the reverse order of disassembly.

- See the **PARTS INFORMATION** on page 8.
- Torque for all seat belt anchor bolts:
49 N•m (5.0 kg-m, 36 ft-lb)
