SIB 72 03 20

RECALL 20V-164: FRONT SAFETY BELT BUCKLES

BMW AG is conducting a Voluntary Safety Recall (effective March 13, 2020) on certain Model Year 2020 BMW vehicles that were produced between January 15, 2020 and March 4, 2020. The issue involves the hall sensor within the driver and/or passenger front seat safety belt buckle.

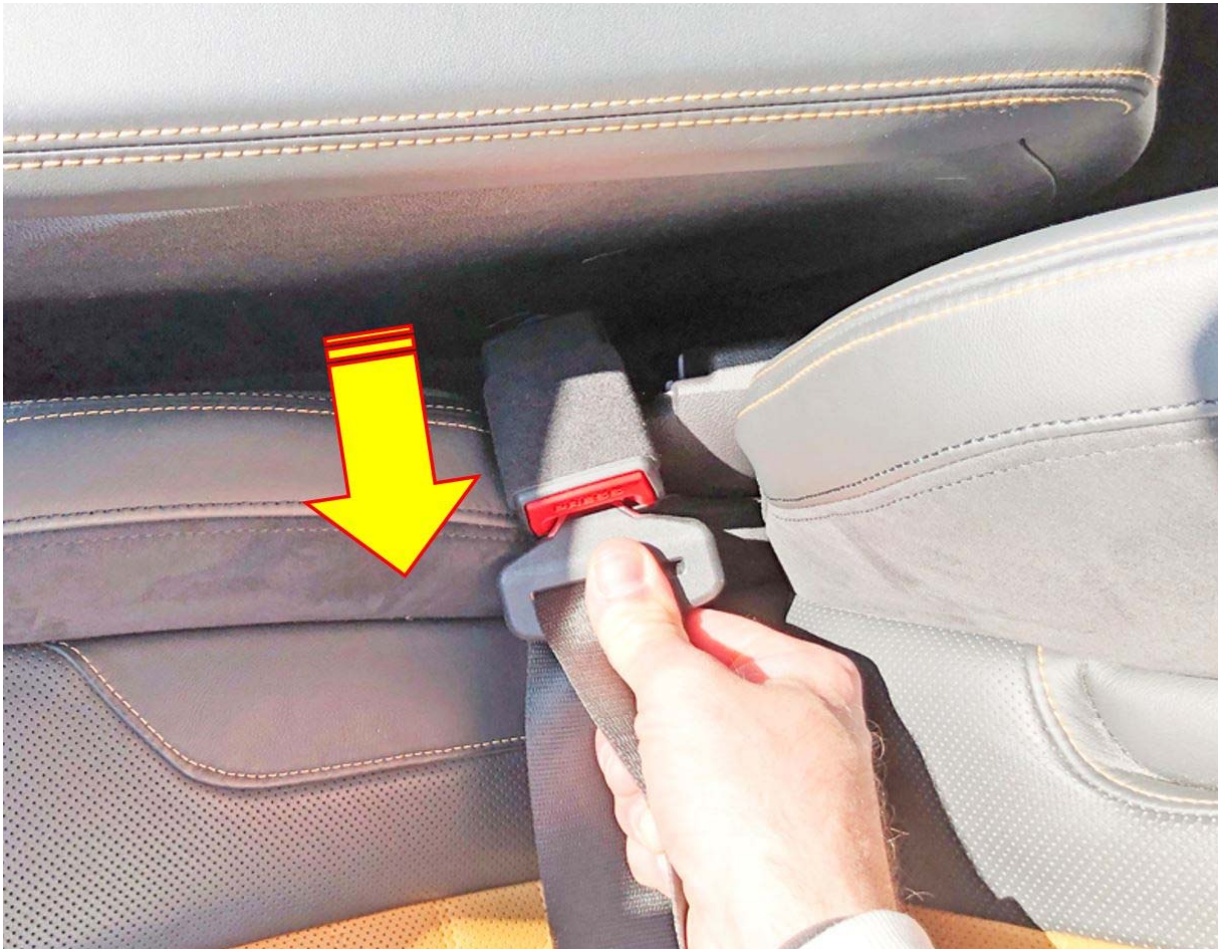
1. Place the front seat height at the lowest position.
2. Bend the buckle head 5 times towards the seat cushion to create a 90-degree bend of the buckle cable.

The safety belt is shown latched into the buckle but is not necessary. The belt end simply increases leverage.

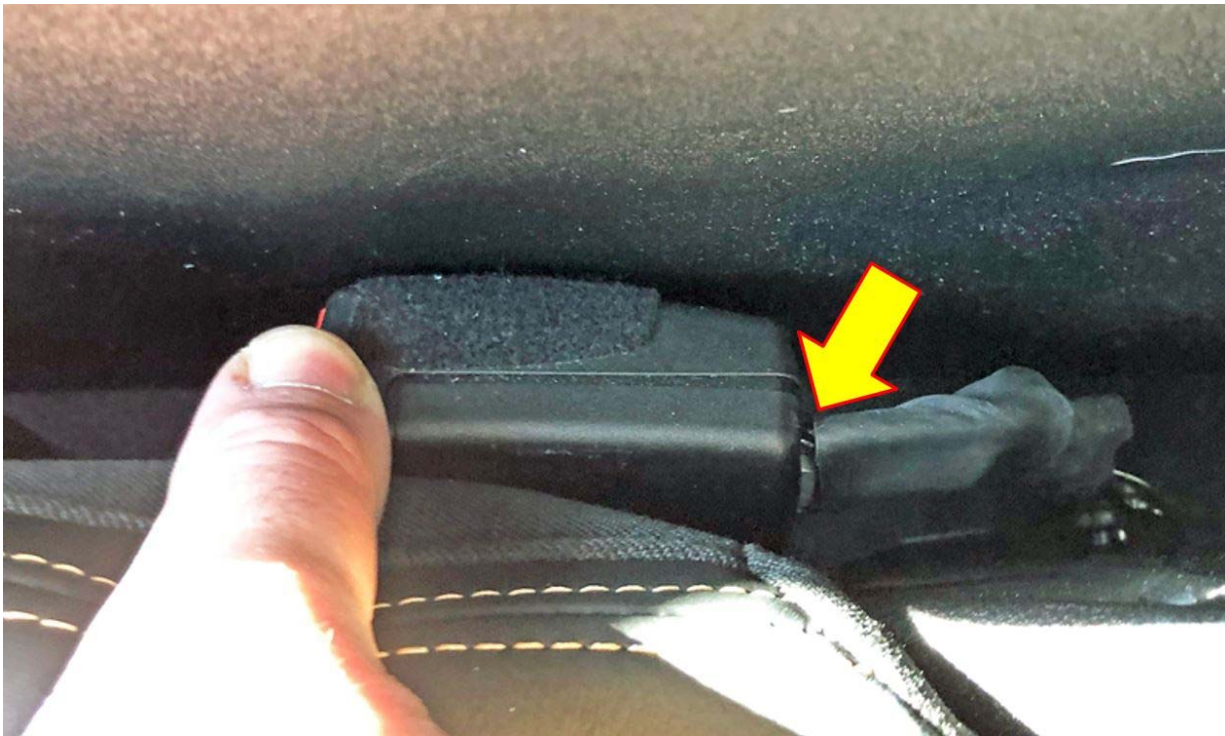
Inspect the bottom of the buckle. If needed for better access, bend the buckle forward. The hall switch connection is at the arrow.

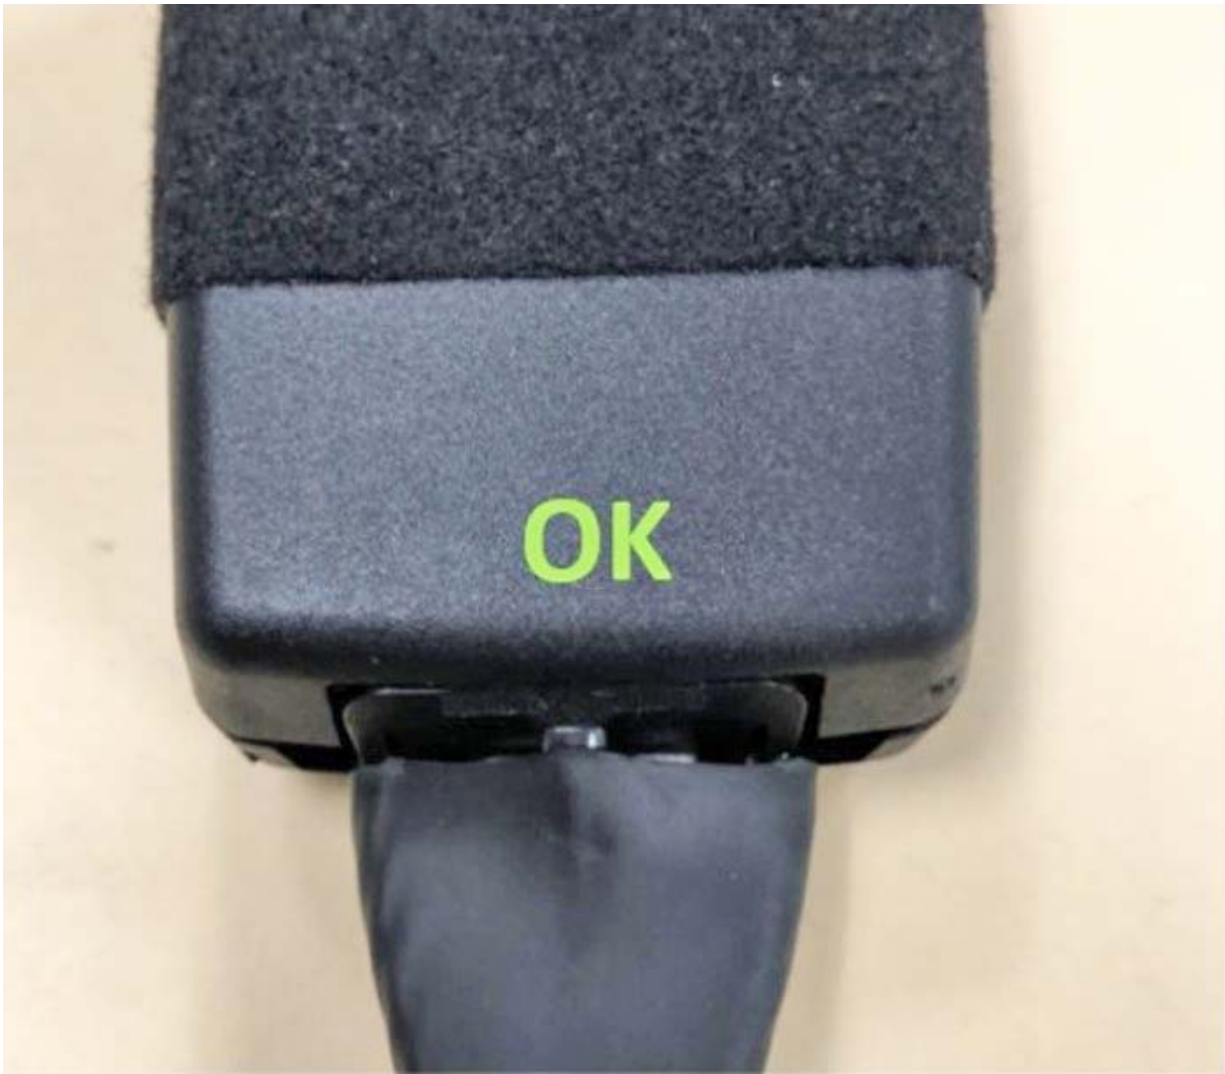
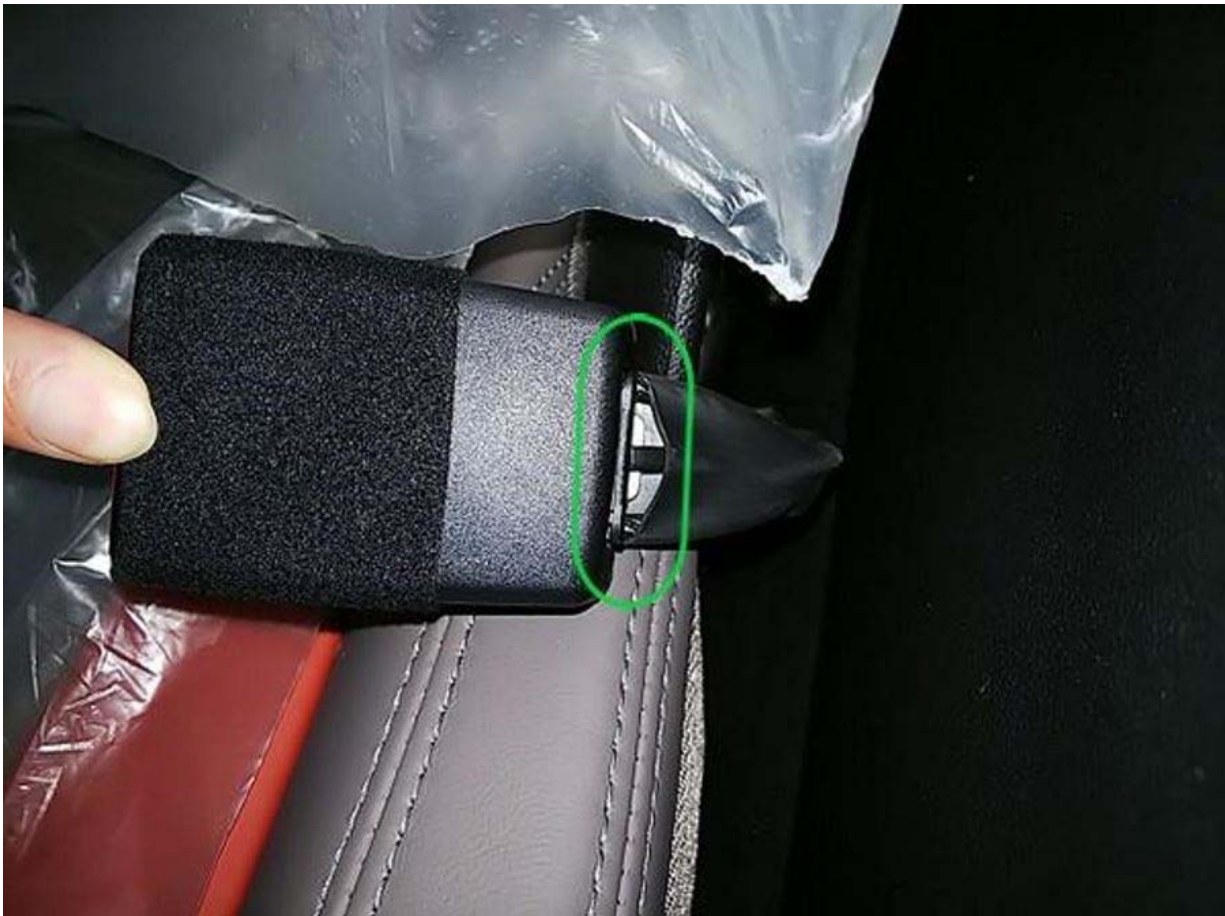
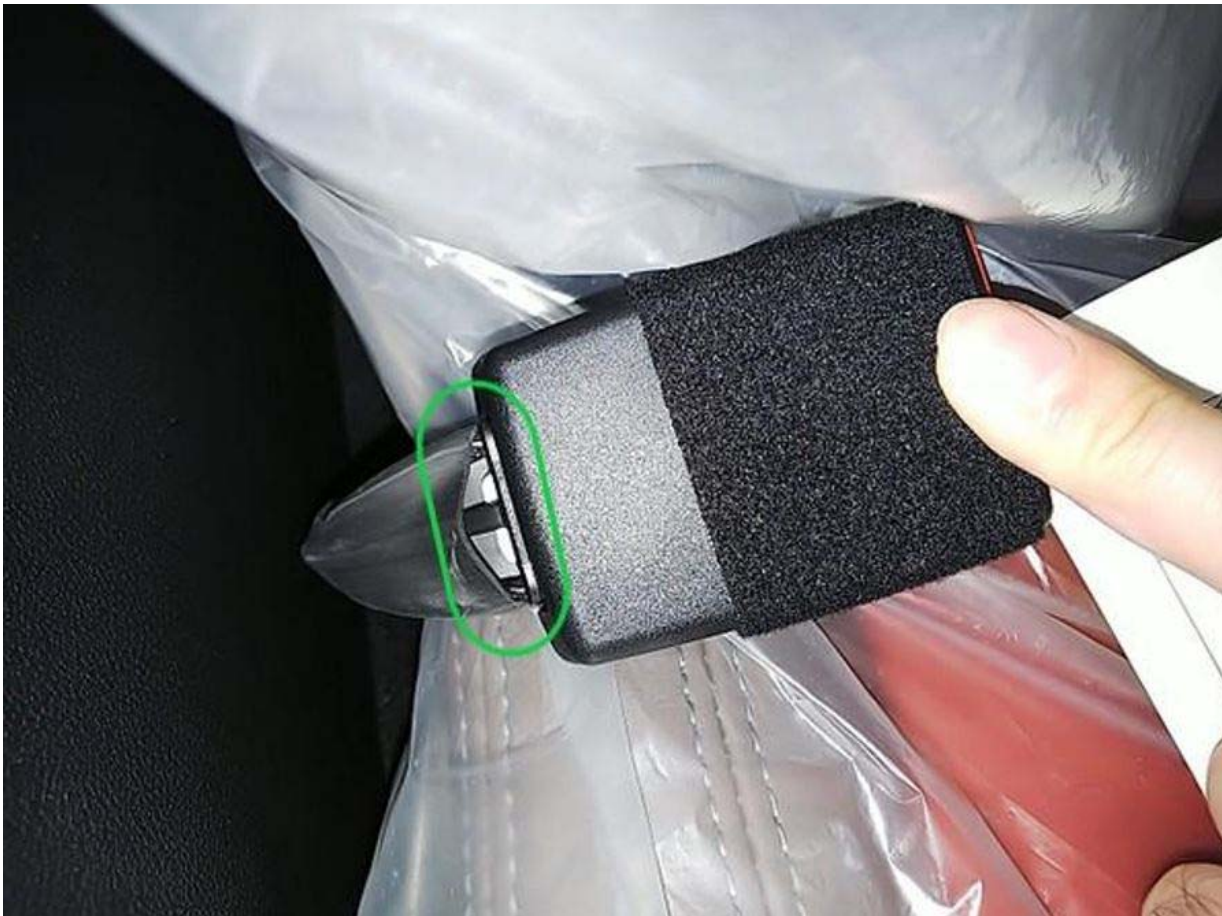
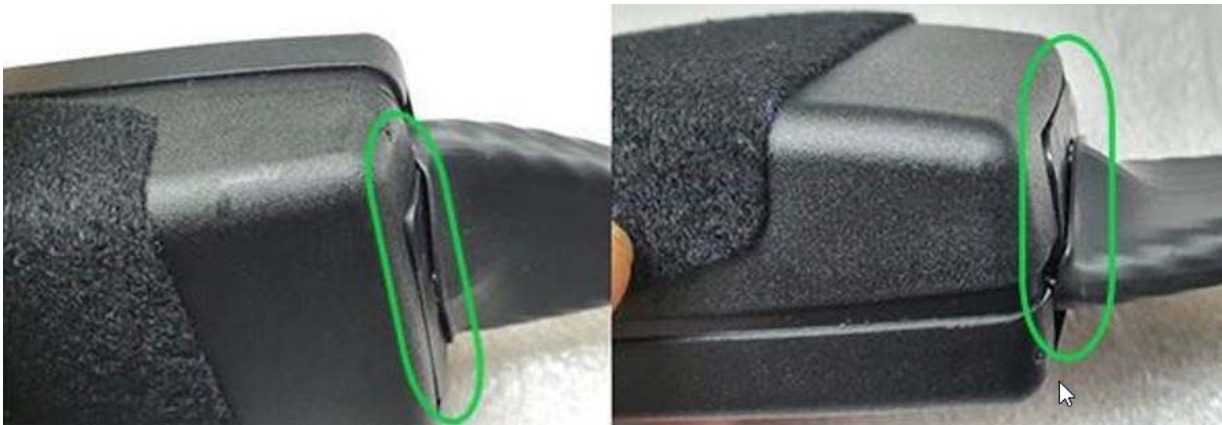
Verify visually if the hall switch remains in the correct position. Movement UP TO 3 mm is acceptable.

The pictures below show acceptable movement in green.

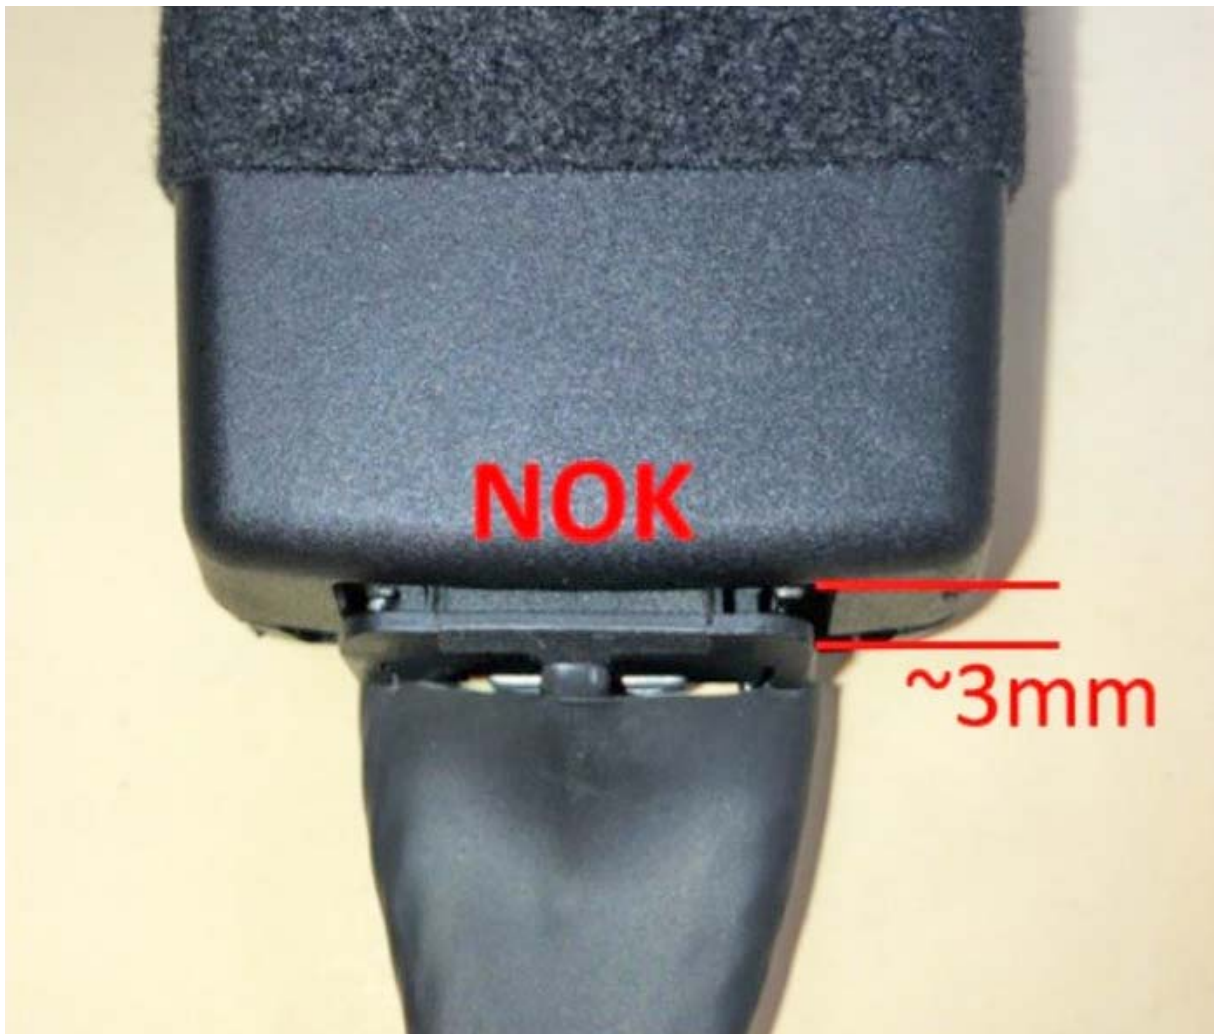
If there is a 3 mm or larger visual gap between the hall switch assembly and the buckle, replace the part.

The pictures below show unacceptable movement in red.

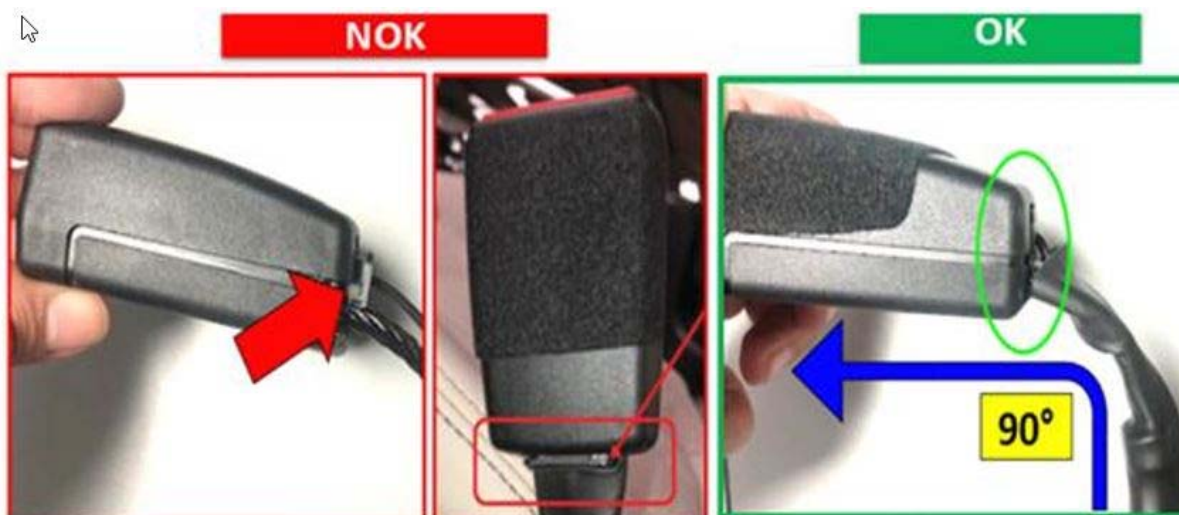
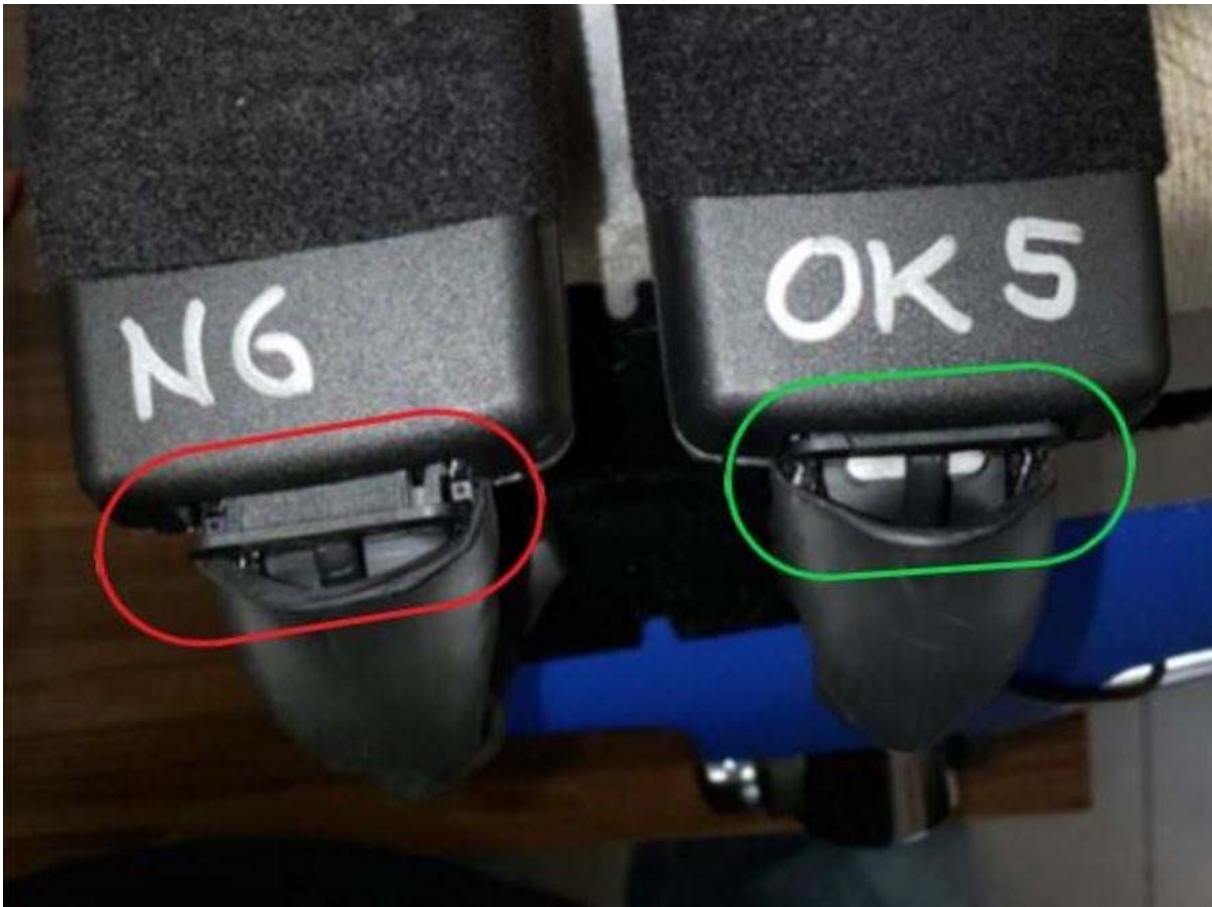
Side-by-side comparison

The following images show the difference between a good (i.O. or OK) and no good (marked as n.i.O., NG, or NOK) part.

After bending the safety belt buckle, the slipped-out hall sensor remains on a NOK safety belt buckle about 3 mm outside and will no longer sit flush, even if the safety belt buckle stretches again.

If the warning light stays on after latching the safety belt any time within these 5 cycles, replace the safety belt latch.

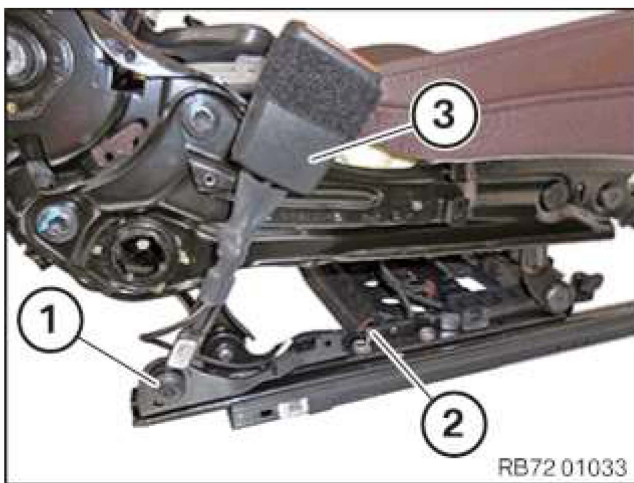
Installing the front lower strap

- Insert and position the lower strap (3).
- Renew the screw (1).

- Tighten down screw (1).
