Campaign No. 2020050034, June 2020

SUBJECT: **Model G-Class vehicles (463 platform)**
Model Year 2019-2020
Labeling Child Safety Lock

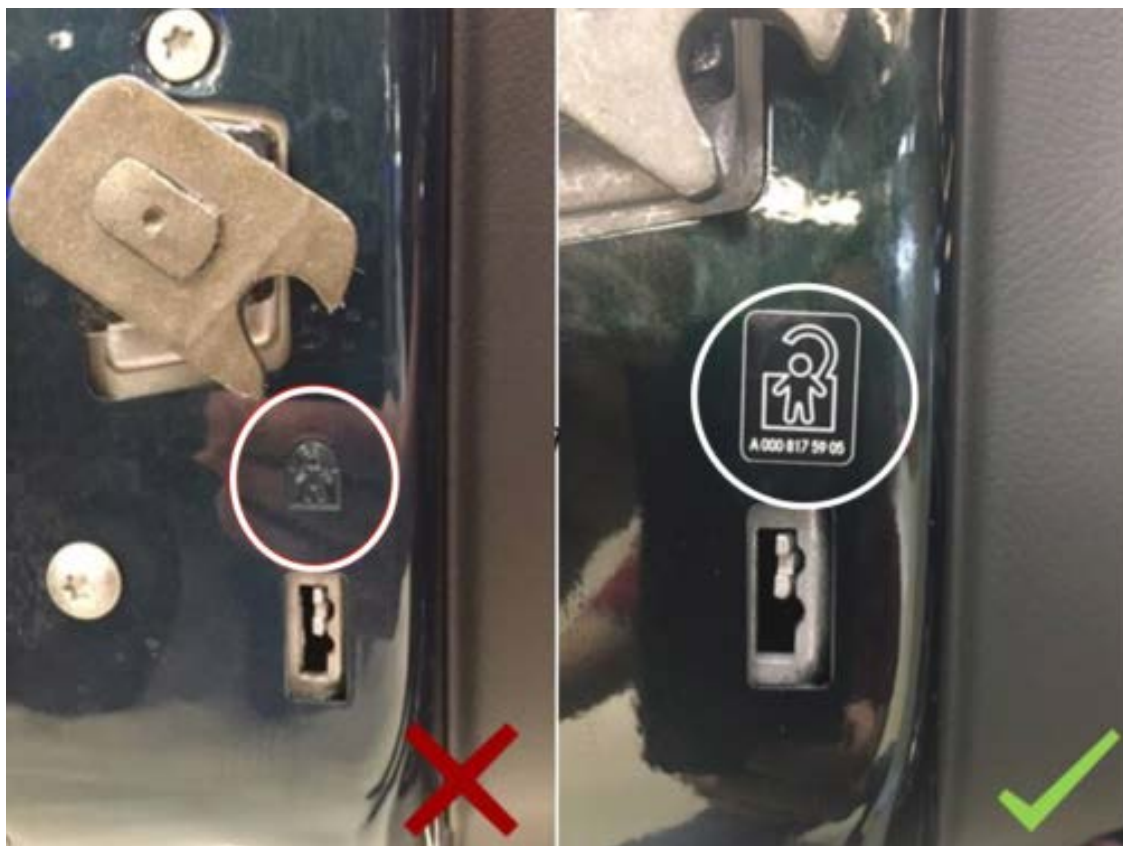
Figure 1

Mercedes-Benz AG ("MBAG"), the manufacturer of Mercedes-Benz vehicles, has determined that on certain Model Year ("MY") 2019-2020 G-Class vehicles (463 platform), the embossed lock symbol for the child safety lock operating lever on the rear doors might indicate the incorrect locking status of the child safety lock. In this case, the incorrectly embossed symbol could lead to a misinterpretation of the locking status of the child safety lock. As a result, the rear doors could be opened from the inside despite the indication of a locked door. Conversely, the rear doors could not be opened from the inside despite the symbol indicating that the rear door is unlocked. This could increase the risk of injury to the occupants in the second seat row. In the Operator's Manual, the operating direction of the child safety lock is stated and described correctly. An authorized Mercedes-Benz dealer will install a label on the rear doors with the correct child safety lock status.

1. Open both rear doors
2. Clean the area and affix, in each case, one label from the label set completely over the pictogram embossed in the sheet metal (**figure 1**) at both rear doors.
