RECALL

R20AR – Air Conditioner Circuit Breaker Installation

Models Affected: Certain Model Year 2020-2021 Vision and All American Buses Equipped with Blue Bird Air Conditioner Feature Numbers 30014-01 and 30014-03

Issue: Air Conditioner 100-Amp Circuit Breakers May Have Been Installed Incorrectly

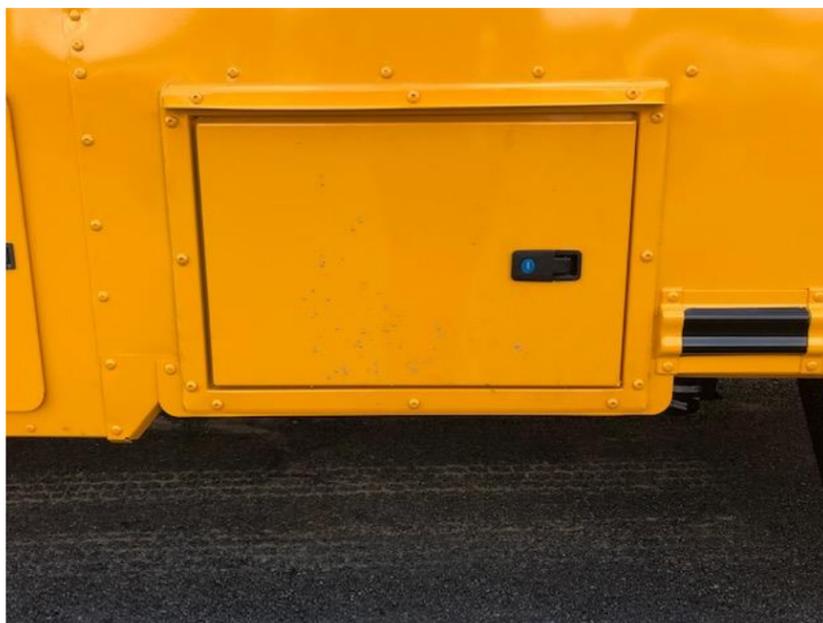
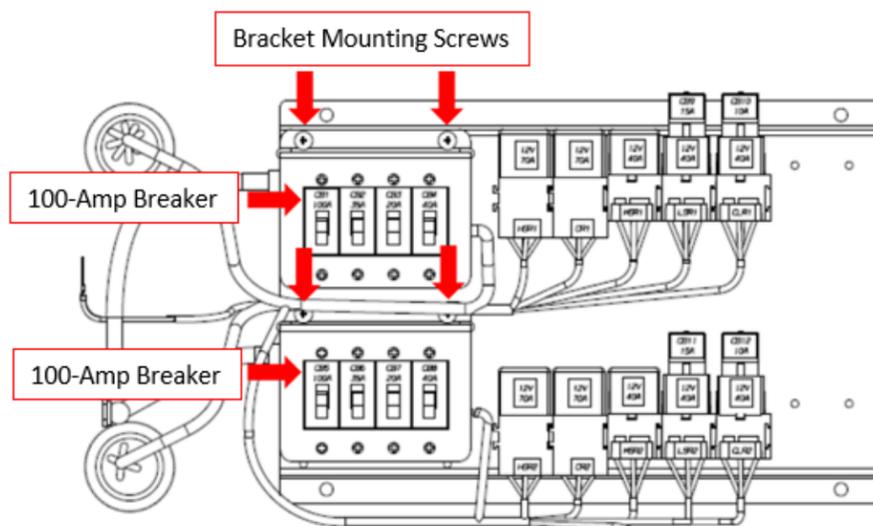
Compartment Door

1. Locate the 100-amp air conditioner circuit breakers. Note: The 100-amp breakers are identified on the decal that is located on the inside of the air conditioner electrical compartment cover.
 - a. For Vision and Front Engine All American, the circuit breakers are in the air conditioner electrical compartment which is on the left-hand skirt panel rear of the battery compartment.

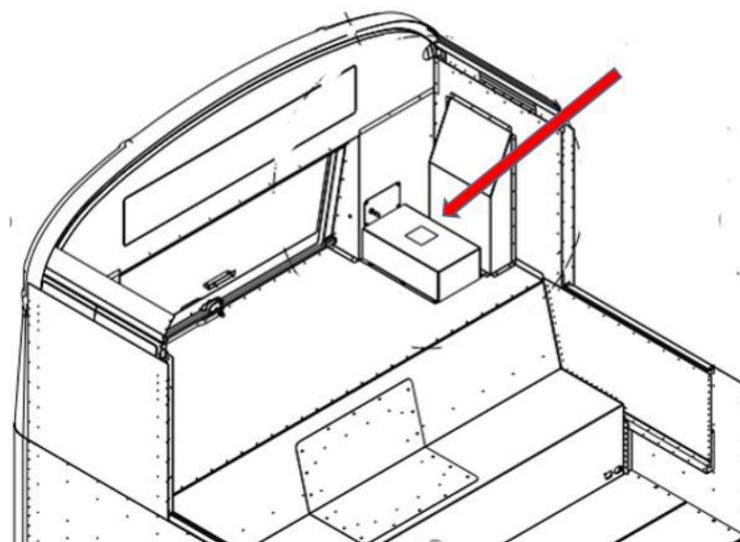
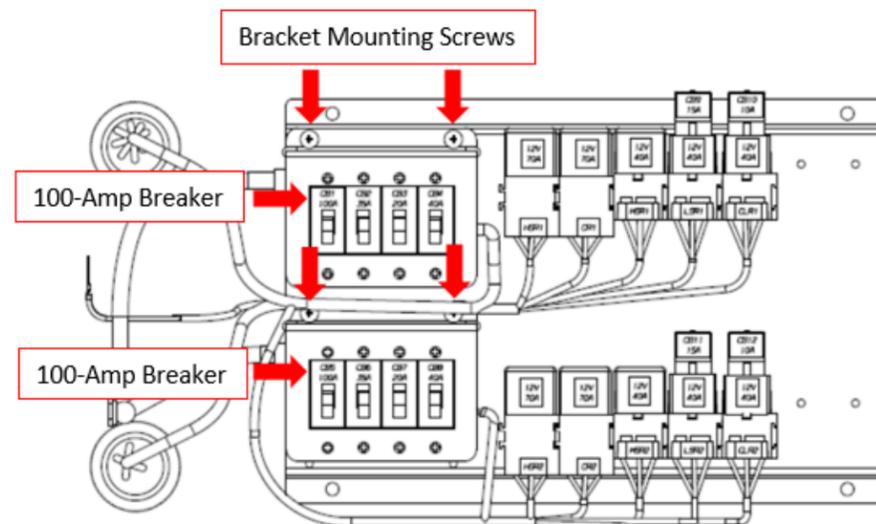
b. For Rear Engine All American, the circuit breakers are in the air conditioner electrical compartment, which is located on the rear davenport deck.

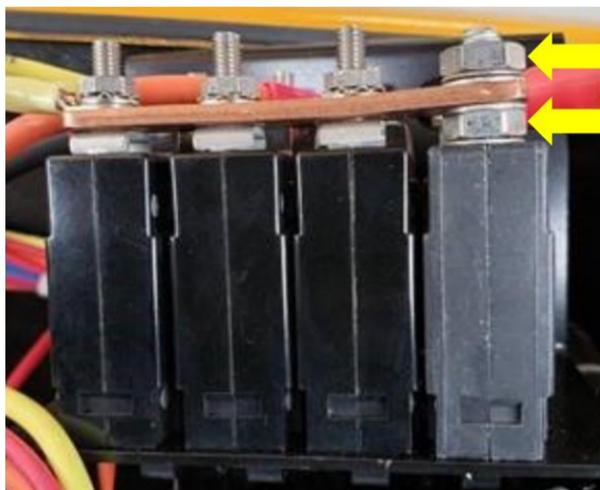
(Photo A) Correct

- a. Washers and #1/4-20 nut installed on top of the bus bar, as required.
- b. A #1/4-20 nut or spacer installed under the bus bar, as required.

2. Visually inspect 100-amp circuit breakers for correct installation of hardware and any signs of thermal damage. As required, use a Phillips screwdriver to remove bracket mounting screws to access rear side of circuit breakers. Note: A mirror or cell phone camera can be used to visually inspect the rear side of the circuit breakers. Refer to (Photo A) on page 3 for Correct installation of hardware.

3. Refer to (Photo A) for Correct installation of hardware. If installation of hardware is correct and no visible signs of thermal damage, replace bracket mounting screws using Phillips screwdriver. Reconnect batteries or turn battery disconnect switch on if equipped, and return bus to service.

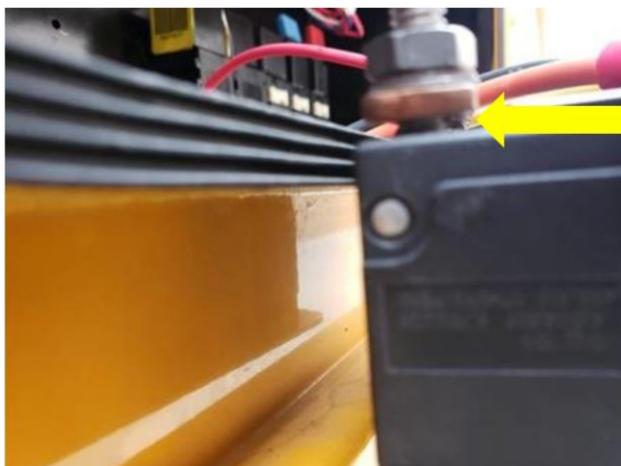
(Photo B) Incorrect

4. Note: On some buses the #1/4-20 nut below the bus bar was NOT installed. Refer to (Photo B) for Incorrect installation. Add #1/4-20 nut if it was not installed. Torque #1/4-20 nut to 30-35 IN-LBS.

- c. A #1/4-20 nut or spacer was NOT installed under the bus bar, as required.

Note: Torque #10-32 nuts to 15-20 IN-LBS, if required.
