Safety Recall

Code: 70H7

Subject	Instrument Panel/Passenger Airbag Deployment																		
Release Date	May 27, 2020																		
Affected Vehicles

Subject: Safety Recall 70H7 - Instrument Panel/Passenger Airbag Deployment

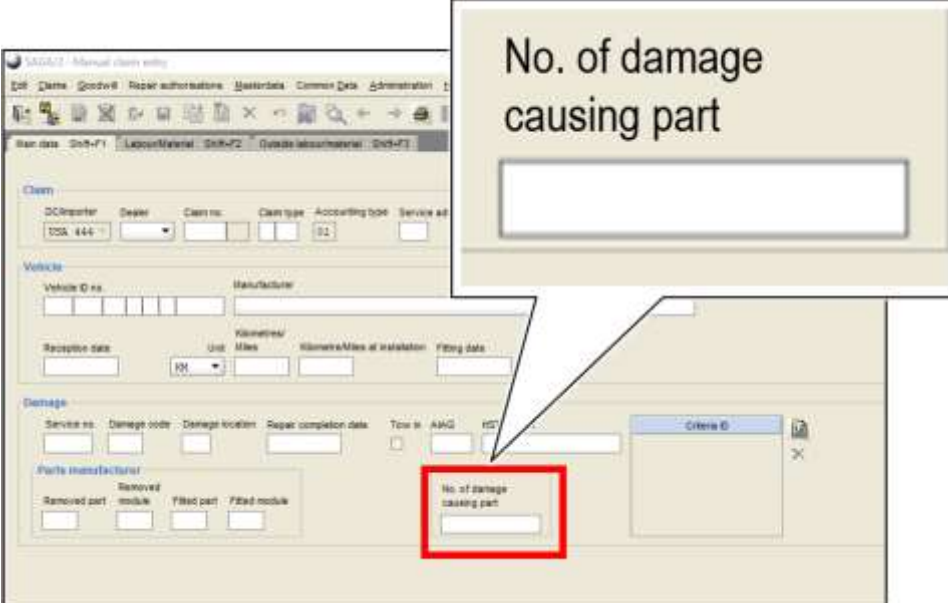
The screenshot shows the SAGA software interface for manual claim entry. The 'Damage' section is visible, with the 'No. of damage causing part' field highlighted in red. A callout box points to this field with the text 'No. of damage causing part'.

Enter the instrument panel serial number in the **"No. of damage causing part"** field in SAGA.

The entered format should be, SMPXXXXXX (letters SMP plus 7 numerals) . .

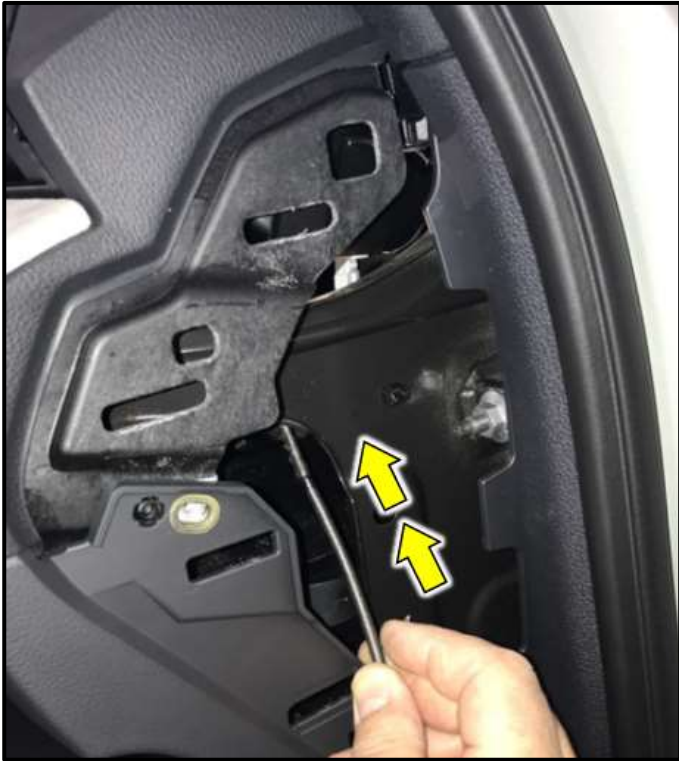
- Remove right (passenger) side instrument panel cover:
 - See ELSA Repair Manual: *Repair manual > Body > Body Interior > 70 Interior Trim > Instrument Panel > Instrument Panel Side Cover, Removing and Installing*
- Inspect using a borescope/endscope from the side and move it upwards towards data sticker for instrument panel.

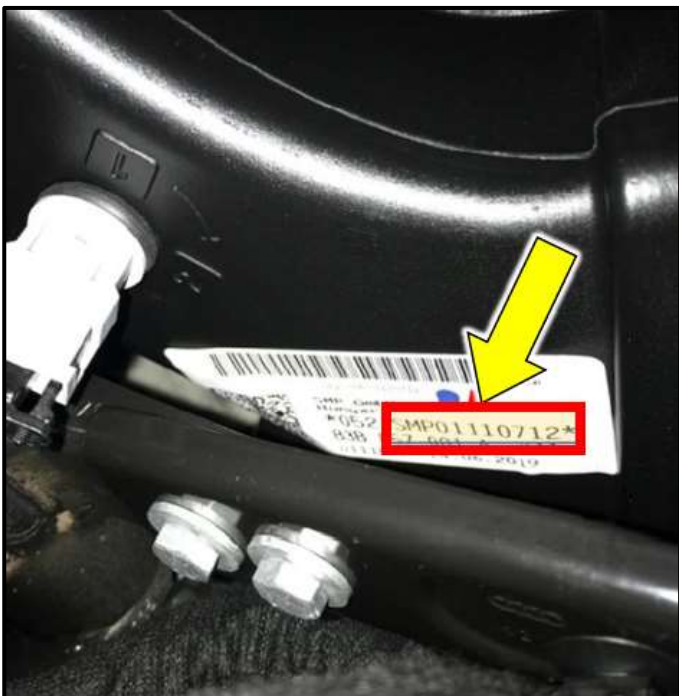
- The data sticker is located above the glove box on the air duct for the air vent.
- The data sticker will be next to an air vent temperature sensor.
- The serial number will start with the letters **SMP**.

Photo shows glovebox removed for clarity.

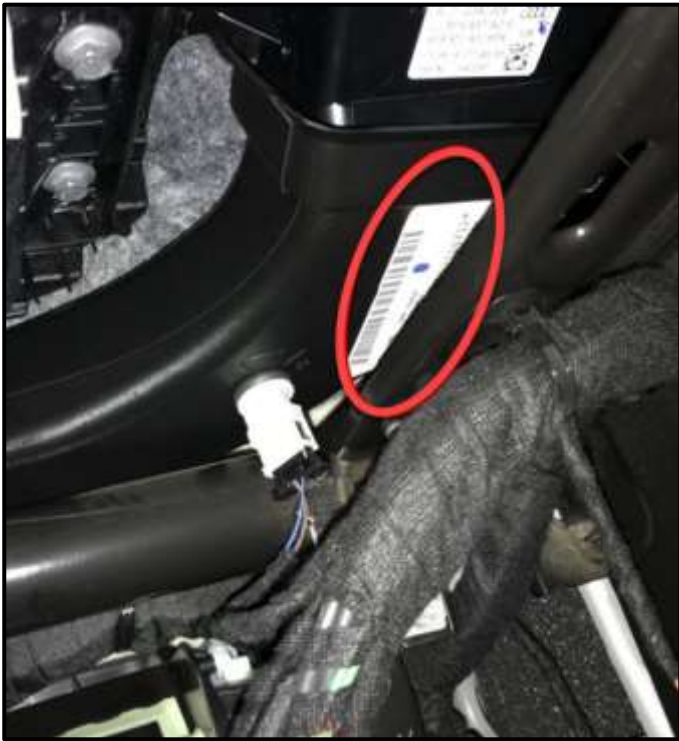
Photo is another example of the sticker location.

- Once the serial number is found, document the serial on the repair order and in any digital repair order notes.

The instrument panel serial number for all vehicles **MUST** be recorded for documentation purposes. The warranty administrator is required to enter the serial number in the SAGA claim.

- The recorded format should be, SMPXXXXXX (letters SMP plus 7 numerals).
