Safety Recall Code: 47Q2

Subject	Front Brake Caliper Bolts				
Release Date	June 24, 2020				
Affected Vehicles	Country	Beginning Model Year	Ending Model Year	Vehicle	Vehicle Count
	USA	2020	2020	JETTA	1
	CAN	2020	2020	GOLF	4
	CAN	2020	2020	JETTA	1
	 Check Campaigns/Actions screen in ELSA on the day of repair to verify that a VIN qualifies for repair under this action. ELSA is the <u>only</u> valid campaign inquiry & verification source. ✓ Campaign status must show "open." ✓ If ELSA shows other open action(s), inform your customer so that the work can also be completed at the same time the vehicle is in the workshop for this campaign. 				
Problem Description	The front brake caliper bolts may come loose. If a brake caliper bolt comes loose, it may affect the vehicle's brake performance, increasing the risk of a crash.				
Corrective Action	Replace front brake caliper bolts.				
Precautions	A metallic noise may be heard due to a loose brake caliper bolt. Customers experiencing this condition with their vehicle are advised to contact an authorized Volkswagen dealer without delay to have the vehicle inspected/repaired.

Subject: Safety Recall 47Q2 – Front Brake Caliper Bolts

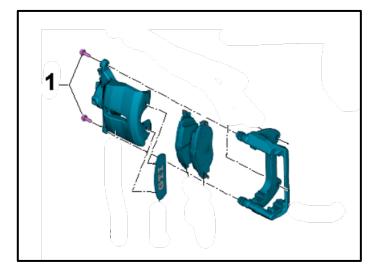
Repair Overview

Replace left front and right front brake caliper bolts <1>.

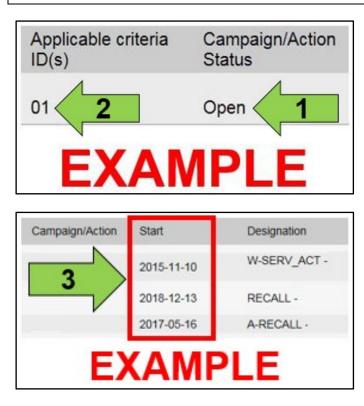
Enter the VIN in Elsa and proceed to the • "Campaign/Action" screen.

On the date of repair, print this screen and keep a copy with the repair order.

- Confirm the Campaign/Action is open • <arrow 1>. If the status is closed, no further work is required.
- Note the Applicable Criteria ID <arrow 2> for use in determining the correct work to be done and corresponding parts associated.

If multiple software update Campaign/Actions are open, they must be performed in order of the Start date <arrow 3>. The oldest should be performed first.

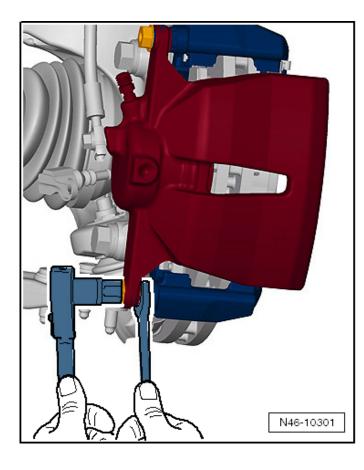
Section B – Replacing Brake Caliper Bolts

- Raise vehicle.
- Remove front wheels.
- Counterhold the guide pins and replace left front and right front brake caliper bolts one at a time.

Part Number	Part Description
WHT-003-252	Bolt

- Torque new caliper bolts to 35 Nm.
- Torque wheel bolts to 120 Nm.
