Safety Recall

Code: 01E7

Subject	Certification Label															
Release Date	July 09, 2020															
Affected Vehicles

Subject: Safety Recall 01E7 – Certification Label

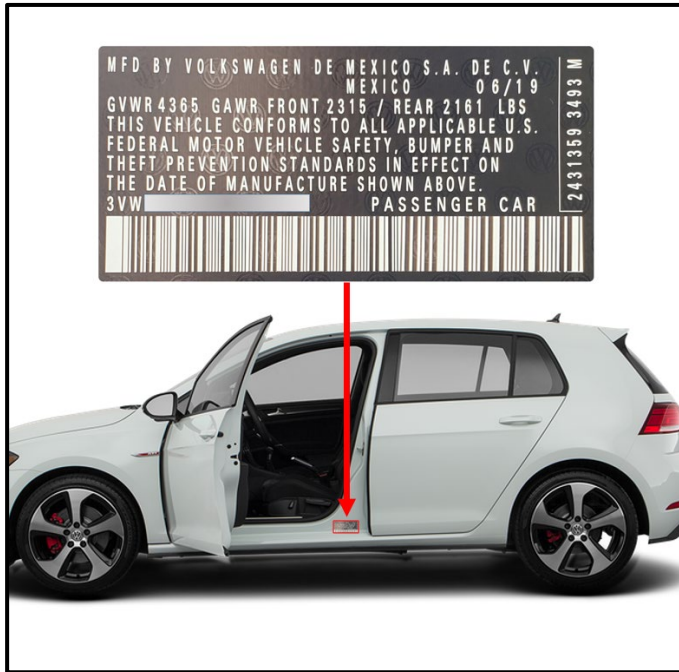
- Open the driver front door.
- Locate the “Safety Certification” label on the lower B-pillar.

- Clean the surface of the existing label.
- Peel the new label off the backing paper.
- Affix the new label over the existing label.
- Ensure minimal air bubbles are created when installing the new label.

- The surface of the existing label must be clean, dry, and free from oil residue prior to applying the new label.
- The new label MUST cover the existing label completely.
- Handle the new label carefully. Do not touch the adhesive backing.
