Quality Bulletin

Recall R10029: Front Seat Belt Fastener, Model Year 2007 - 2018 S60CC, S60L, V60CC, S60, XC60, V60, XC70, V70, S80, S80L

GROUP: 88	CAT/NO: R10029	ISSUING DEPARTMENT: Regulations and Compliance		CAR MARKET: United States and Canada	
REVISIONS: Updates to Section H. and Section I.				ISSUE DATE: 2020-09-23	STATUS DATE: 2020-09-23
Service Personnel: Read and initial		SERVICE MANAGER	SERVICE WRITER	WARRANTY ADMINISTRATOR	Page 1 of 4

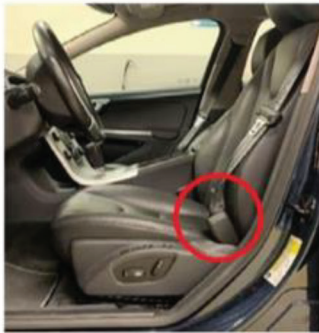
The seat belt lower fixing buckle rests in a position that is past the bolster of the seat

Customers can also prevent any damages to the cable from occurring when entering or exiting the vehicle (see image below). We recommend that the driver and front seat passenger secure that the seat belt fastening is in a vertical position, aligned with the backrest, so that it will not be bent over the seat cushion when entering the seat.

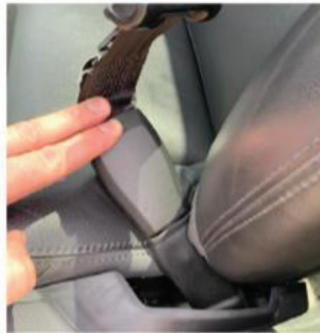
Volvo has identified an issue regarding the front seat belt fastening, mounted on the outboard side of the front seat. The front seat belt fastening cable, may under certain circumstances, suffer from wear and fatigue if repeatedly bent over the seat cushion. This could cause damage to the cable, which could result in reduced or no seat belt restraint function.

During entry, this "buckle" is permitted to fold over the lower cushion repeatedly

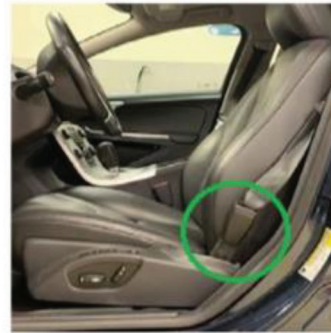
Seatbelt folded over onto the bottom of the seat

This can be avoided by placing the seatbelt as above before entry and exit
