**SUBJECT: FL855 – Limited Parts Availability**

September 2020  
FL855A  
NHTSA #20V-390  
Transport Canada #2020-305

## **Subject: Braking System Platform Single Modulator Valves**

**Models Affected: Specific Model Year 2017-2021 Freightliner  
Cascadia vehicles manufactured March 8, 2016, through  
June 25, 2020.**

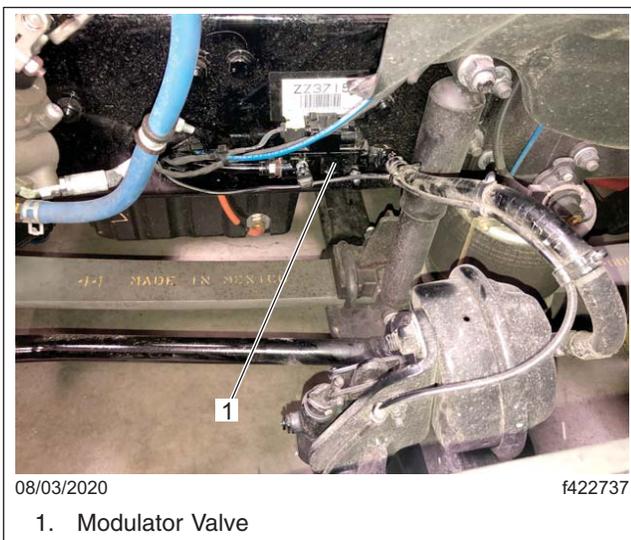
**Fig. 1, Locating the Modulator Valve**

4. Locate the modulator valve on the left-front frame rail behind the wheel. See [Fig. 1](#).
5. Using the flat end of a screwdriver, disconnect the electrical modulator valve connector on the front side of the frame rail above the front axle. See [Fig. 2](#).

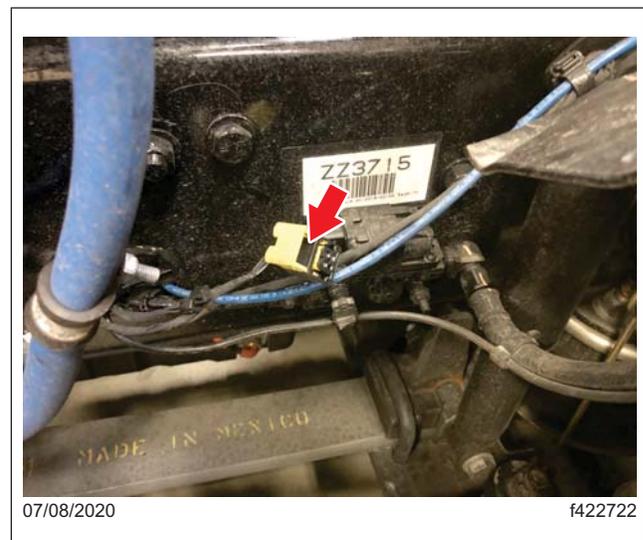
**Fig. 2, Electrical Connector**

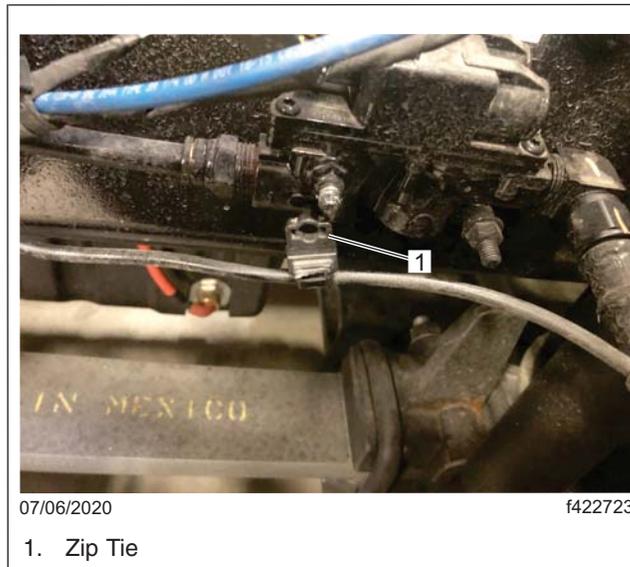
**Fig. 3, ABS Zip Tie**

6. Remove the ABS zip tie from the modulator mounting bolt. See **Fig. 3**.
7. Using special tool NQ307001-1 in kit number NQ307001, disconnect the plastic air line from the modulator valve. See **Fig. 4** and **Fig. 5**.

20. Install the ABS zip tie on the modulator mounting bolt (to prevent chafing). See [Fig. 3](#).

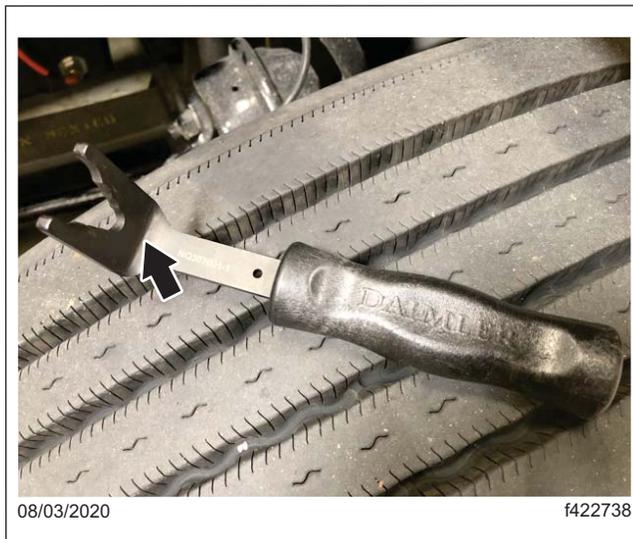
**Fig. 4, Special Tool NQ307001-1**

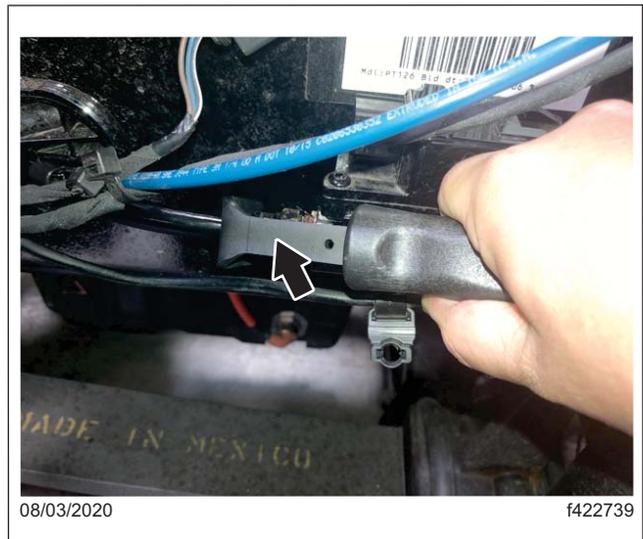
**Fig. 5, Disconnecting the Plastic Air Line**

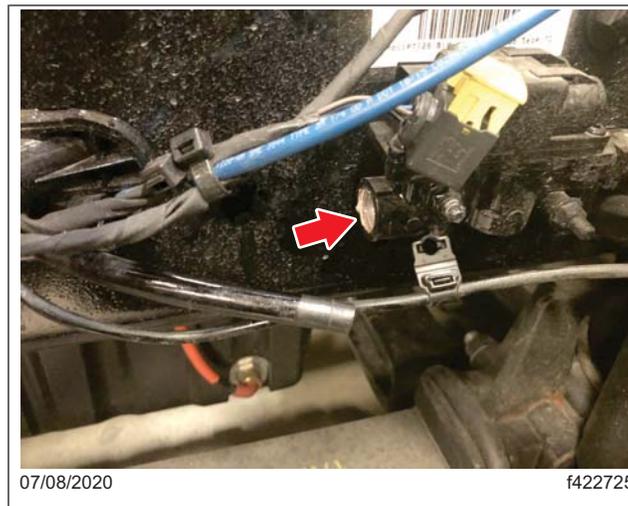
**Fig. 6, Disconnecting the Quick Connect Fitting**

8. Using a 7/8 inch wrench, remove the quick connect fitting from the modulator. See [Fig. 6](#).
9. Using a 7/8 inch wrench, remove the threaded air line that goes from the modulator to the brake chamber. See [Fig. 7](#).

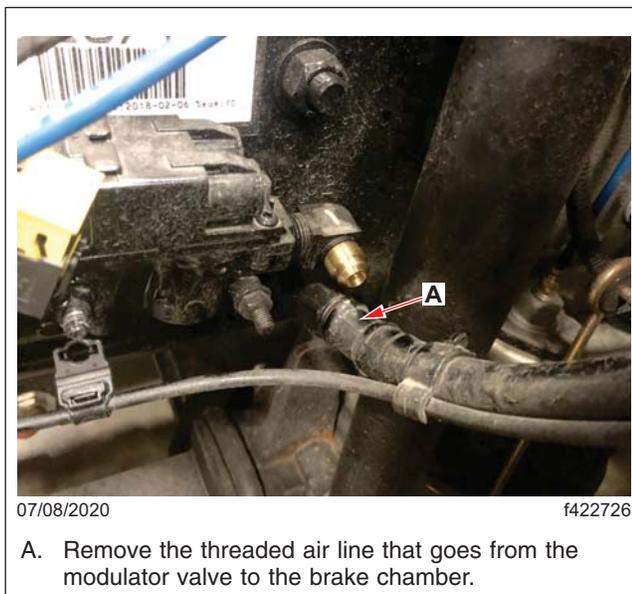
**Fig. 7, Removing the Threaded Air Line**

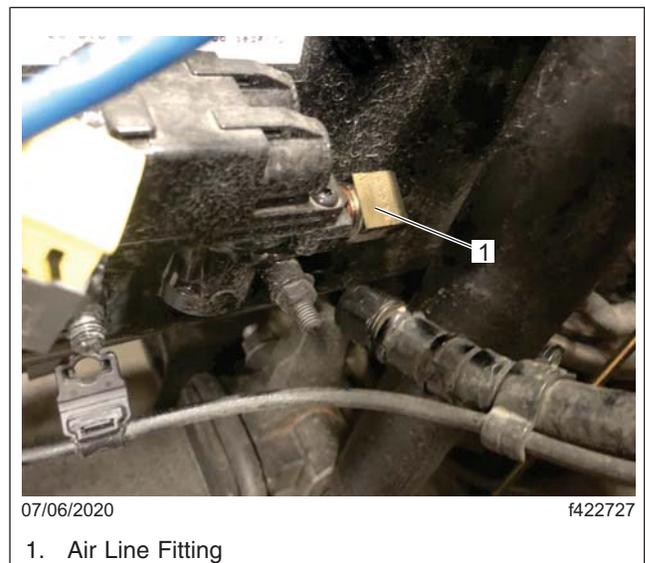
**Fig. 8, Loosening the Brake Chamber Air Line Fitting**

10. Using a 23 mm wrench, loosen the brake chamber air line fitting on the modulator valve. See [Fig. 8](#).

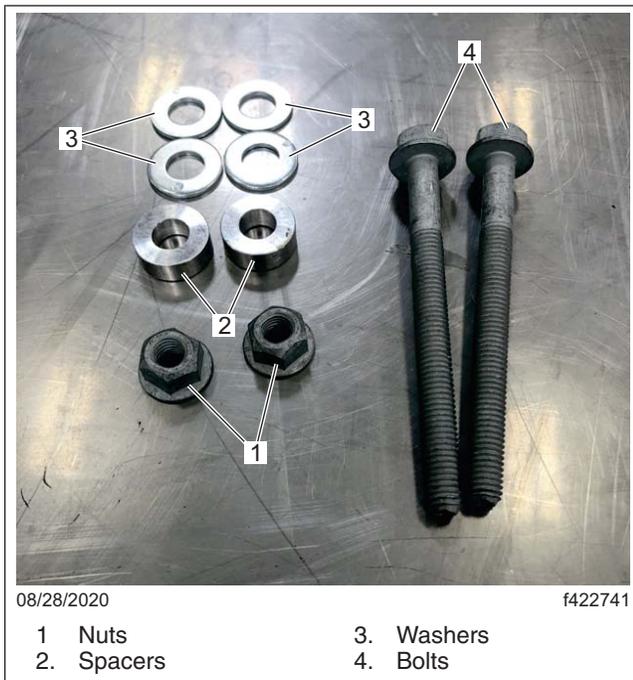
**Fig. 9, 25-FL855-001 Kit Components**

11. Using a 1/2 inch socket wrench, remove the two modulator valve mounting bolts, then remove the modulator valve from the vehicle.
  12. Using a 23 mm wrench, remove the brake chamber air line fitting from the modulator valve.
- IMPORTANT: Be careful when applying sealant to the threads of the air line fitting to avoid internal contamination of the air system.
13. Clean any old sealant off of the threads and apply Loctite® 567 on the quick connect fitting.
  14. Using a 23 mm wrench install the brake chamber air line fitting on the new modulator valve.
  15. Using a 1/2 inch socket wrench and the new bolts, spacers, and washers from the kit, install the modulator on the vehicle. Tighten the bolts 11 lbf-ft (15 N-m). See [Fig. 9](#), [Fig. 10](#), [Fig. 11](#), and [Fig. 12](#).

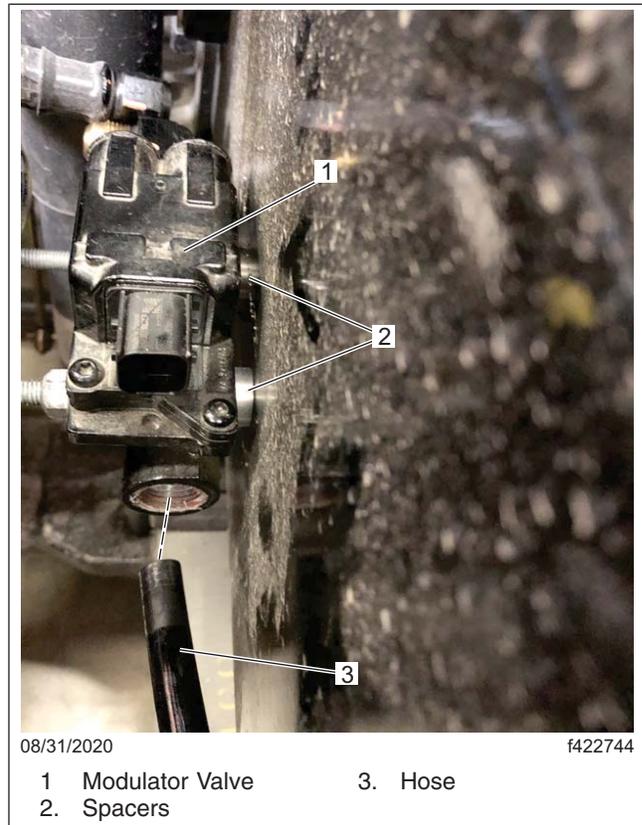
**Fig. 10, Installing the Spacers**

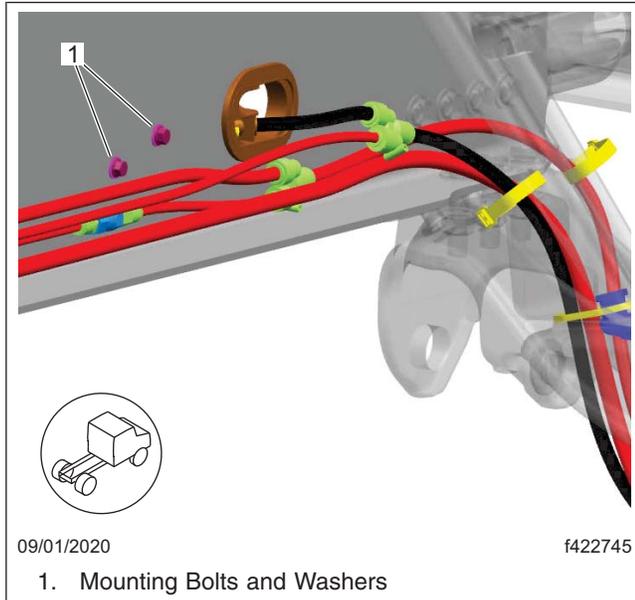
**Fig. 11, Modulator Valve Mounting Bolt and Washers;  
Inside Frame Rail View**

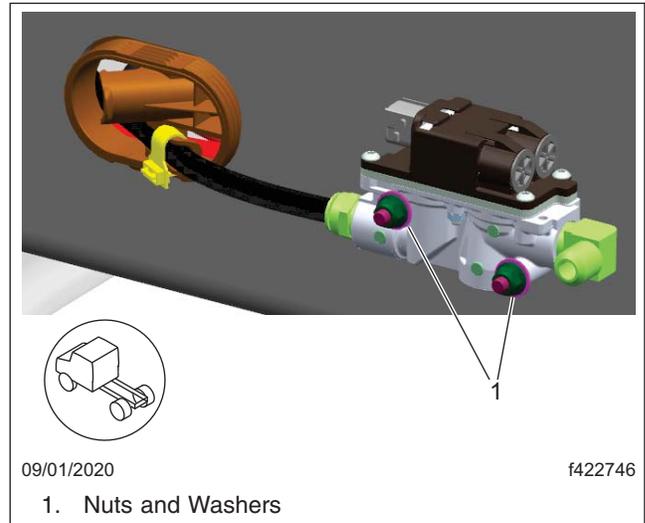
**Fig. 12, Modulator Valve Nuts and Washers; Outside  
Frame Rail View**
