Safety Recall: 2018 – 20 Odyssey Sliding Door Outer Handle CablesSupersedes 20-024, dated September 23, 2020, to revise the information highlighted in **yellow**.**AFFECTED VEHICLES**

REVISION SUMMARY**Under REPAIR PROCEDURE, step 7 was revised.****BACKGROUND**

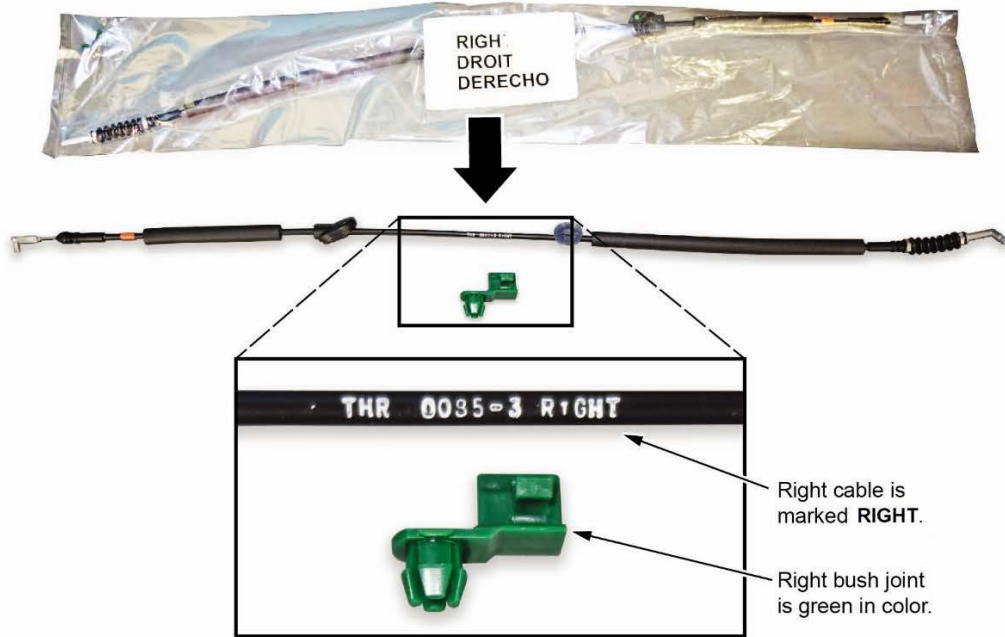
RIGHT CABLE AND BUSH JOINT

Part Name	Part Number	Quantity
Sliding Door Outer Handle Cable Kit (includes right and left side)	06721-THR-308	1

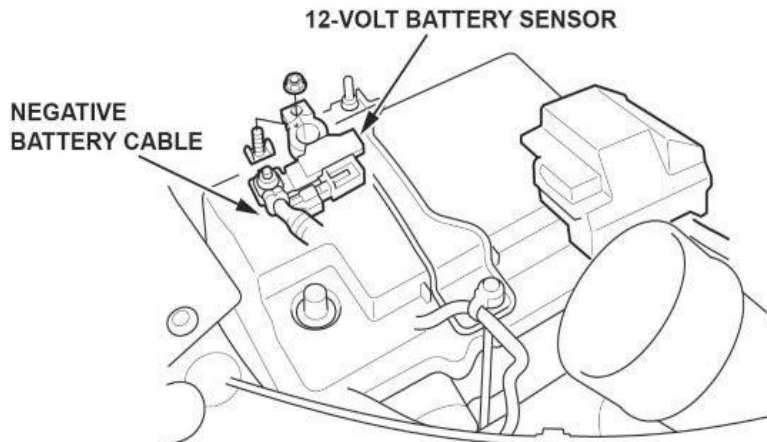
- Always disconnect the negative terminal first.

- To protect the battery sensor connector from damage, do not hold it when removing the terminal.
- Do not disconnect the 12-volt battery sensor from the cable.
 - 4.1. Make sure the ignition is turned to OFF.
 - 4.2. Disconnect and isolate the negative cable with the 12-volt battery sensor from the 12-volt battery.
 - 4.3. Disconnect and isolate the positive cable from the 12-volt battery.

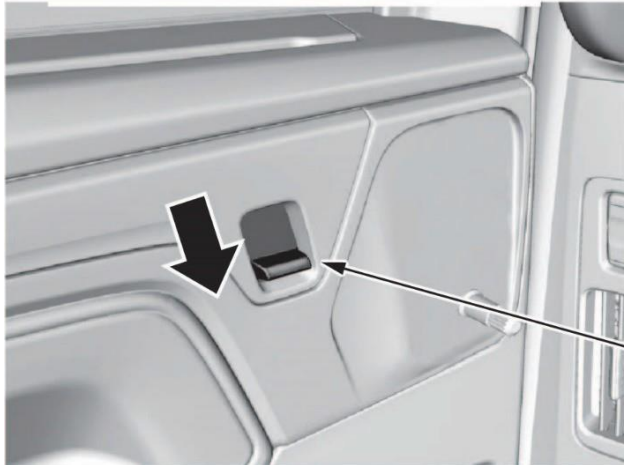
6. With the sliding door open, push the door lock knob down to the locked position to prevent it from being damaged when removing the door panel.

Push the door lock knob down.

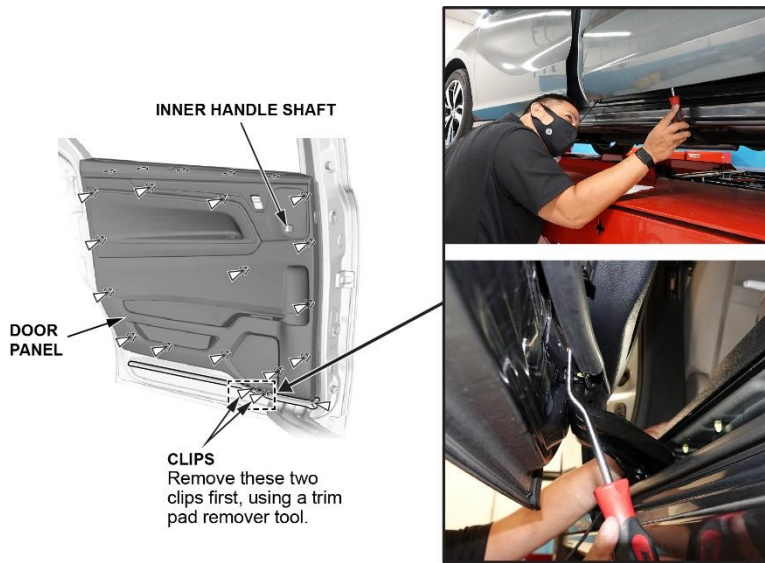
Revised Image

7. Remove the two clips at the bottom of the door panel first **with a trim pad remover** to release the lower door seal from the door panel

NOTE: Removing the two clips prevents pulling the door seal off the door as the door panel is lifted and removed.

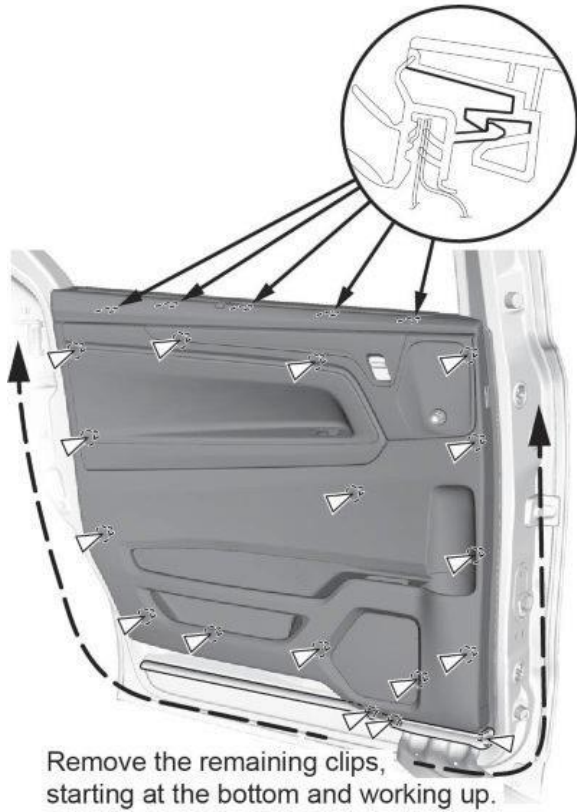
8. Starting at the bottom of the door panel, remove the remaining clips with a commercially available trim pad remover.

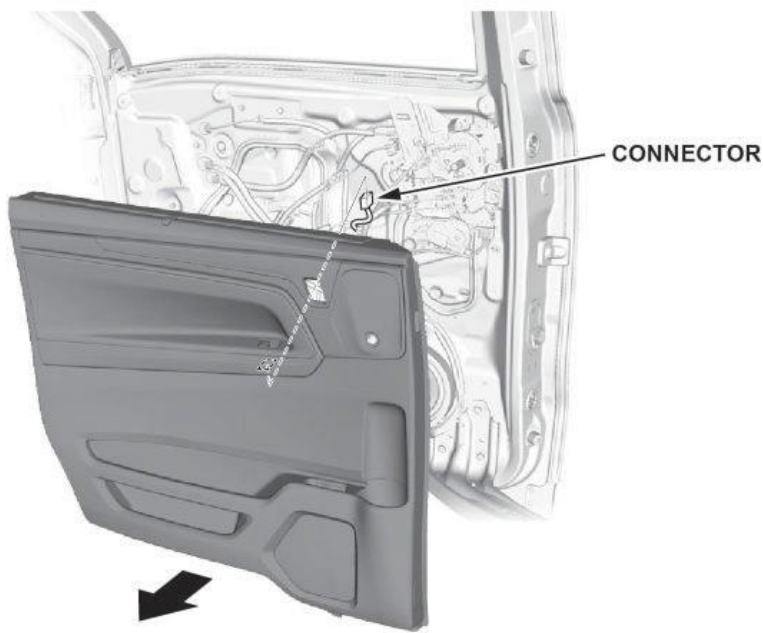
10. While holding the sliding door panel away from the door, disconnect the connector. Then, remove the door panel.

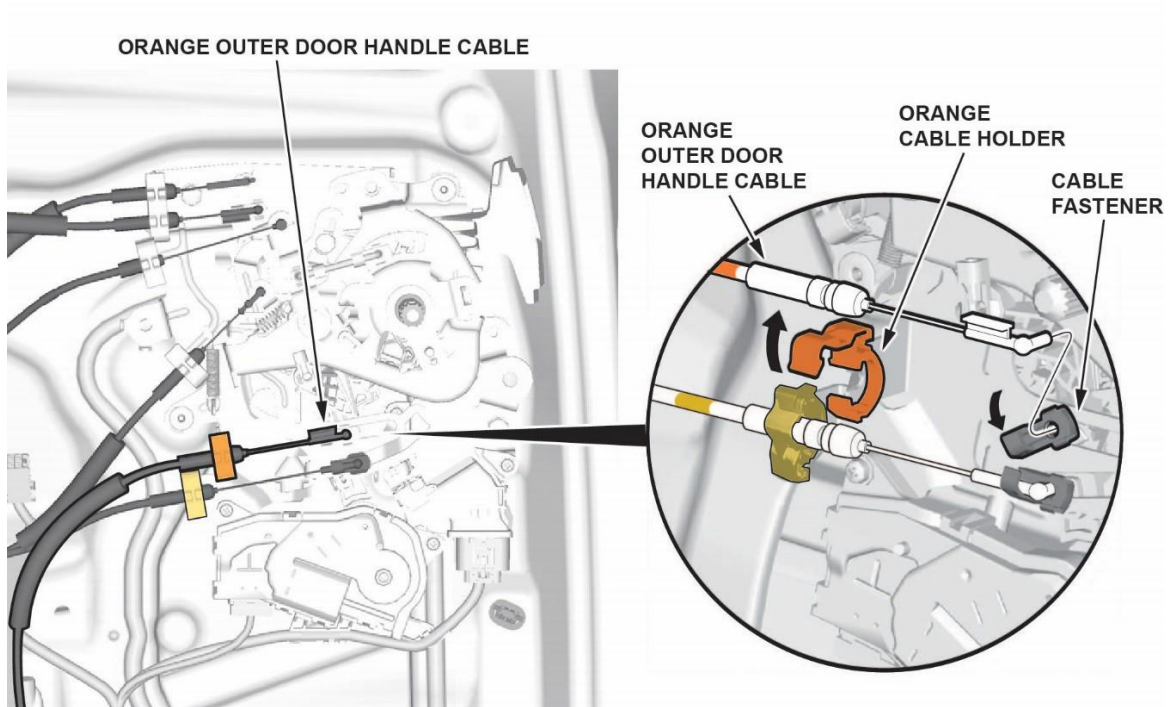
12.1. Release the cable holder and cable fastener, then disconnect the orange outer handle cable.

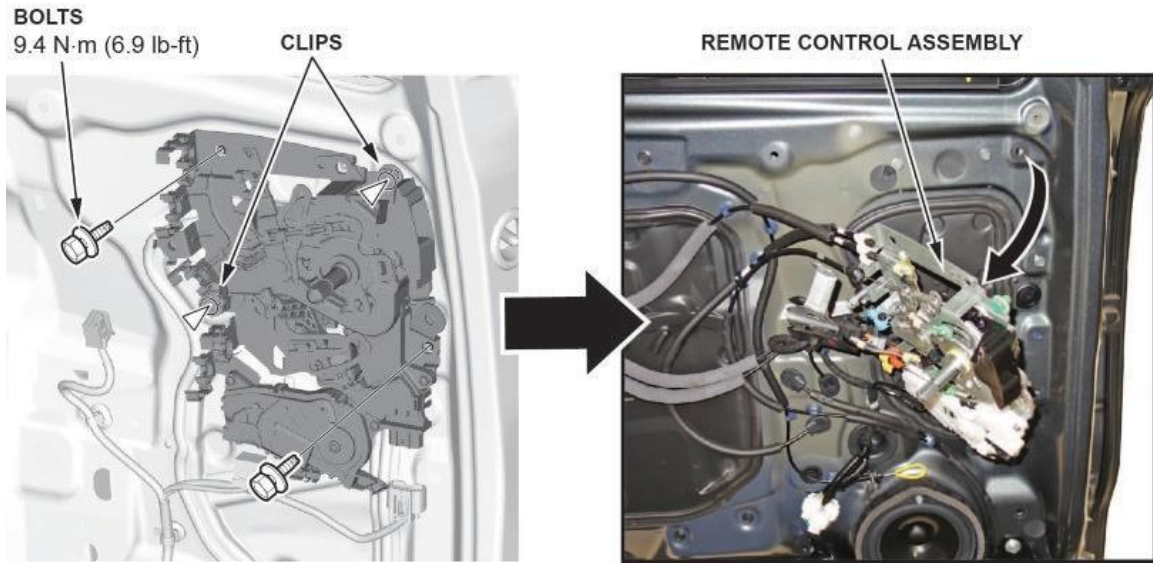
- 12.2. Remove the **10 mm** bolts and green clips, then detach the remote control assembly.
NOTE: Do not completely remove the remote control assembly. Just detach it from the door panel assembly to sliding door panel barrier B.

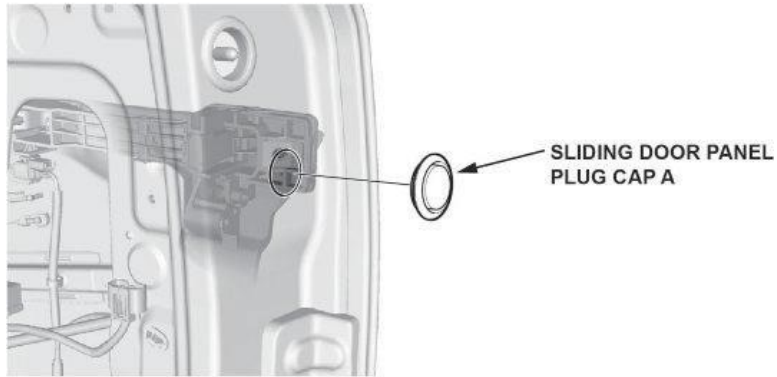
14. Remove sliding door panel plug cap A.

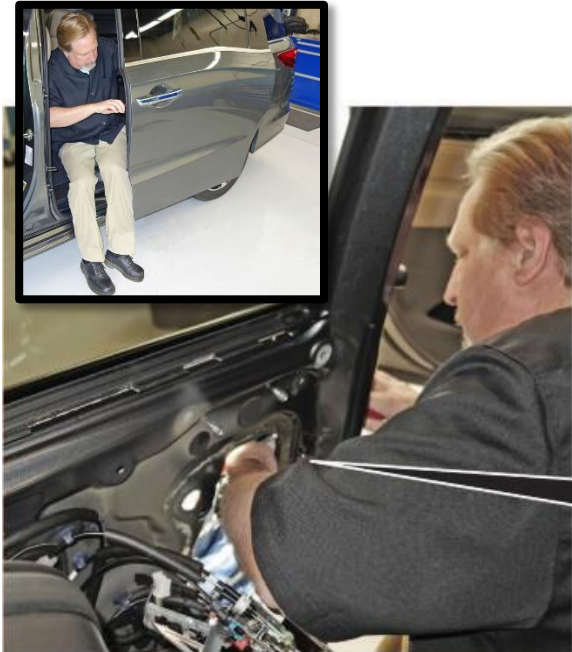
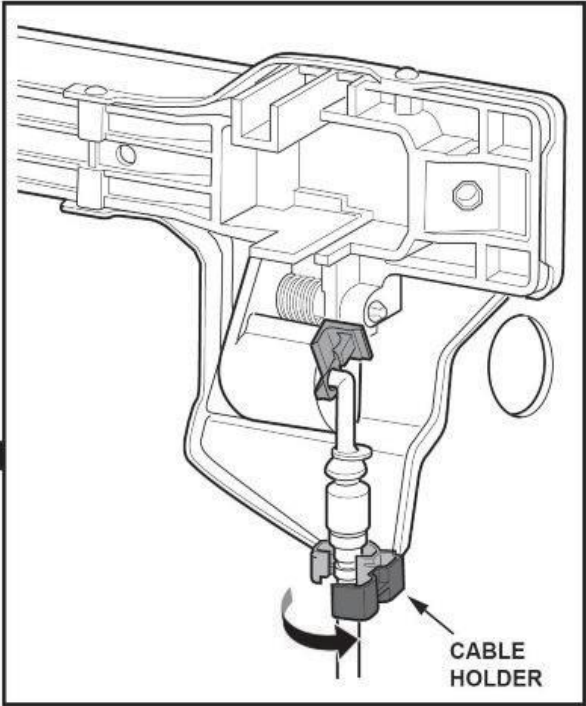
16. Sit in the sliding door opening with both legs in front of the lower roller as shown to avoid straddling the lower roller, then detach the cable holder.

Be careful when getting into position or exiting the vehicle. Avoid accidentally kicking and possibly damaging the sliding door articulating harness.

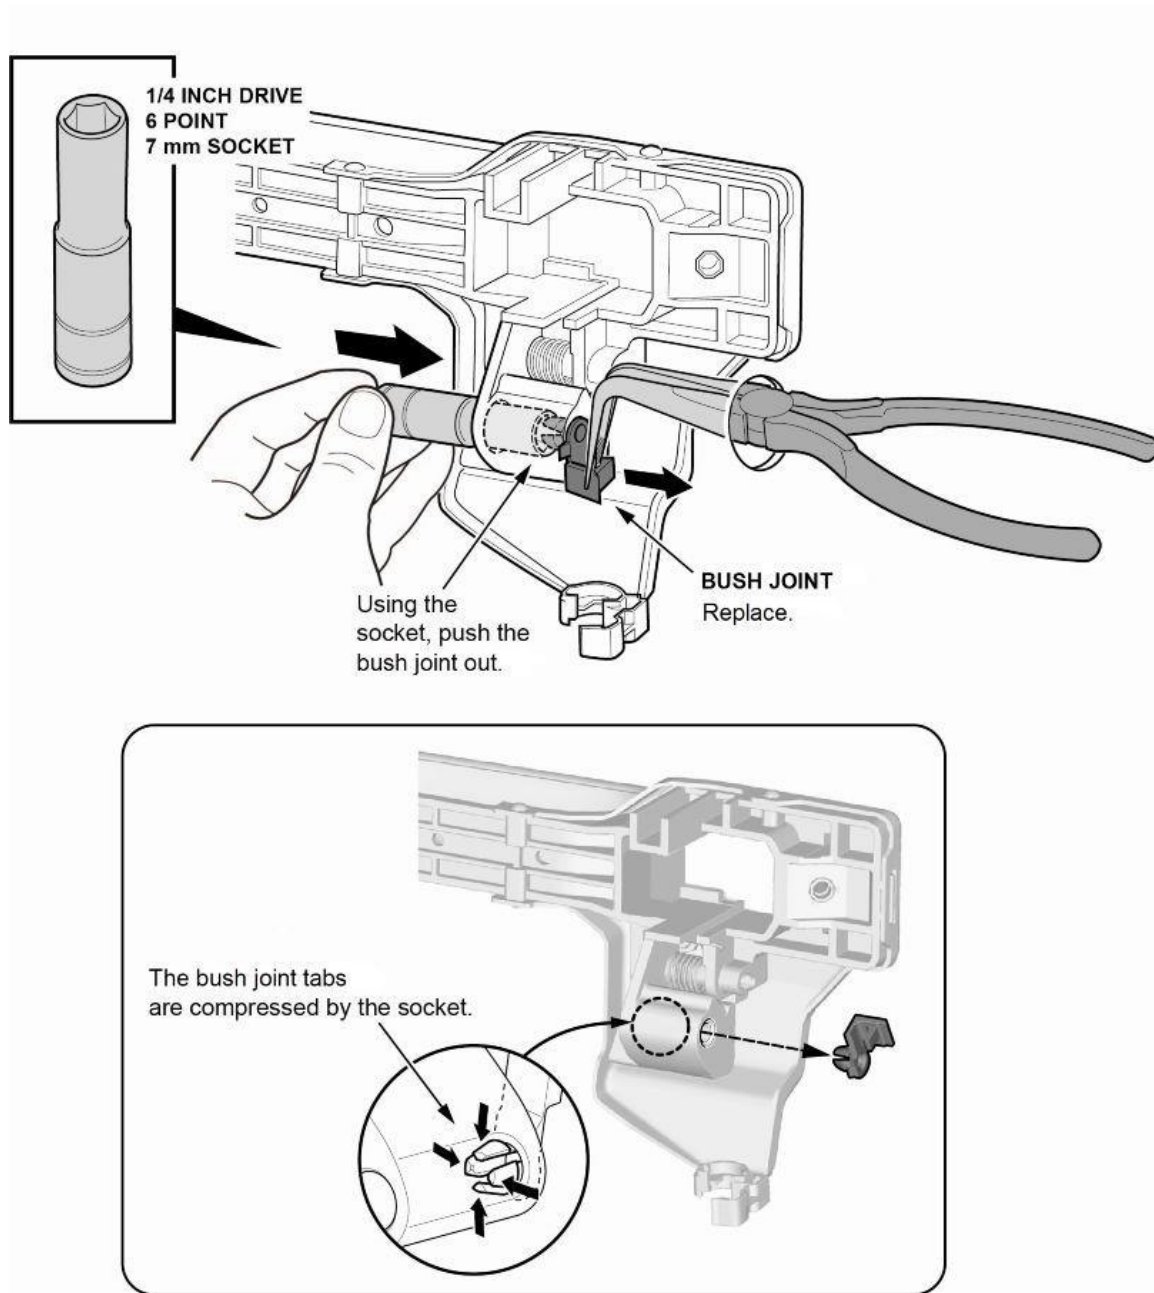
20. Insert 90° needle nose pliers through the plug opening to hold the bush joint. Insert a 1/4" drive, 6 point, 7 mm socket into the back of the bush joint cavity to compress / release the bush joint tabs, and remove the bush joint from the handle base.

NOTE: Be careful not to drop the bush joint into the door.

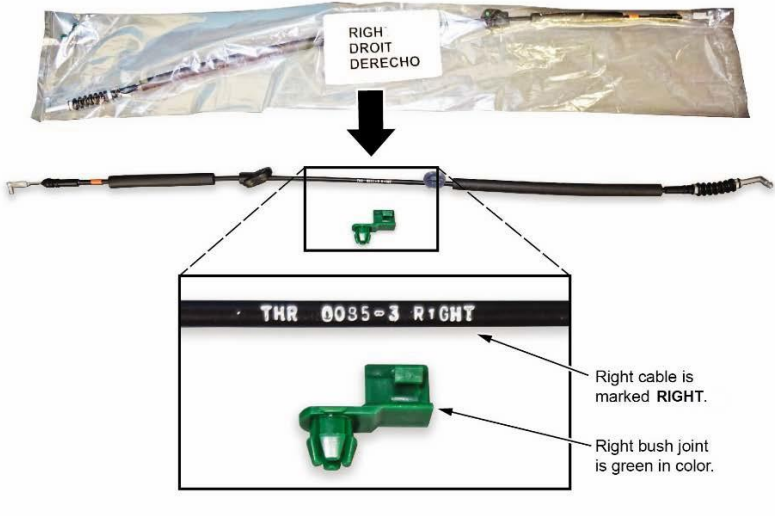
RIGHT CABLE AND BUSH JOINT

NOTE: Make sure to use the correct cable kit for the sliding door you are working on.

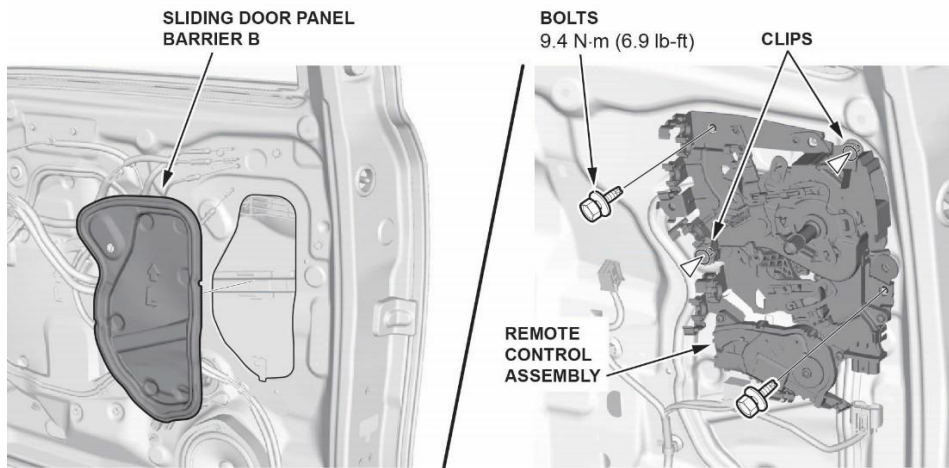
23. Install the new sliding door outer handle cables to the remote control assembly.

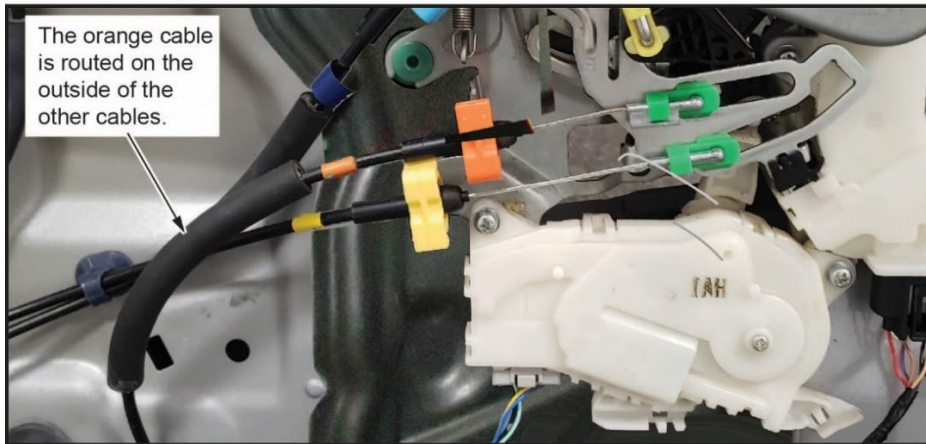
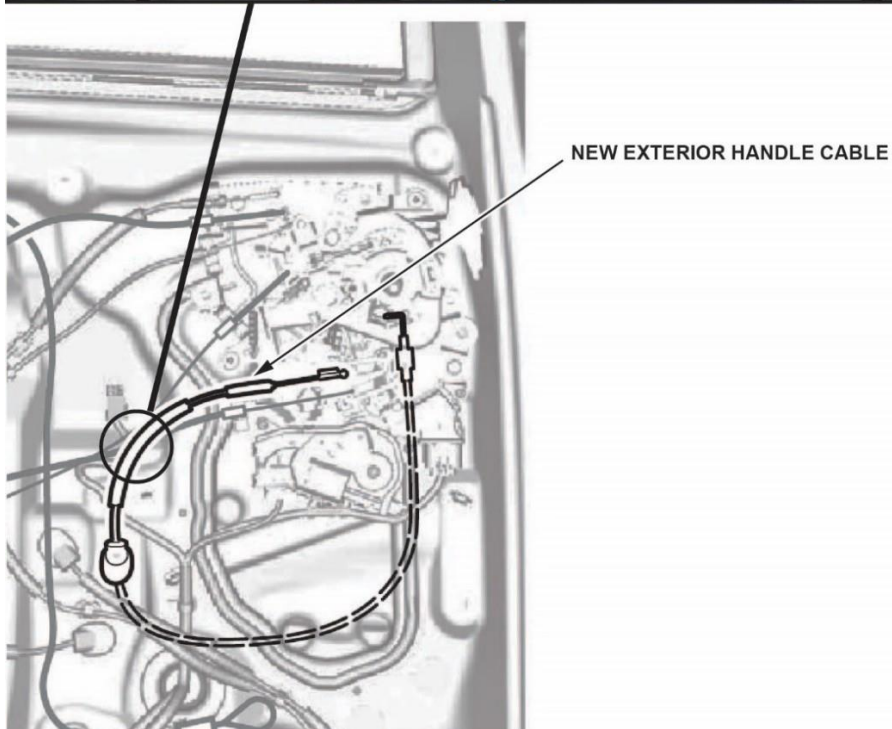
23.1. Remove the shop towels in the door cavity that was placed to prevent objects from falling into the door. Install sliding door panel barrier B, then the remote control assembly.

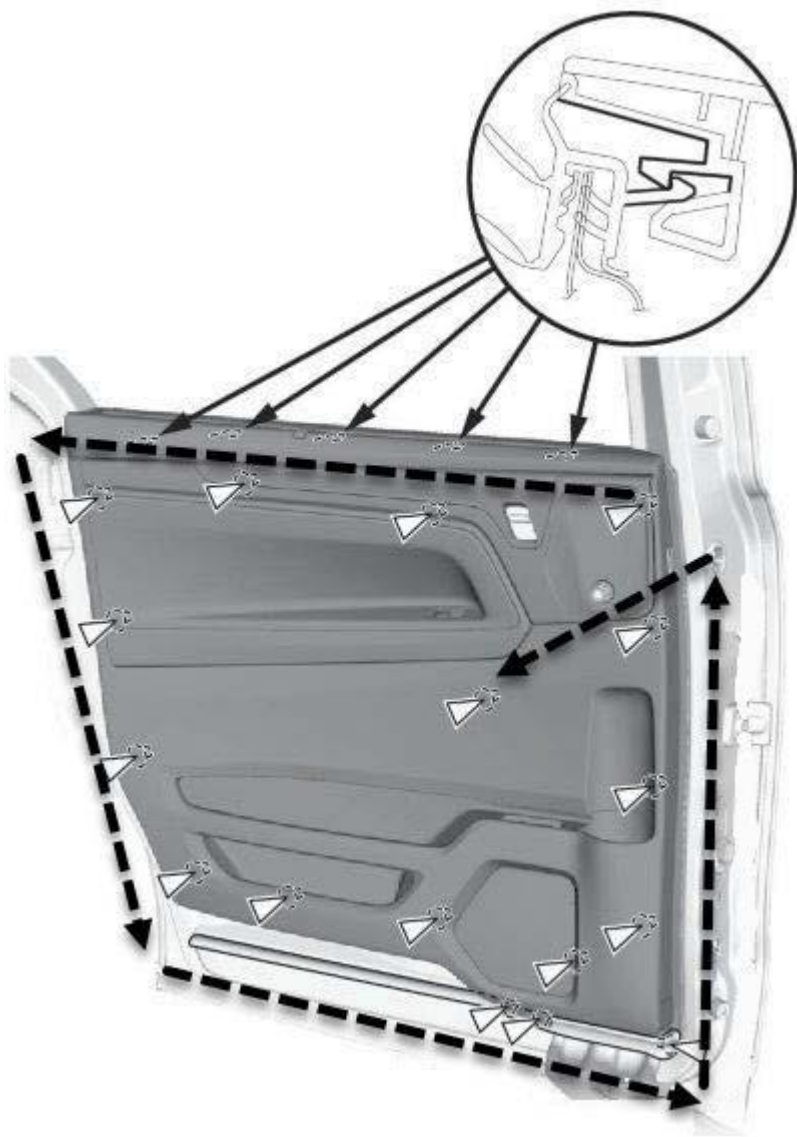
24. Install all of the remaining parts in the reverse order of removal. Tighten all fasteners to the specified torque, and make sure of the following:
- The Inner handle is fully set
 - The manual lock knob functions/moves freely
 - The sliding door panel plug cap A is installed
 - The door liner and lower sub-seal are fully set

NOTE: To prevent miss-setting the door panel, make sure you install it exactly as shown.

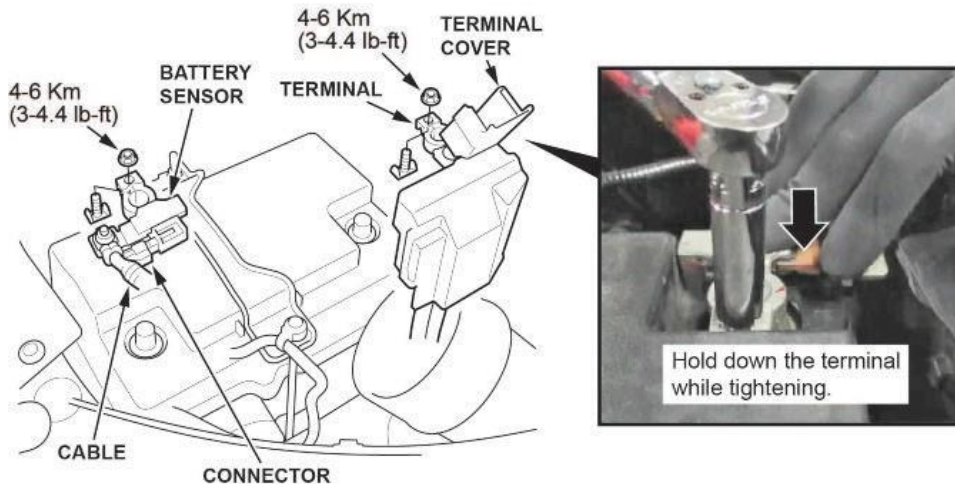
26.1. While holding down the terminal, torque both positive and negative clamps to **35-53 lb-in (4-6 N•m)**.

- Do not over torque the terminal.
- Always connect the positive side first.
