HONDA

Safety Recall: 2018 – 20 Odyssey Sliding Door Outer Handle Cables

Supersedes 20-024, dated July 29, 2020, to revise the information highlighted in yellow.

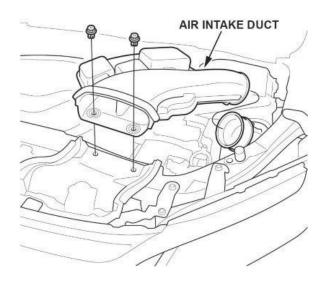
- 2. Confirm both sliding door windows are raised to the fully closed position.
- 3. Remove the air intake duct.

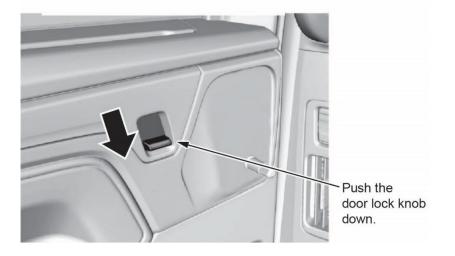
6. With the sliding door open, push the door lock knob down to the locked position to prevent it from being damaged when removing the door panel.

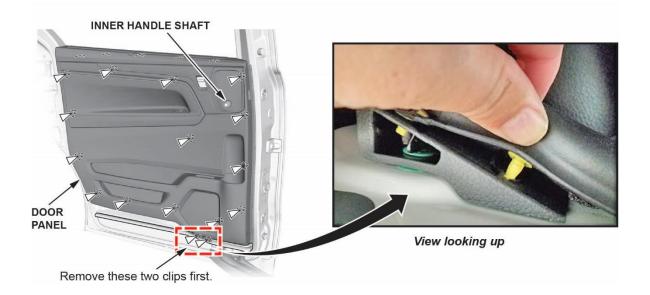
7. Remove the two clips at the bottom of the door panel first to release the lower door seal from the door panel.

Removing the two clips prevents pulling the door seal off of the door as the door panel is lifted and removed.

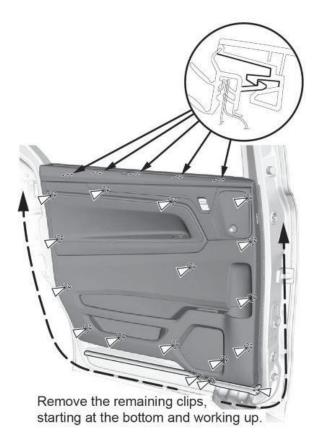
8. Starting at the bottom of the door panel, remove the remaining clips with a commercially available trim pad remover.

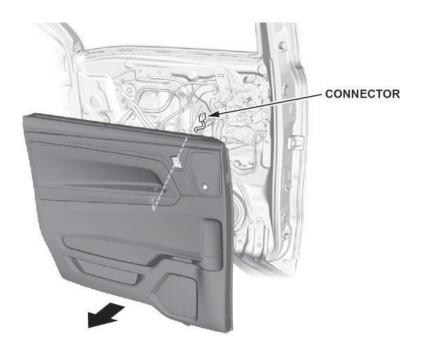
10. While holding the sliding door panel away from the door, disconnect the connector. Then, remove the door panel.

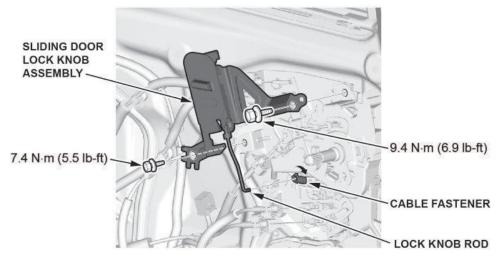
- 11. Remove the sliding door lock knob assembly.
 - 11.1. Release the cable fastener.

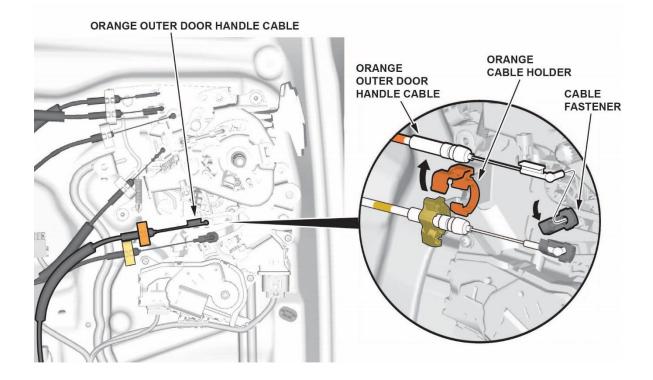
- 11.2. Disconnect the door lock knob rod.
- 11.3. Remove the sliding door lock knob assembly.
- 12. Disconnect the outer door handle cable from the remote control assembly.
 - 12.1. Release the cable holder and cable fastener, then disconnect the orange outer handle cable.

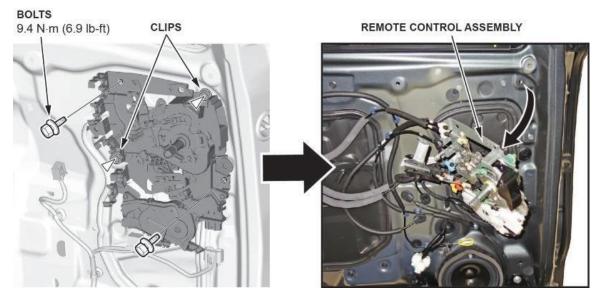
12.2. Remove the **10 mm** bolts and green clips, then detach the remote control assembly.

Do not completely remove the remote control assembly. Just detach it from the door panel assembly to access sliding door panel barrier B.

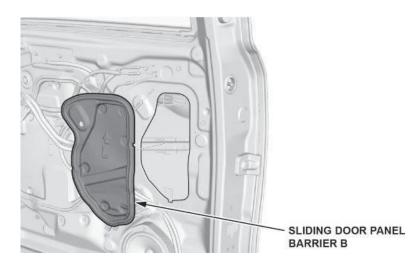
13. Remove sliding door panel barrier B.

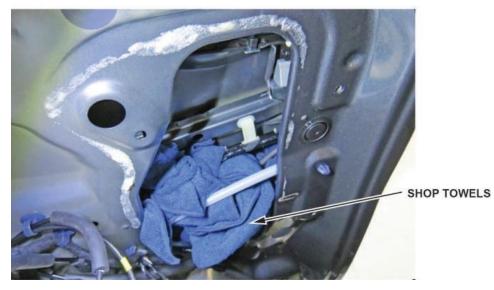
14. Place several clean shop towels in the door cavity to prevent objects from falling into it.

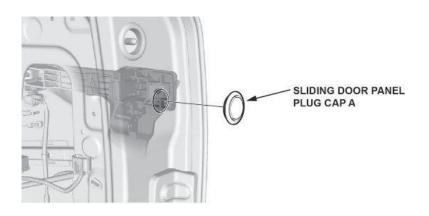
15. Remove sliding door panel plug cap A.

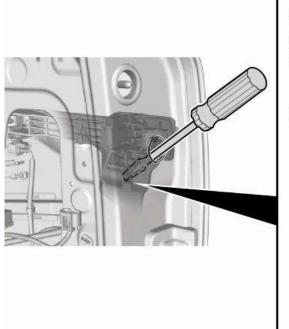
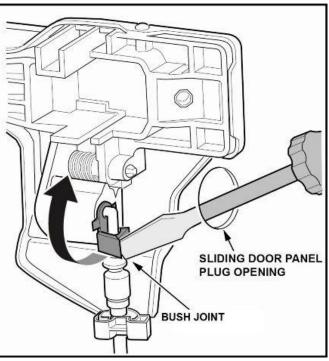
16. Insert a flat-blade screwdriver through the plug opening to detach the bush joint from the cable end fitting.

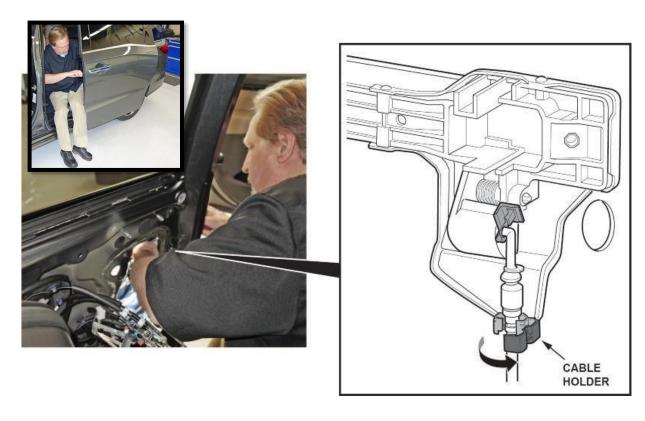
17. Sit in the sliding door opening with both legs in front of the lower roller as shown to avoid straddling the lower roller, then detach the cable holder.

Be careful when getting into position or exiting the vehicle. Avoid accidently kicking and possibly damaging the sliding door articulating harness.

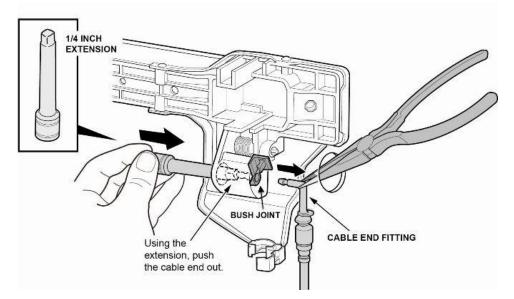
18. Insert a 1/4" extension into the back of the bush joint cavity. While pushing on the extension, insert the needle nose pliers through the plug opening to pull the cable end fitting from the bush joint.

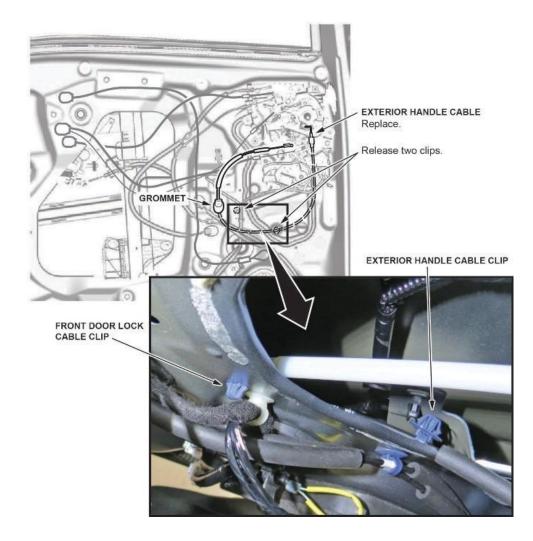
19. Release the exterior handle cable clip and the front door lock cable clip and grommet, then remove the cable from the door.

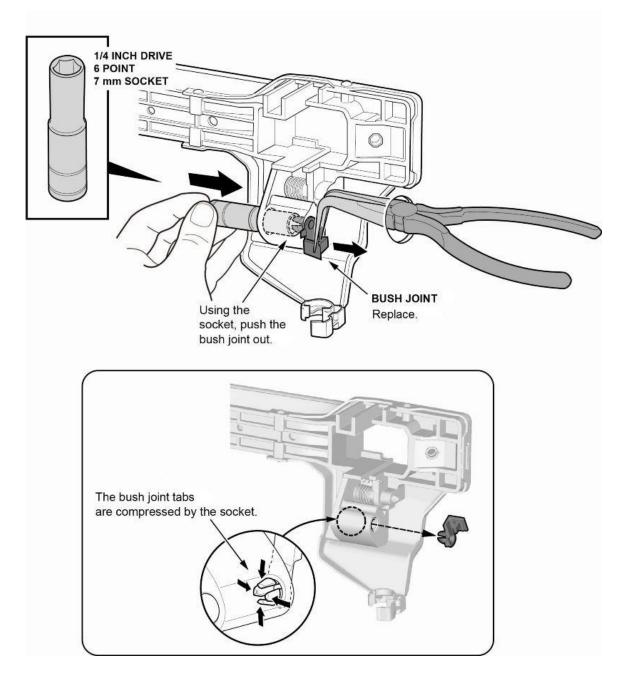
20. Insert 90° needle nose pliers through the plug opening to hold the bush joint. Insert a 1/4" drive, 6 point, 7 mm socket into the back of the bush joint cavity to compress / release the bush joint tabs, and remove the bush joint from the handle base.

Be careful not the drop the bush joint into the door.

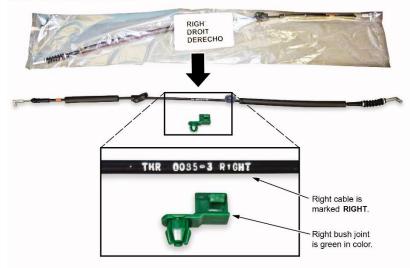
RIGHT CABLE AND BUSH JOINT

21. Use the 90° needle nose pliers to insert and install a new bush joint.

Make sure to use the correct cable kit for the sliding door you are working on.

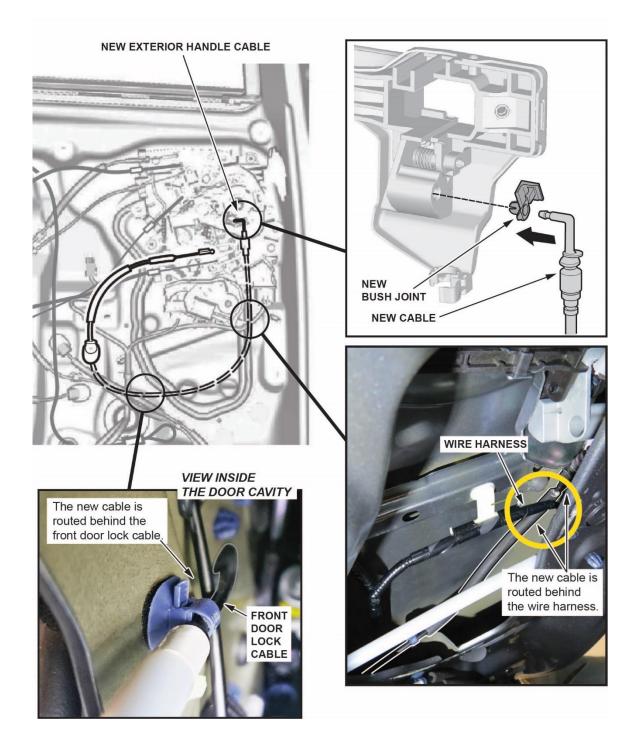
22. Install the new sliding door outer handle cable.

- Make sure to use the correct cable kit for the sliding door you are working on.
- Make sure the cables are routed as shown.

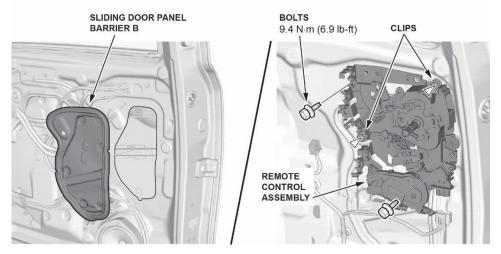
23. Install the new sliding door outer handle cables to the remote control assembly.

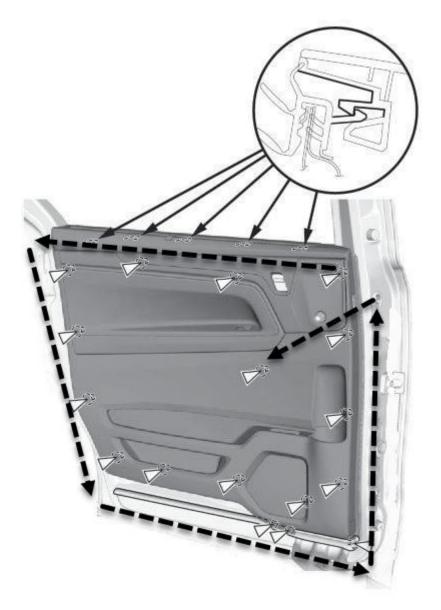
24. Install the remaining removed parts in the reverse order of removal, tightening all fasteners to the specified torque.

When installing the door panel, it is important that it be installed in the order as shown to prevent any mis-setting of the panel.

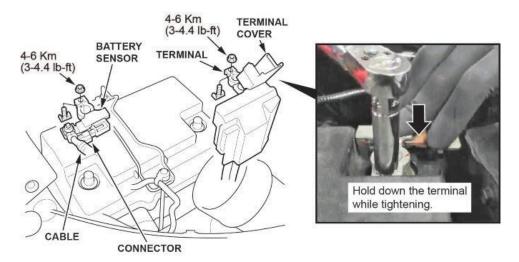
26.1. While holding down the terminal, torque both positive and negative clamps to 35-53 lb-in (4-6 N•m).

- Do not over torque the terminal.
- Always connect the positive side first.

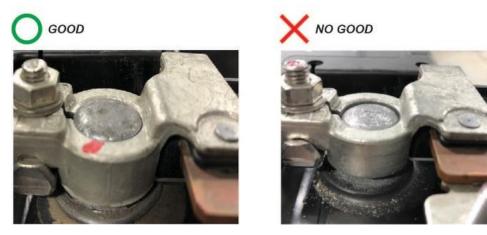
26.2. Make sure the battery terminals are correctly attached as shown.

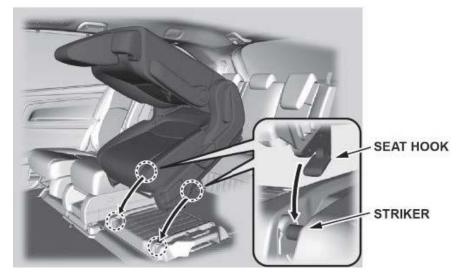
- 30. Install the second row outer seats.
 - 30.1. Insert the front seat hooks into the front floor strikers.

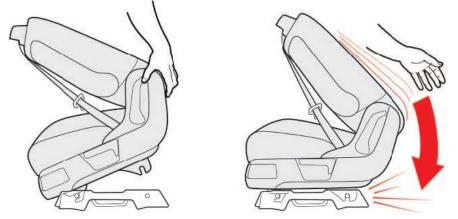
30.2. After confirming both front hooks are fully inserted into the front strikers, begin to lower the seat, then allow it to drop and lock to the rear strikers.

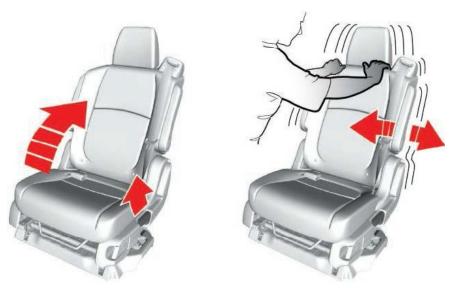
30.3. Raise the seat-back to an upright position, then rock the seat back and forth to confirm both the inner and outer latches are securely locked into position.
