## INSTRUCTIONS TO PERFORM RECALL CAMPAIGN 162

Certain 2021 model year Revel Motorhomes. These motorhomes were manufactured June 01, 2020 through July 31, 2020.

# Xantrex Revel Alternator/Belt Inspection & Rework Instructions

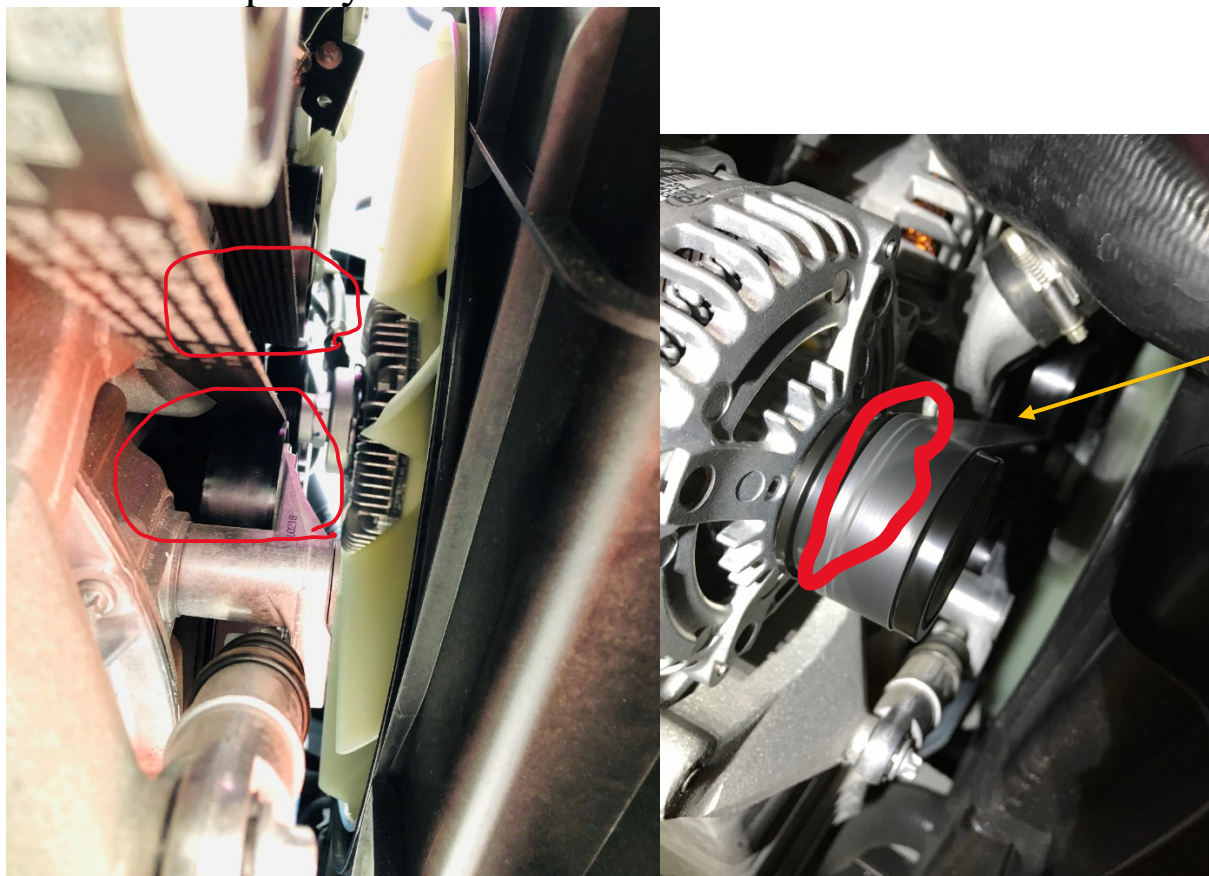
Start vehicle and check alignment of belt. Paying close attention to the Idler and tensioner smooth pulleys. Making sure that the belt is 100% on these pulleys. Even if it is on the edge it could track on and off while engine is running. Needs to be fully on while engine running. Another indication that the belt is tracking off the pulleys is the appearance of thin white line/lines on the belt. See image below. Yellow arrow shows belt off the idler pulley.

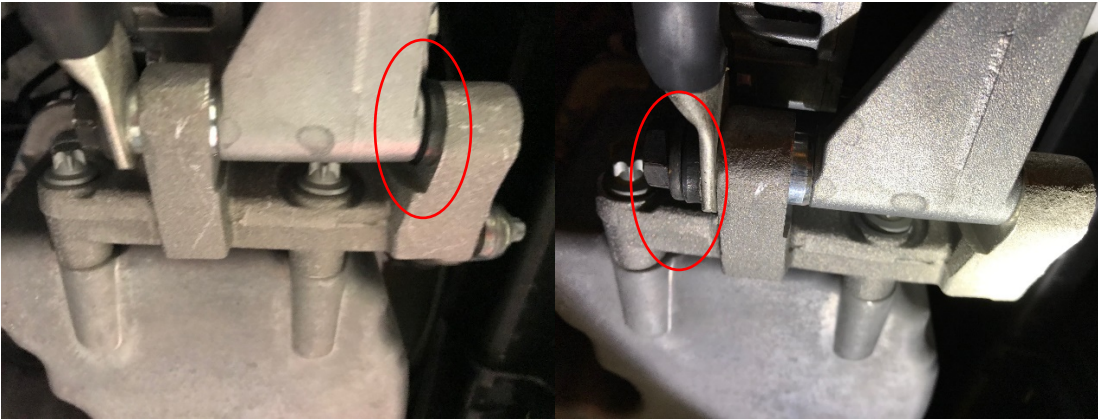
1) (1A) Incorrect placement of black spacer washer

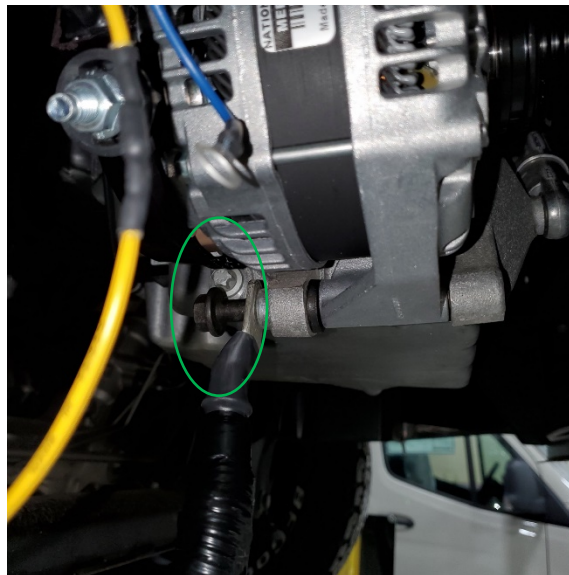
1) (1B) Correct placement of spacer washer

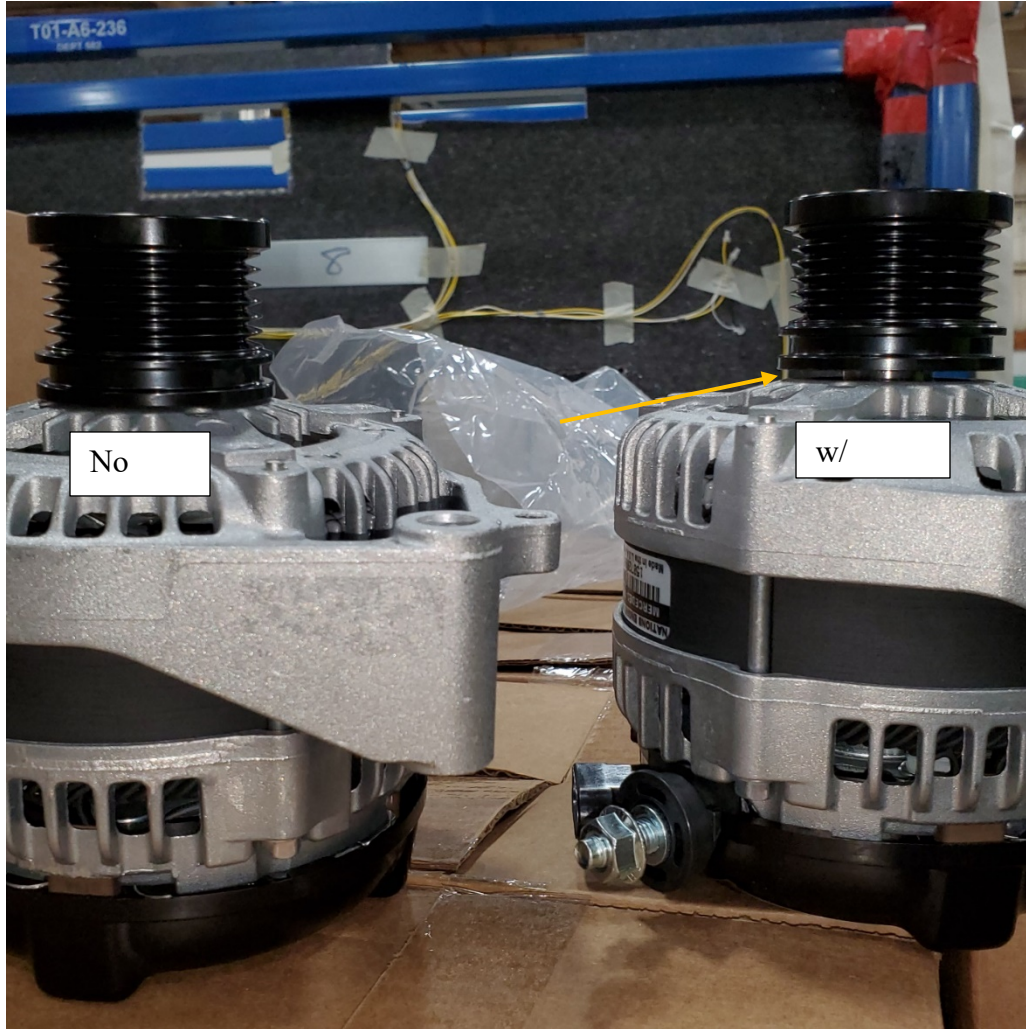
2) See image below of alternators with and without shims. There should be just over 2mm of space between the back of the pulley and the casting. See yellow arrow.
