SIB 51 23 20

RECALL 20V-484: REAR SPOILER

2020-08-21

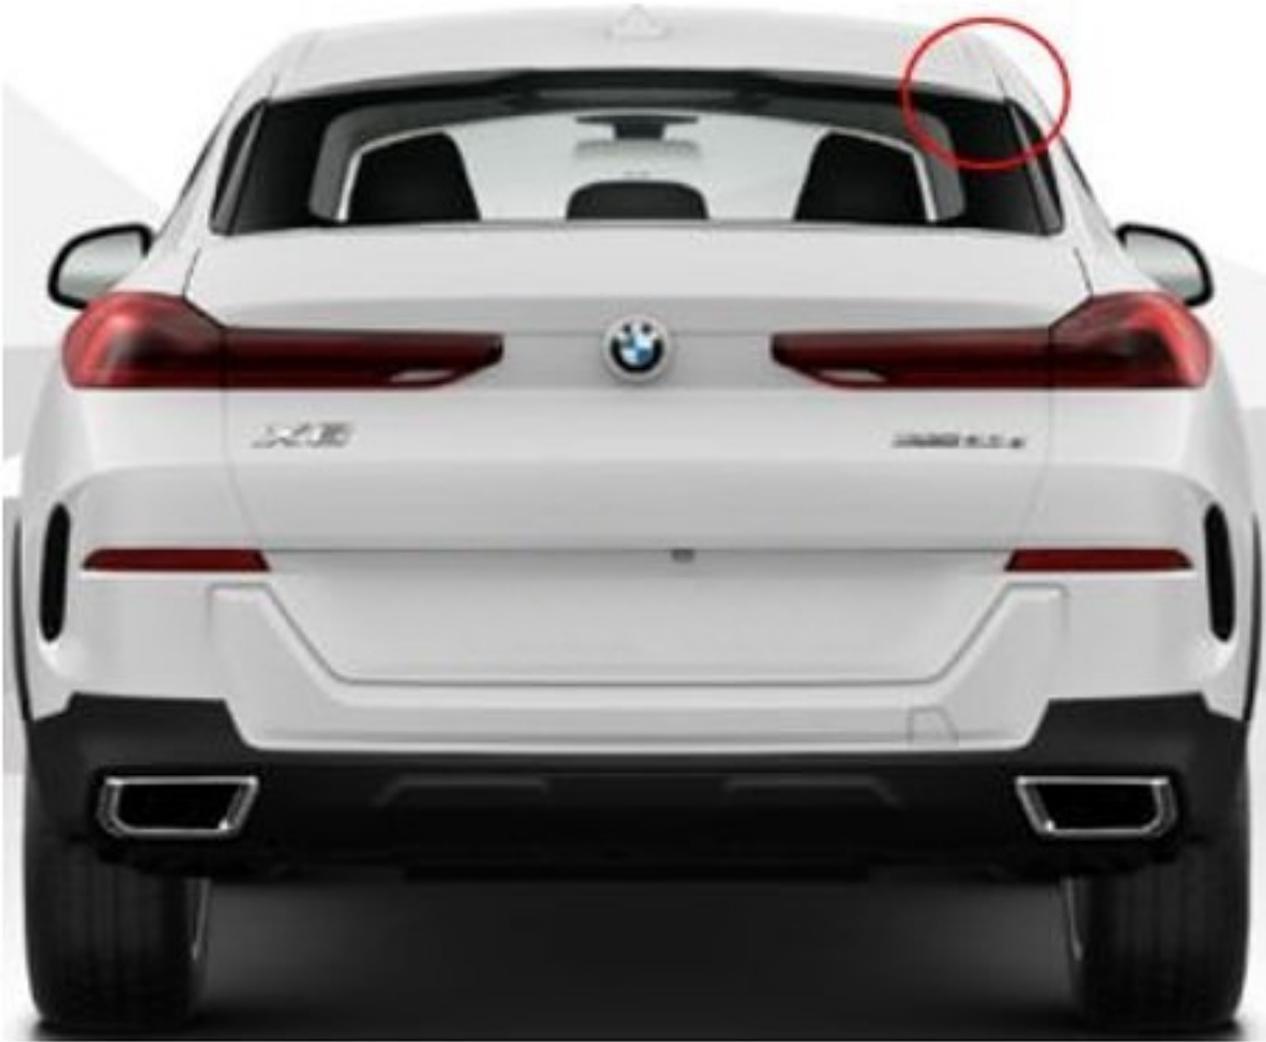
Shown below is the area (circled; right side shown, both sides to be checked) of the spoiler that will be inspected **on both sides**.

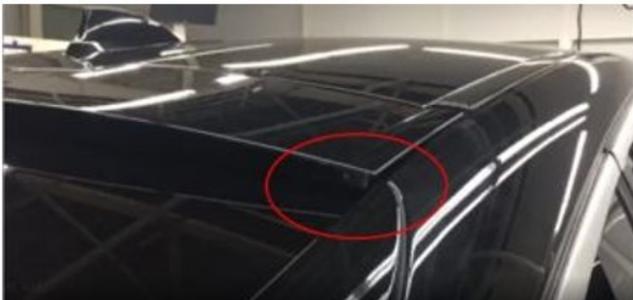
1. In the area shown above and below, visually compare the height of the rear spoiler from left to right.

Note: Both sides should be of similar height and appearance.

2. Using a ruler, measure the distance between the bottom of the spoiler and the rear window (2 mm shown).

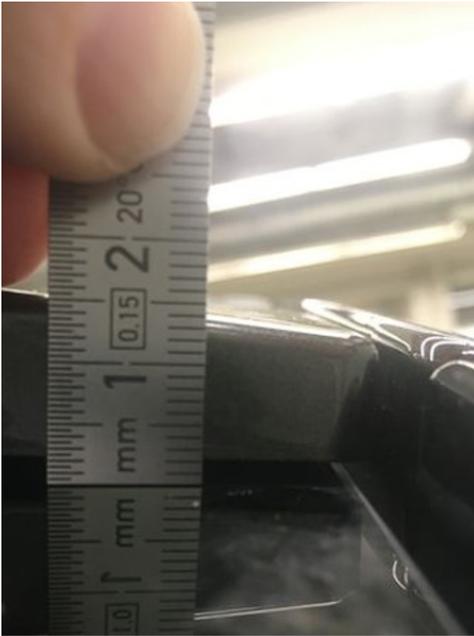
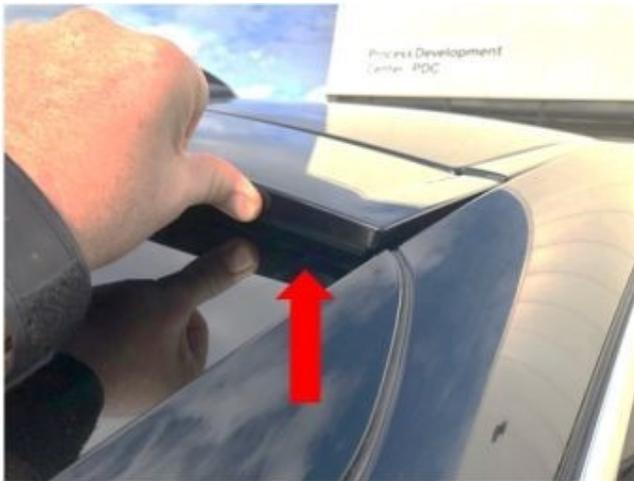
3. While pressing upwards using a thumb and moderate force, measure the gap between the glass and the bottom of the rear spoiler (arrow) again.

Taking into consideration the original distance between the spoiler and the rear window, were you able to lift the spoiler more than 6 mm **above the original value measured in step 2 on either side?**

**5. Replace the rear spoiler following repair instructions REP 51 71 407 “Replace rear spoiler:”**
