# Safety Recall

## Code: 72K8

**Subject** Front Seat Backrest Frame Welds

**Release Date** November 14, 2020

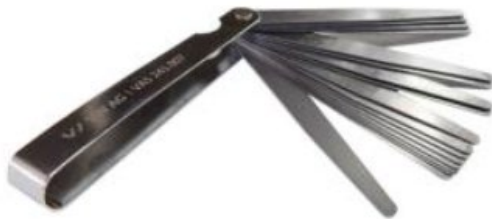
Feeler Gauge  
(locally sourced)
