Dealer Service Instructions for:

Safety Recall W63 / NHTSA 20V-513 Drivers Side Floor Mat

2019 - 2020 (DT) Ram Pickup

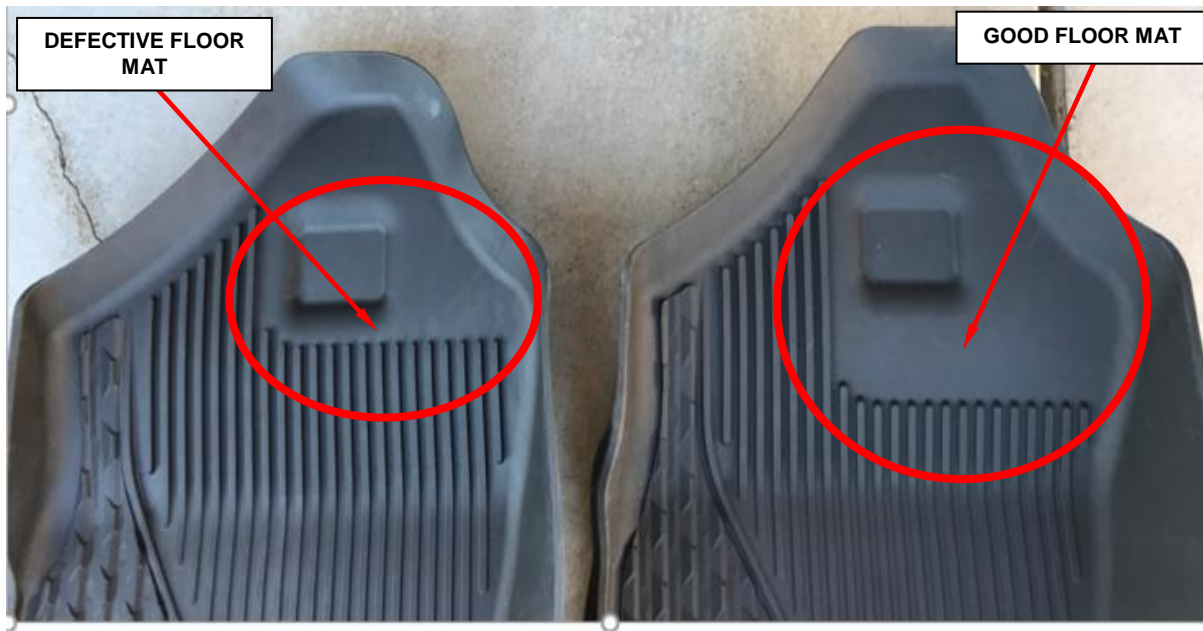
Figure 1 – All-Weather Drivers Side Floor Mat

Visually inspect the driver’s All-Weather floor mat for the rib space as shown in the **Figure 1** of the illustration. Look on the backside of the mat for last two letters at the top row number **Figure 2** as shown in the illustration below. If the last two letters are **AA, AB, AC** that is defective floor mat. If a defective floor mat is identified, the rib material on 4 ribs that are in front of the accelerator pedal **MUST** be removed.

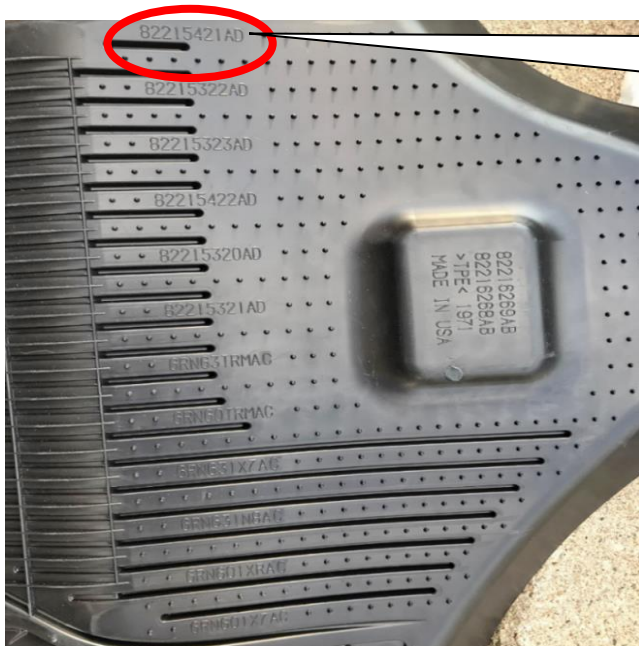
Figure 2 – Back of Floor Mat

Look for the last 2 letters at the top of the mat number and end of the number, any letters that are **AA, AB, AC** is a **defective** driver side floor mat.
