Cyclone Land leg bracket installation for all models excluding 3413

It has been decided that certain 2019-2021 Heartland Cyclones in this recall population may experience the front landing legs collapsing.

Big Horn Traveler, Elkridge, & Cyclone 3413

It has been decided that certain 2019-2021 Heartland Cyclones 3413, 2020-2021 Big Horn Traveler, & 2020-2021 Elkridge in this recall population may experience the front landing legs collapsing.

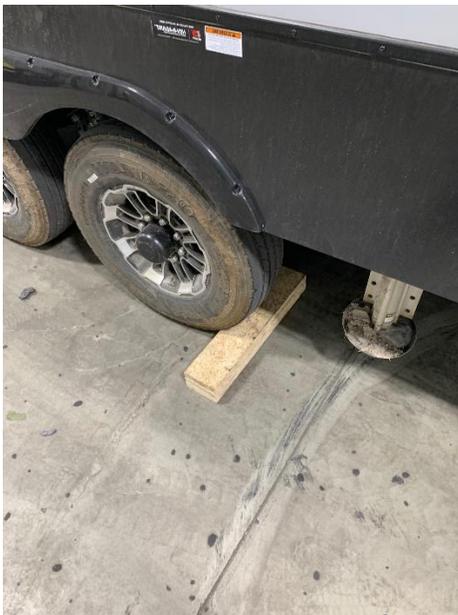
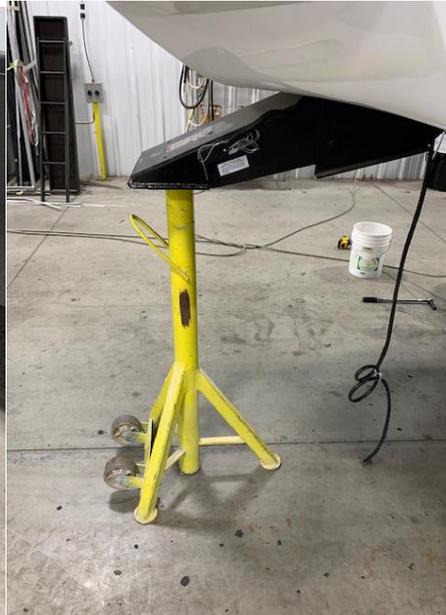
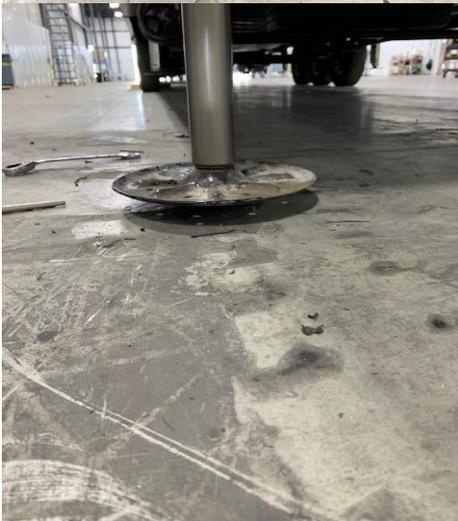
1. Chock the wheels so the unit does not roll back while performing the repairs.
2. Use a tripod to take the weight off the front landing legs leaving the legs about ½"-1" off the ground.

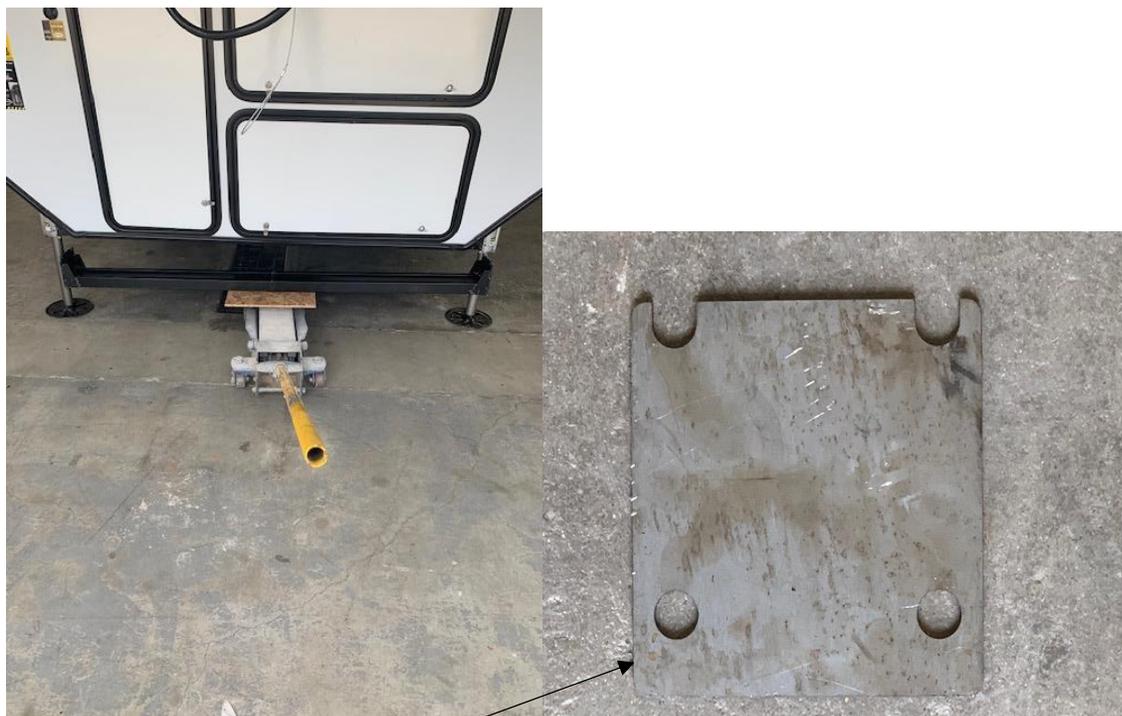
3. Use a floor jack with a piece of wood wide & long enough to support the bracket in the middle.
4. Lift bracket using floor jack into position between the front leveling jacks until the bottom set of holes on the bracket are lined up with the bottom set of holes on the jack leg.

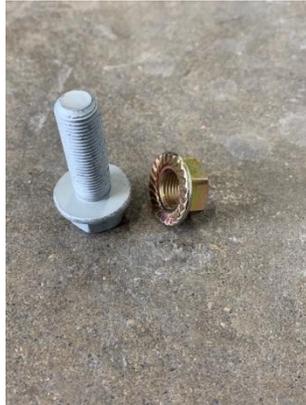
Matte silver bolt with nut

5. Use the provided shims that are 1/8" & 1/4" thick to ensure that the bracket has no more than a 1/2" gap to be closed up when tightening bolts. (Some brackets may not require any shims & will have less than 1/2" gap once in place)
6. Once the bracket holes are lined up use a 3/4" impact socket and driver to start the stainless steel self-tapping bolts in the bottom two holes. Insert the matte silver bolts into the top holes and use a 3/4" impact socket and driver on the bolt and a 3/4" wrench to hold the nut on the back while tightening. Only snug up bolts until all bolts have been installed in the bracket.

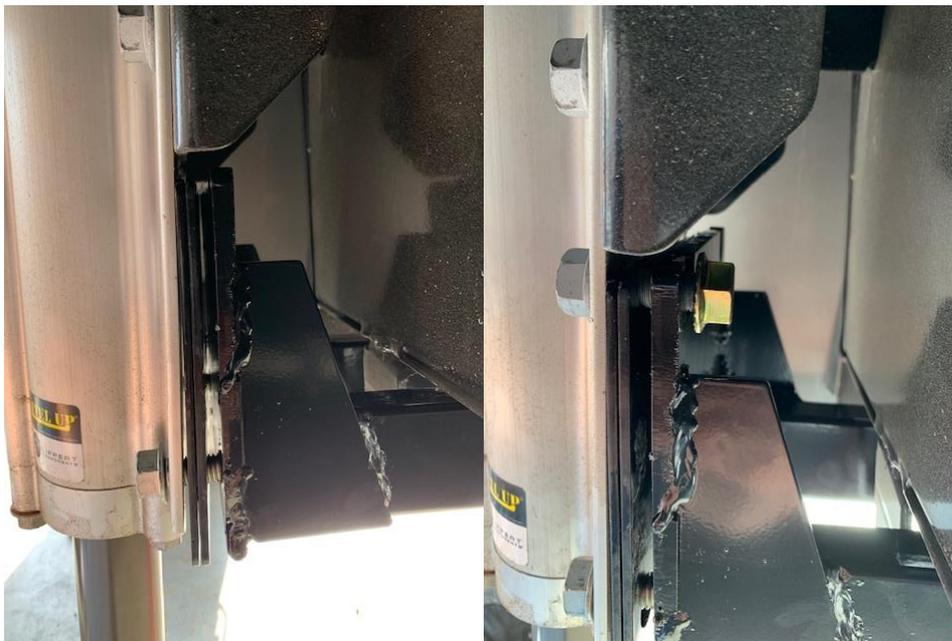
Pictures below show bracket installed with shims in place and the bolts started holding the bracket in place.

7. Once you have all the bolts on both sides of the bracket snug all bolts down until tightened.
8. Using a torque wrench, torque all the bolts to 65 ft. lbs.
9. Lower the front landing legs back down and remove the tripod and wheel chock

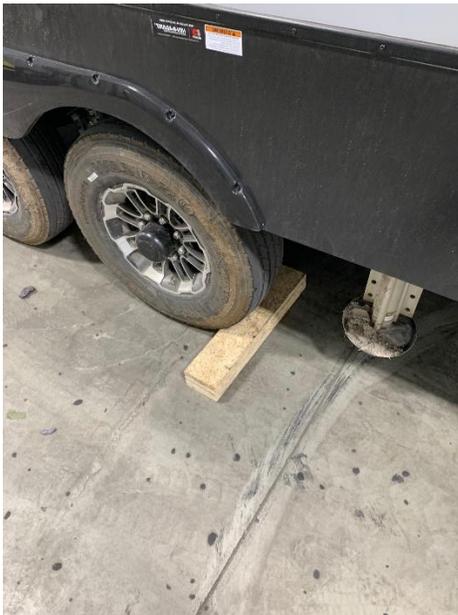
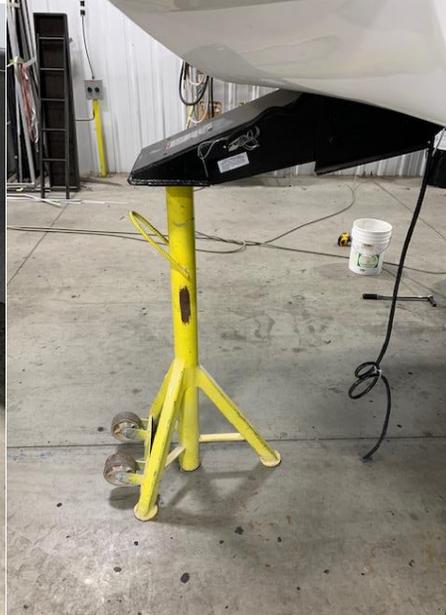
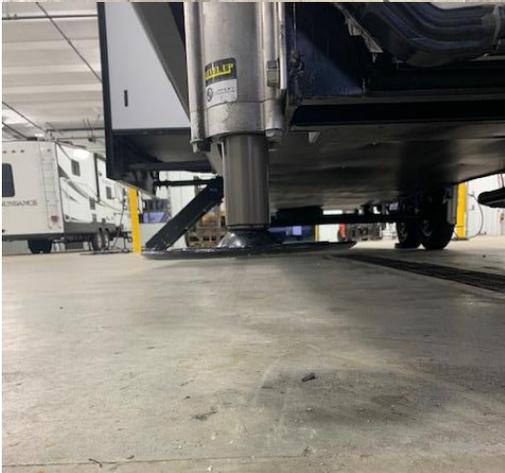
10. Chock the wheels so the unit does not roll back while performing the repairs.
11. Use a tripod to take the weight off the front landing legs leaving the legs, raising the legs about 6-8" off the ground.

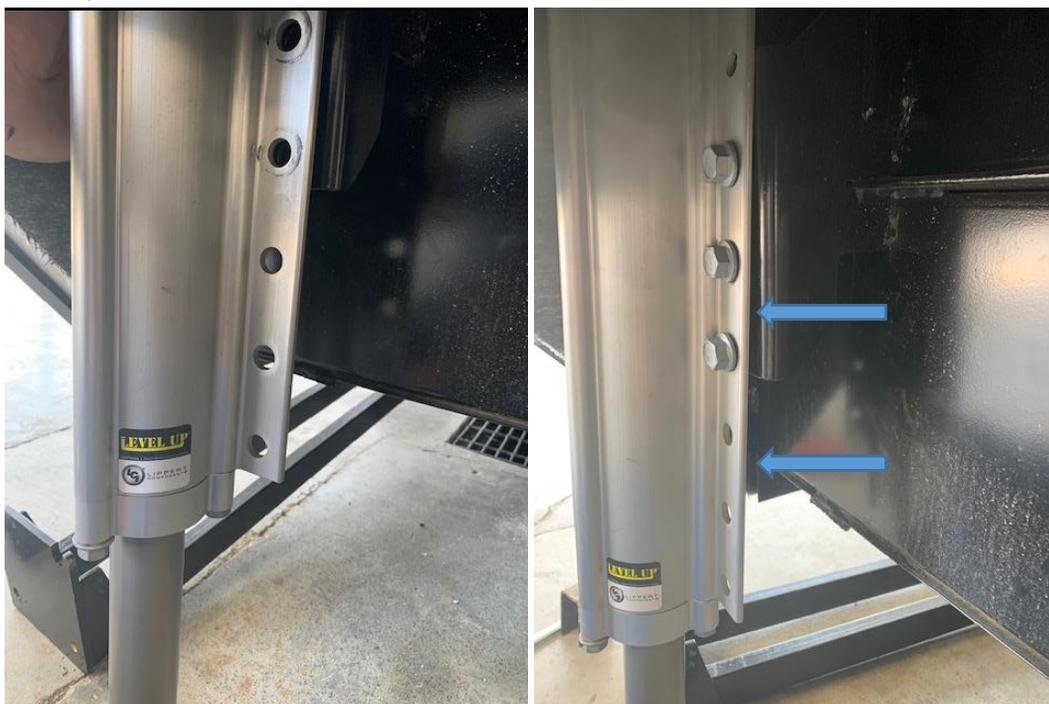
12. Use a floor jack with a piece of wood wide & long enough to support the bracket in the middle.
13. The jack brackets bottom set of holes need to be lined up with the bottom set of holes in the jack leg. The front landing legs may need to be uninstalled and lowered 1-2 sets of bolt holes so the bracket will be able to be installed correctly. Use a $\frac{3}{4}$ " impact socket and driver with a $\frac{3}{4}$ " wrench to loosen and remove the bolts from the jack. There should be three sets of bolt holes available once the bracket has been reinstalled correctly. The jack bolts may need to remain loosened until the bracket is in place and then all bolts can be tightened down. All bolts need to be torqued to 65ft. lbs.

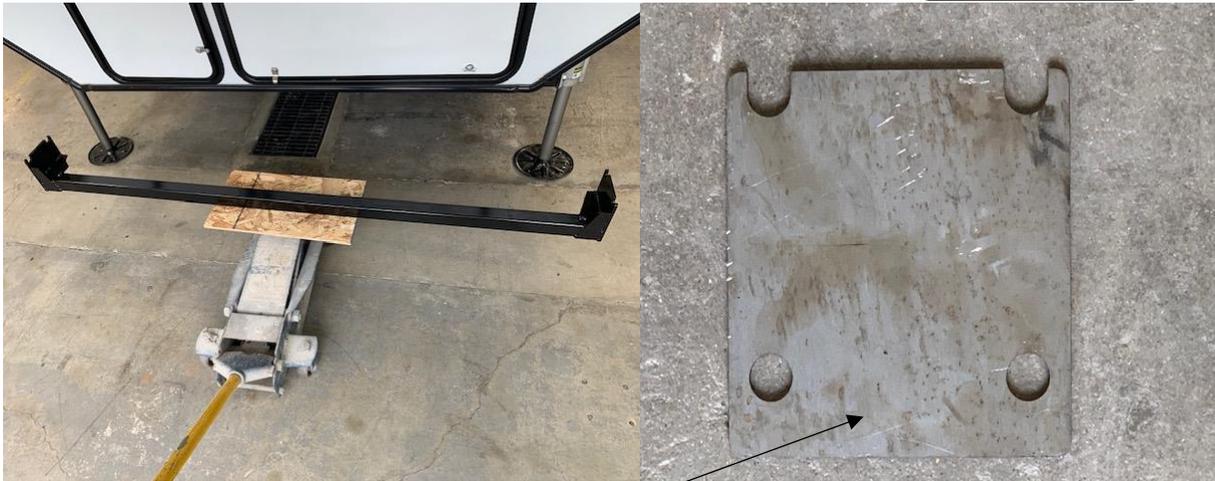
14. Lift bracket using floor jack into position between the front leveling jacks until the bottom set of holes on the bracket are lined up with the bottom set of holes on the jack leg.

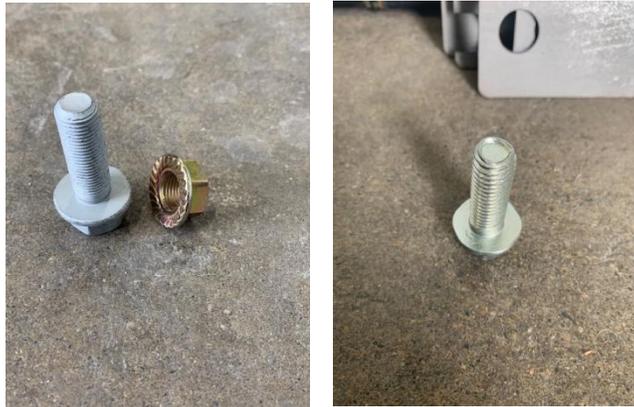
Matte silver bolt with nut Stainless steel self-tapping bolt

15. Use the provided shims that are 1/8" & 1/4" thick to ensure that the bracket has no more than a 1/2" gap to be closed up when tightening bolts. (Some brackets may not require any shims & will have less than 1/2" gap once in place)
16. Once the bracket holes are lined up use a 3/4" impact socket and driver to start the stainless steel self-tapping bolts in the bottom two holes. Insert the matte silver bolts into the top holes and use a 3/4" impact socket and driver on the bolt and a 3/4" wrench to hold the nut on the back while tightening. Only snug up bolts until all bolts have been installed in the bracket.

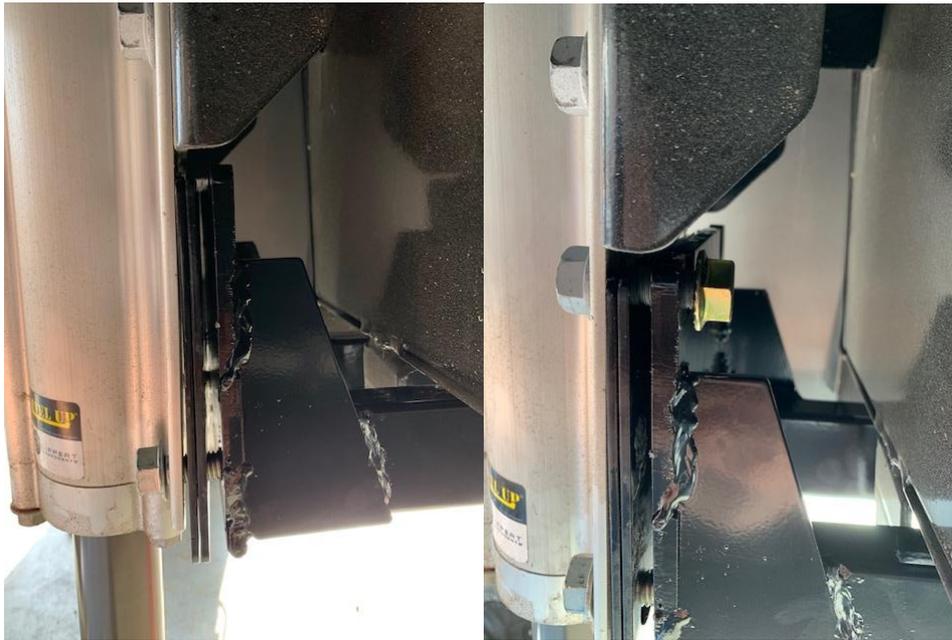
Pictures below show bracket installed with shims in place and the bolts started holding the bracket in place.

17. Once you have all the bolts on both sides of the bracket snug all bolts down until tightened.
18. Using a torque wrench, torque all the bolts to 65 ft. lbs.
19. Lower the front landing legs back down and remove the tripod and wheel chock
