# Safety Recall 20V-523

## Repair Instructions

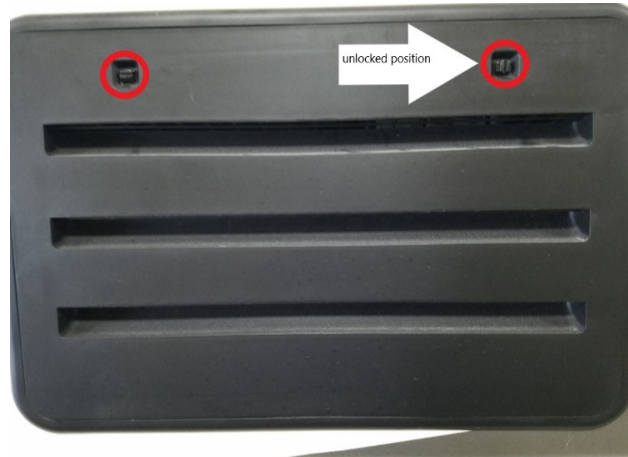
### Step 1:

Remove the lower exterior vent cover of the refer compartment. This is done by turning the two locking tabs 90 degrees, when the groove in the tab is vertical it is unlocked (*vent covers may vary by model and year of the unit*)

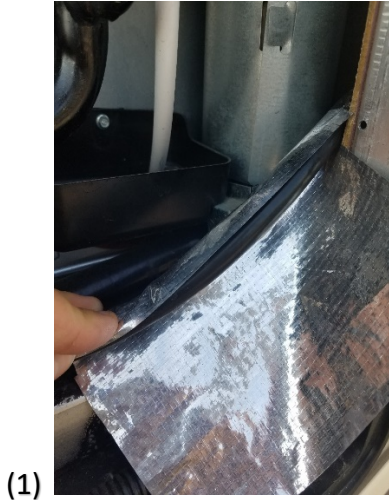
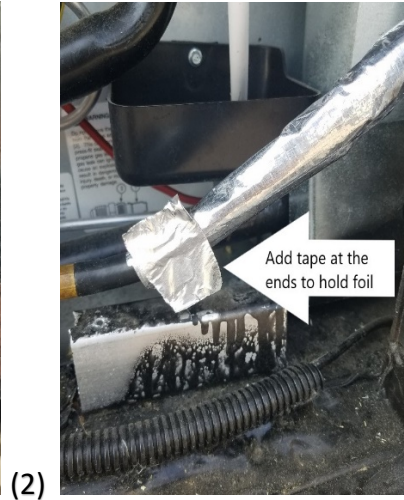
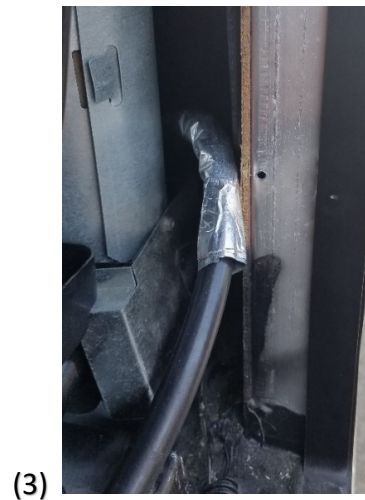
### Step 3:

Add insulating thermal-foil to LP line.

- A. Use a section of insulating thermal-foil (approximately 6" x 8"). Wrap the foil lengthwise around the rubber LP line. (Photo 1)
- B. Use a small piece of foil duct tape to secure the insulating foil to the hose and prevent it from unraveling while it is slid into place. (Photo 2)
- C. Center the section of hose closest to the burner box/chimney (Photo 3) to protect the LP hose from contact and heat emanating from the burner box and chimney of the cooling unit.
