| Subject: Coolant Hoses Replacement | | | |
| Field Change Program: Field Campaign | FCP Number: FCP 486 | Revision: | Date: 10/27/2020 |
| Coach Section: 06 - Cooling | P/N: 06-08-1006, 16-11-1970 | | Type: Safety Recall |

| Ref. NHTSA Recall No.: 20V-526 | Ref. Transport Canada Recall No.: 2020-501 |

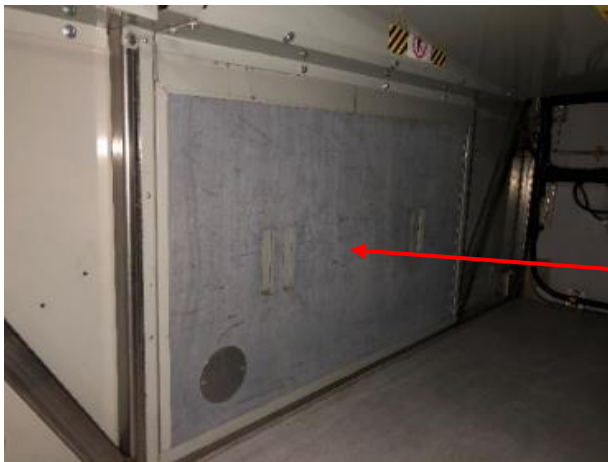
Remove and save the evaporator door

Remove and save the evaporator door in the Baggage Bay #3 compartment.

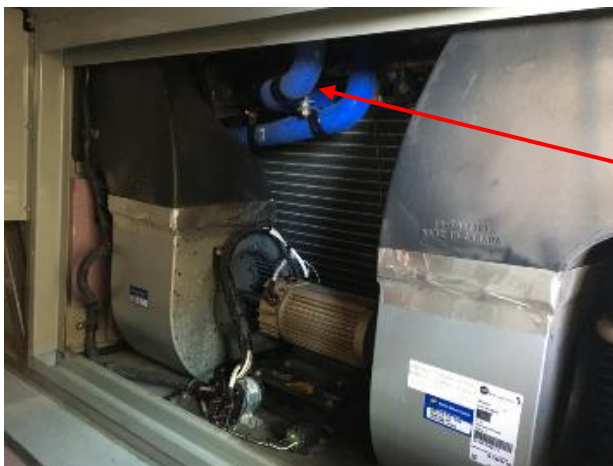
Locate the coolant hose 16-11-1970

Locate the evaporator hot water coolant hose, MCI P/N: 16-11-1970.

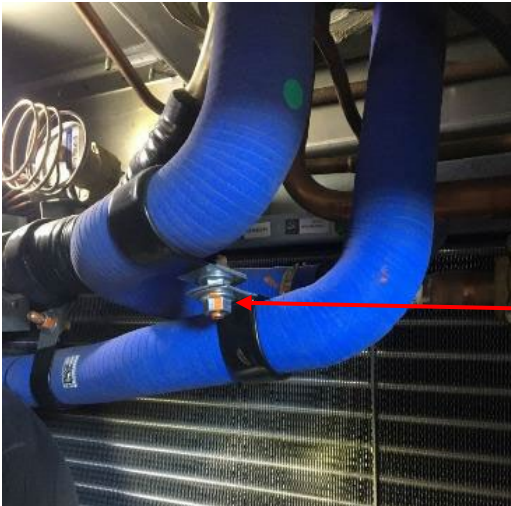
Remove and save
bolt, nut and clamp

Remove and save the nuts and bolts securing clamp on the coolant hose. Save the clamp.

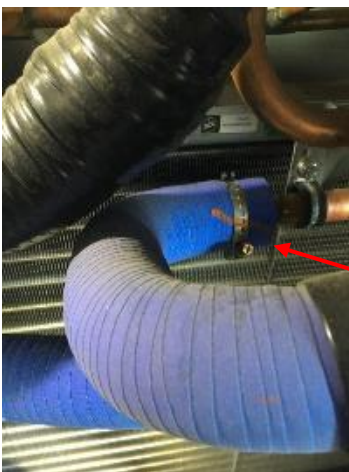
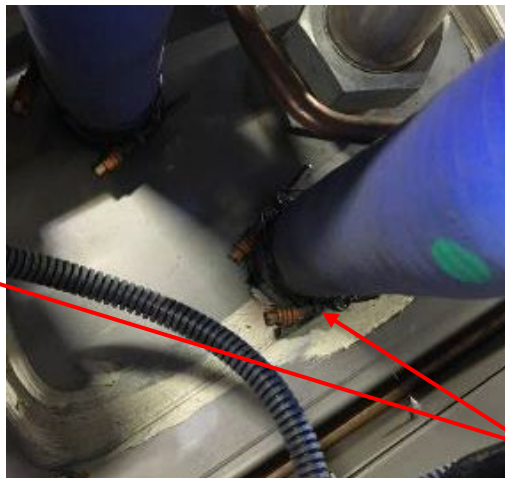
Remove and discard
the clamps and hose

Remove and discard the clamps securing the hose. Discard the hose.

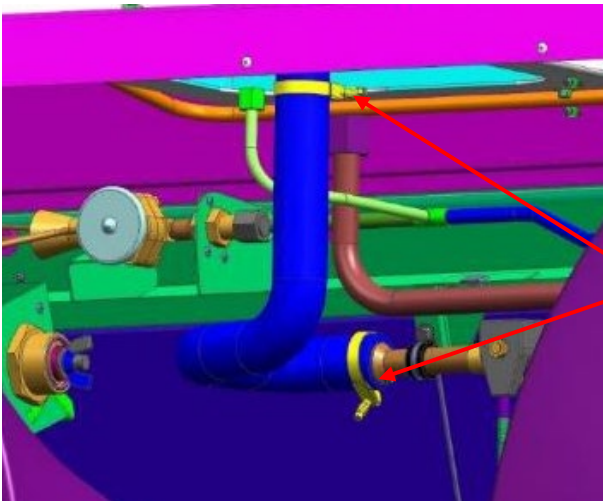
Install new hose, 16-
11-2768, using
clamps, 19-4-205

Install the new coolant hose, MCI P/N: 16-11-2768, using two new clamps, MCI P/N: 19-4-205. Torque the clamps to 18 In-Lb.

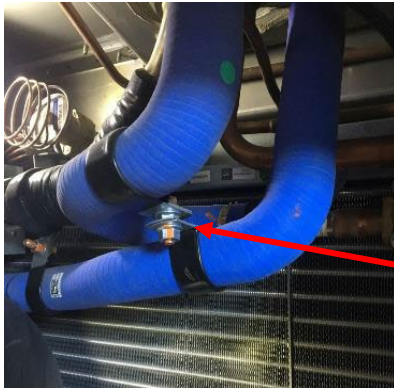
Reinstall the clamp using existing nuts and bolt

Reinstall the clamp using the existing bolt and nuts.

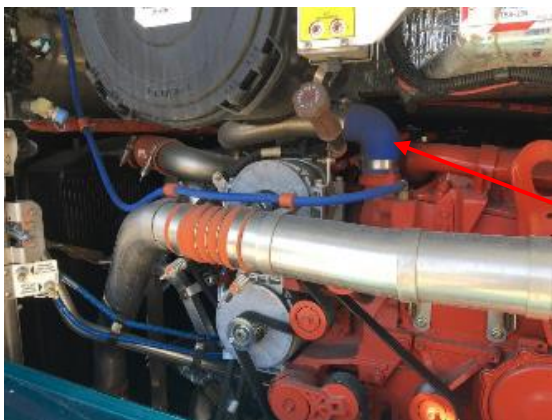
Coolant elbow hose

Locate the coolant hose elbow in the rear of the engine compartment.

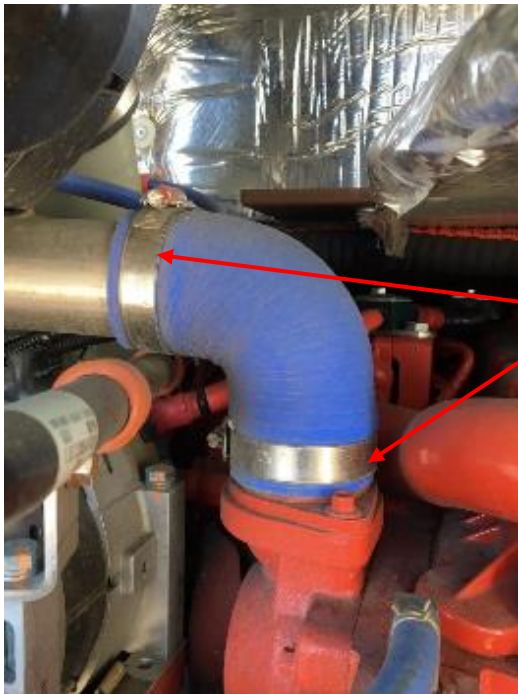
Remove and discard
the clamps and hose

Remove and discard the two clamps securing the coolant elbow hose. Discard the hose.

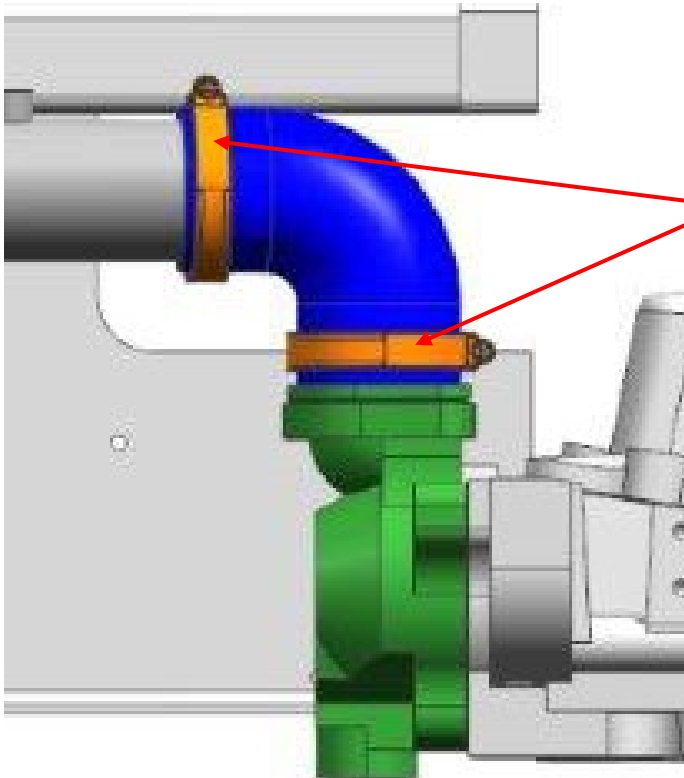
Install new hose, 06-08-
2261, using clamps, 19-
04-0520

Install the new elbow hose, MCI P/N: 06-08-2261, using two new clamps, MCI P/N: 19-04-0520. Torque clamps to 105 In-Lb.

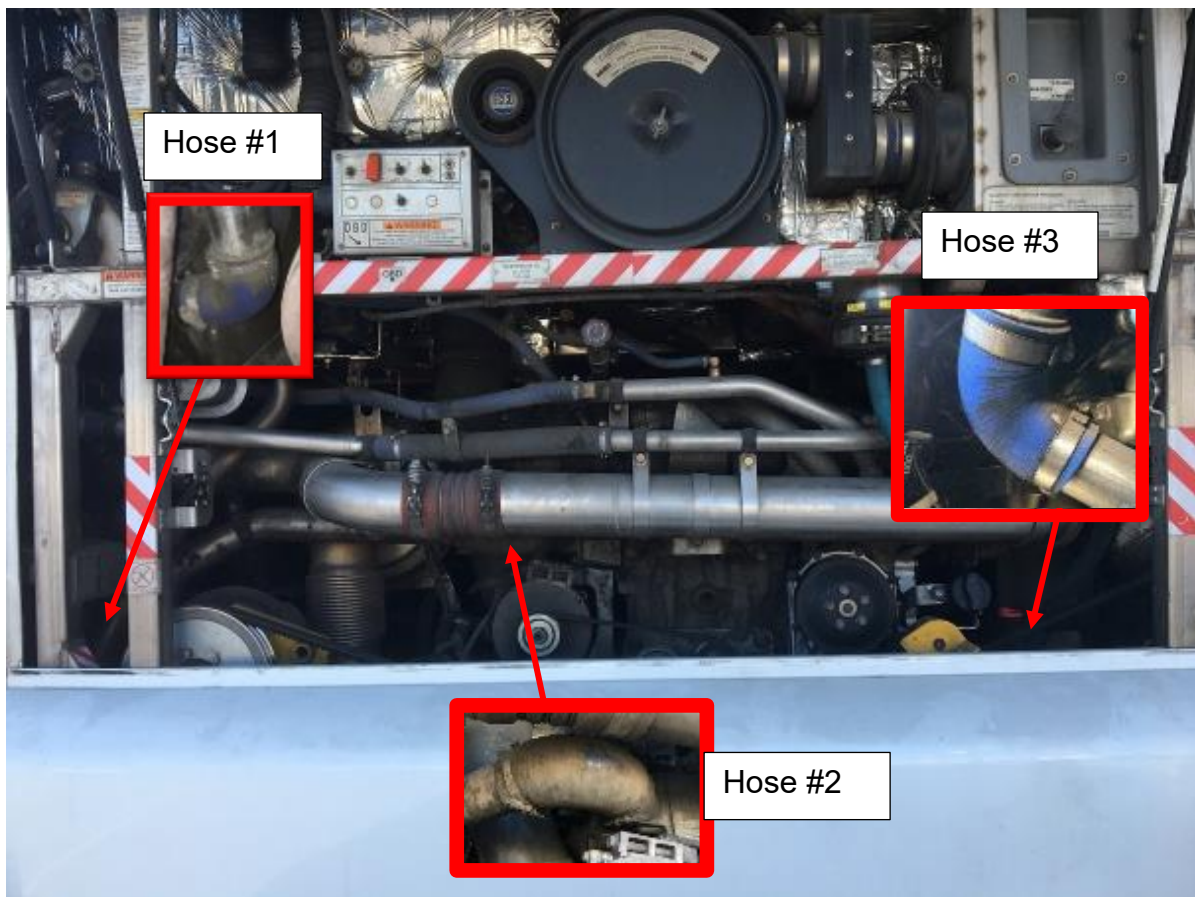
Locate the three coolant elbow hoses in the rear of the engine compartment.

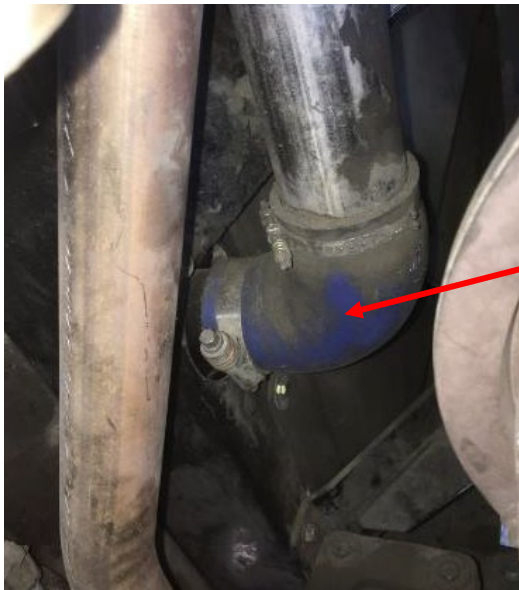
Remove and discard
elbow hose and clamps

Remove and discard the clamps securing the coolant elbow hose #1. Discard the hose.

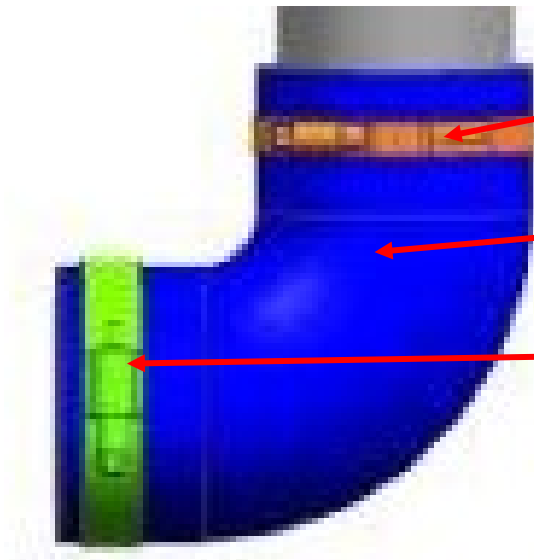
Thinner clamp, 19-04-0520

Install the new elbow
hose, 06-08-2261

Wider clamp, 19-4-150

Install the new elbow hose, MCI P/N: 06-08-2261, using the wider clamp, MCI P/N: 19-4-150, towards the radiator and the thinner clamp, MCI P/N: 19-04-0520, towards the engine. Torque the wider clamp to 115 In-Lb and thinner clamp to 105 In-Lb.

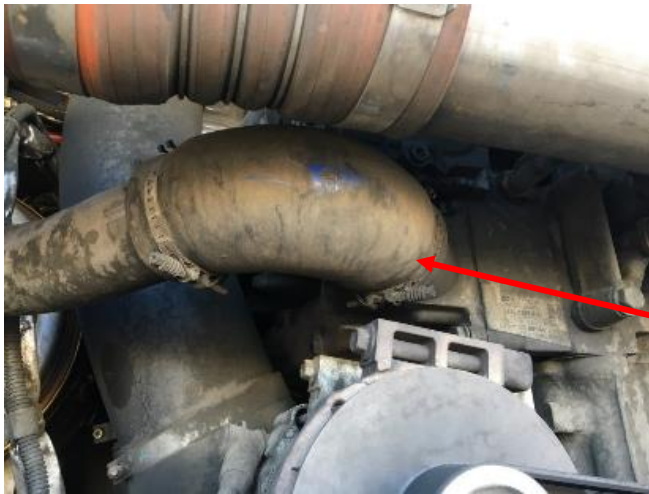
Remove and discard
clamps and hose

Remove and discard the clamps securing the coolant elbow hose #2. Discard the hose.

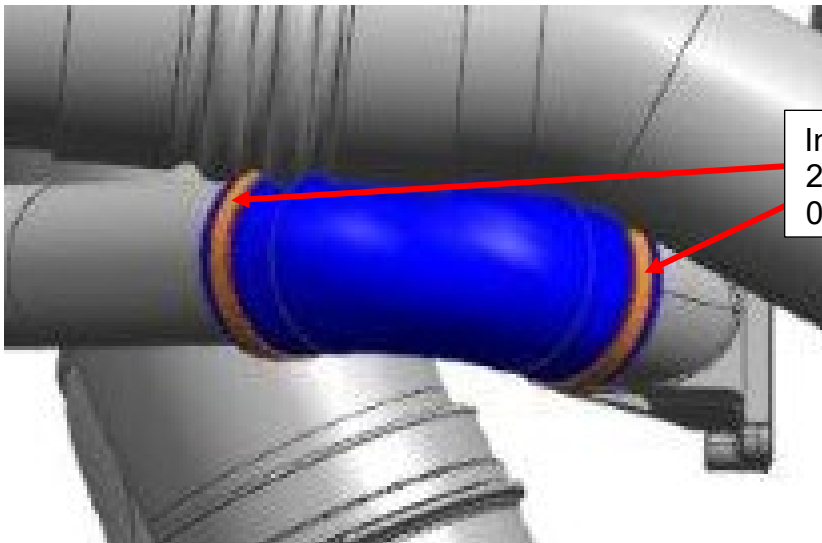
Install new hose 06-08-
2261, using clamps, 19-
04-0520

Install the new elbow hose, MCI P/N: 06-08-2261, using new clamps, MCI P/N: 19-04-0520. Torque the clamps to 105 In-Lb.

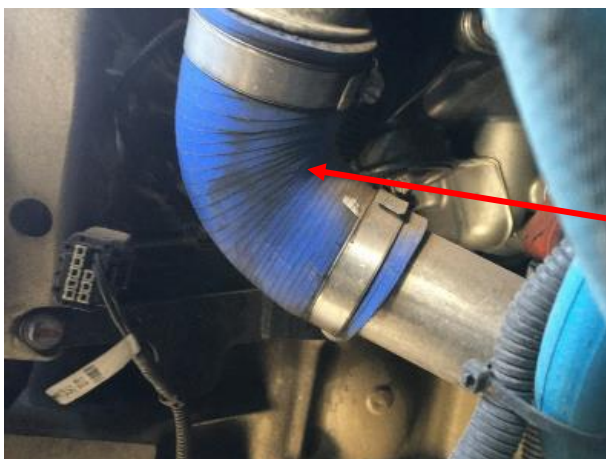
Remove and discard
clamps and hose

Remove and discard the clamps securing the coolant elbow hose #3. Discard the hose.

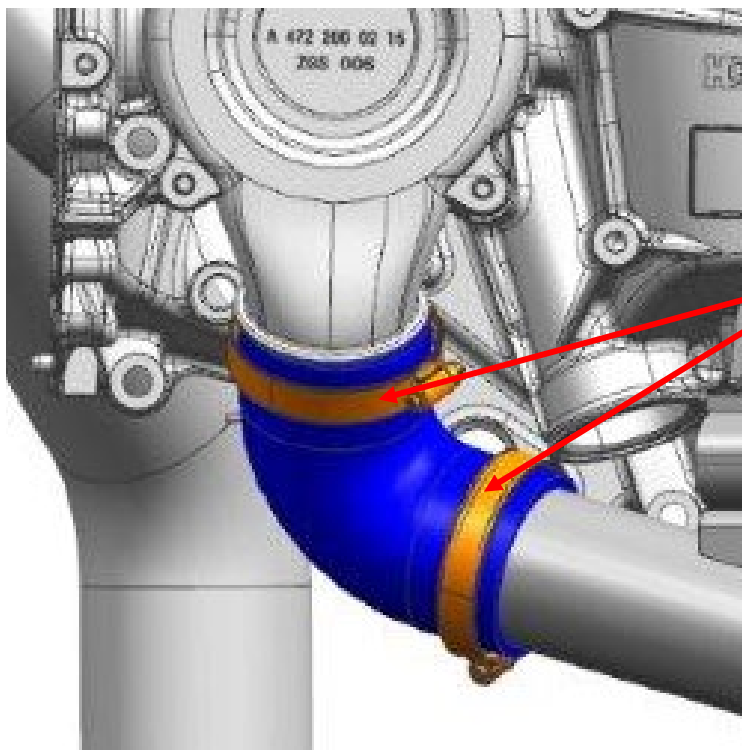
Install new hose 06-08-2261, using clamps, 19-04-0520

Install the new elbow hose, MCI P/N: 06-08-2261, using new clamps, MCI P/N: 19-04-0520. Torque the clamps to 105 In-Lb.

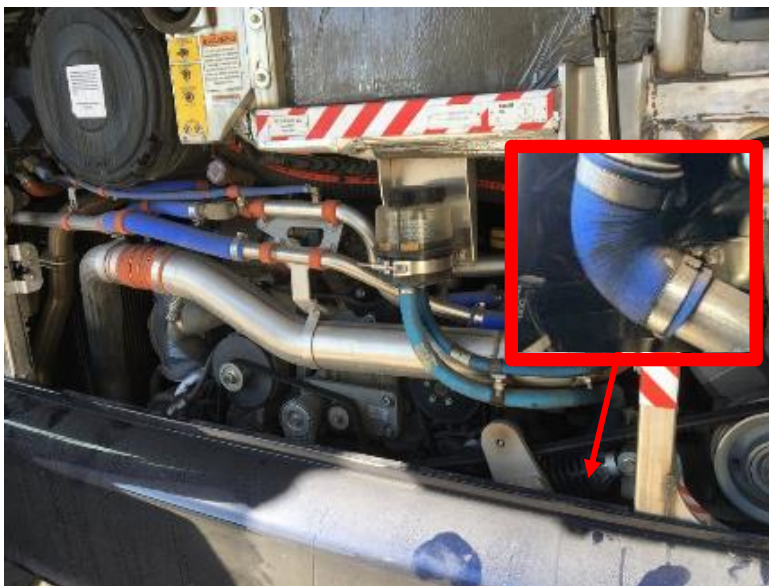
Locate the coolant hose elbow on the right hand side of the engine.

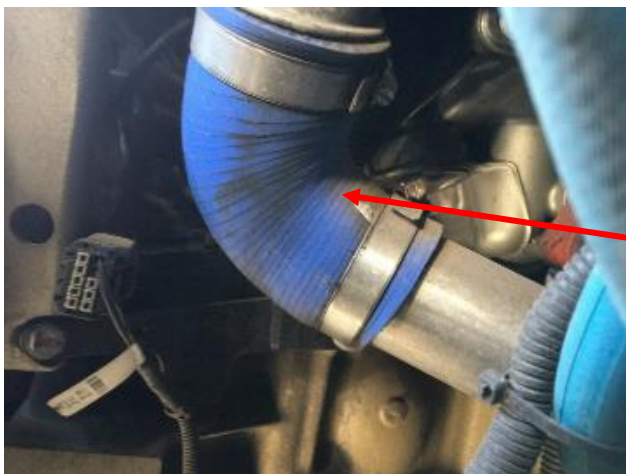
Remove and discard
hose elbow and clamps

Remove and discard the coolant hose elbow and the two hose clamps.

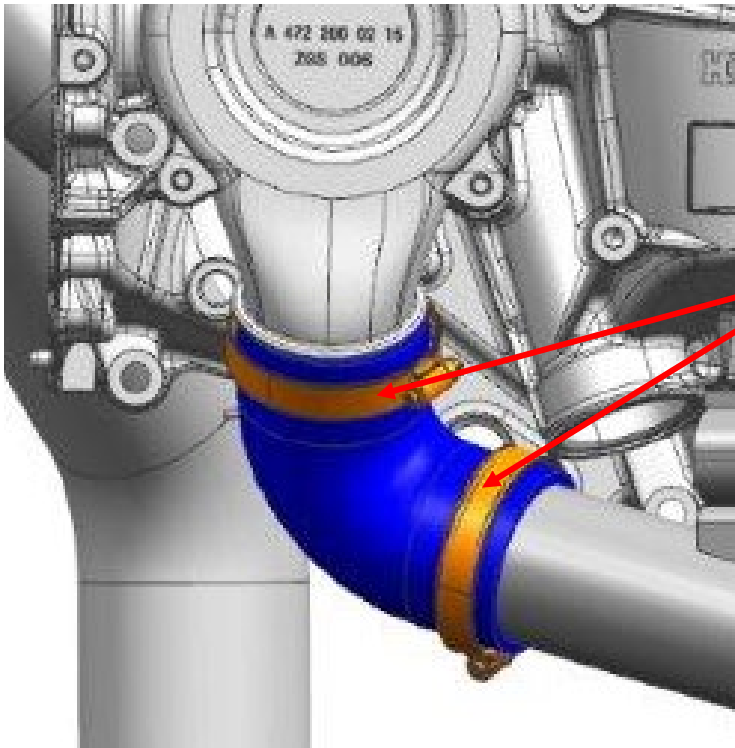
Install new hose 06-08-2261, using clamps, 19-04-0520

Install the new elbow hose, MCI P/N: 06-08-2261, using new clamps, MCI P/N: 19-04-0520. Torque the clamps to 105 In-Lb.

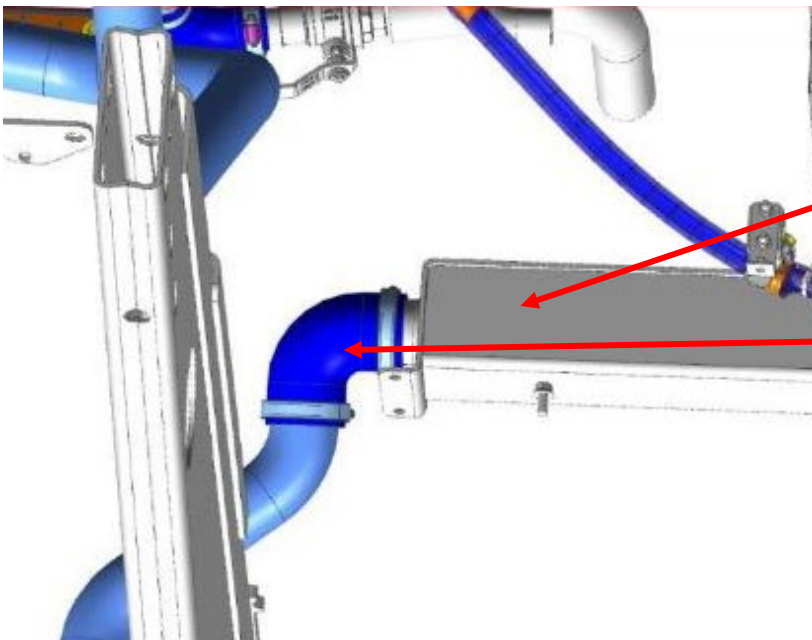
Transmission cooler

Coolant elbow hose,
06-08-2261

Locate the coolant elbow hose connected to the transmission cooler.

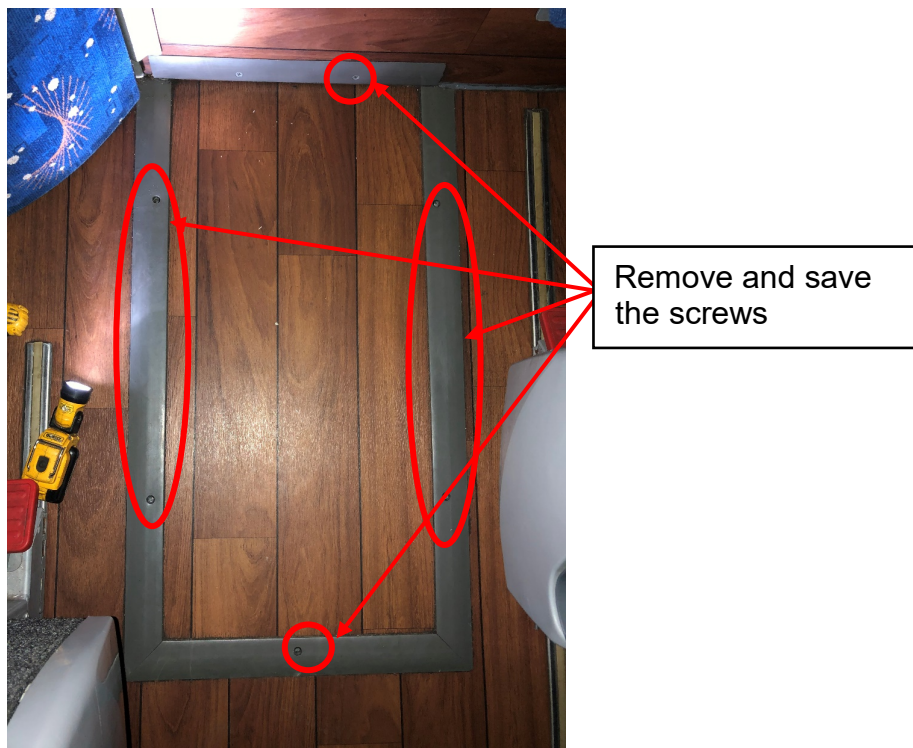
Remove and save the six screws securing the engine compartment access panel inside the coach.

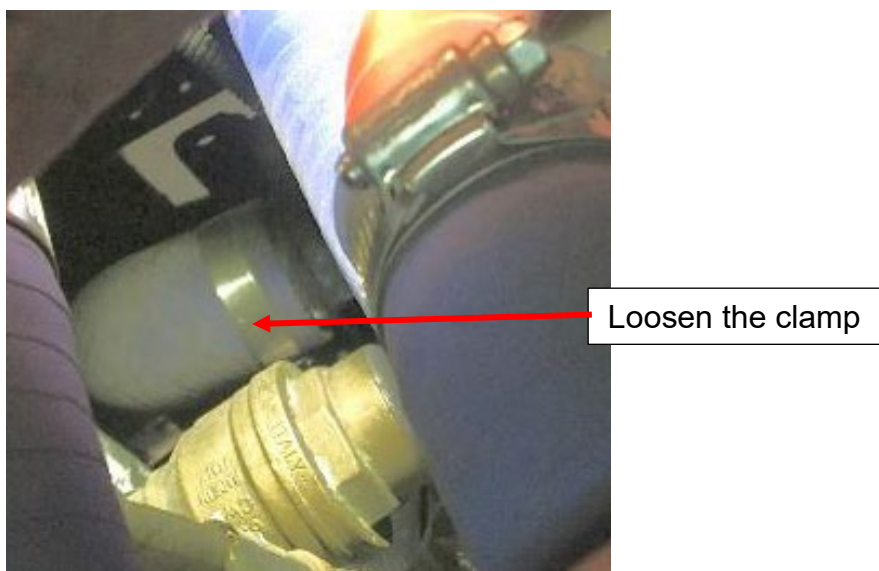
Loosen the clamp on the top of the coolant hose.

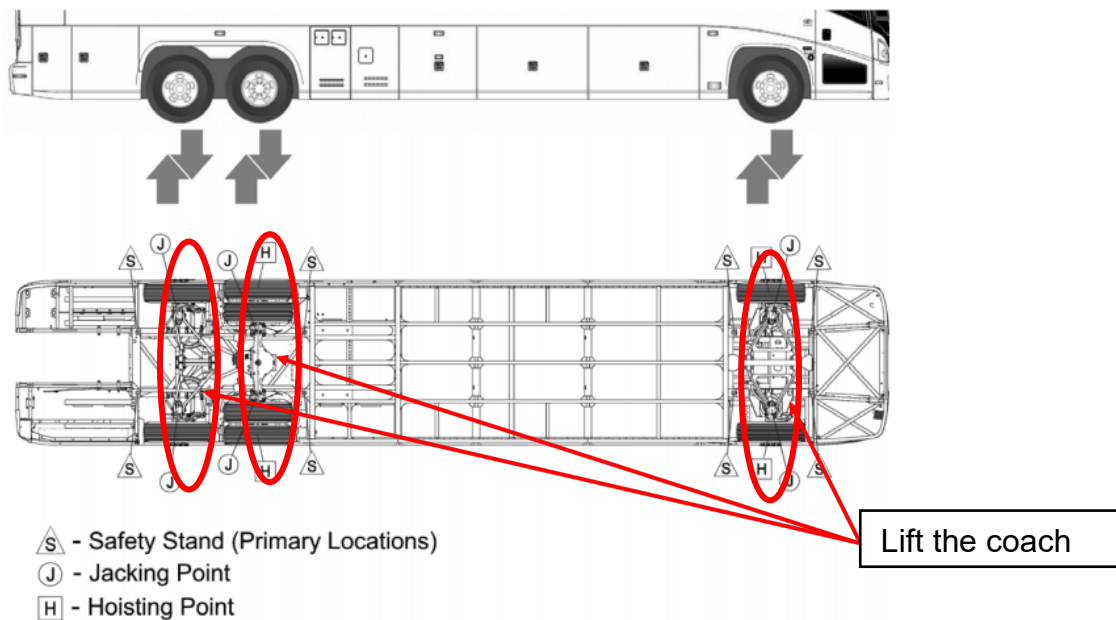
11768

Lift the coach at the jacking points following the instruction in Section 3F in the MCI J4500 maintenance manual.

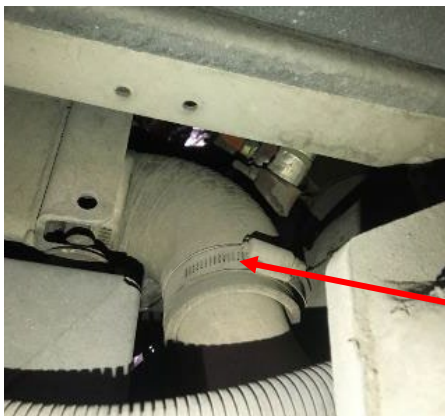
Remove and discard
elbow hose and clamps

From under the coach, remove the clamp securing the coolant hose. Discard the hose

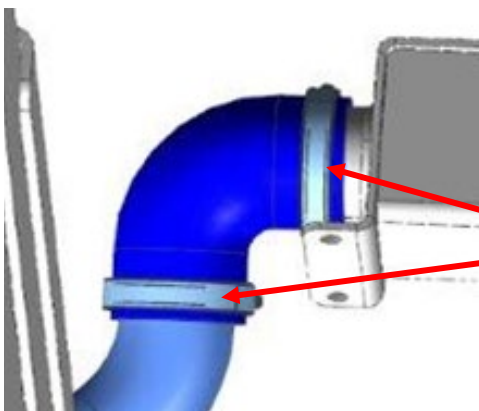
Install new hose 06-08-2261, using clamps, 19-04-0520

Install the new elbow hose, MCI P/N: 06-08-2261, using new clamps, MCI P/N: 19-04-0520. Torque the clamps to 105 In-Lb.
