## RECALL CAMPAIGN

CR5140ER1

SUBJECT:	Power Steering
JUSTIFICATION:	Certain power steering pipes may separate at the connection joint. This may cause a power steering assist lost and power steering fluid spillage from the ceiling in the cabin.

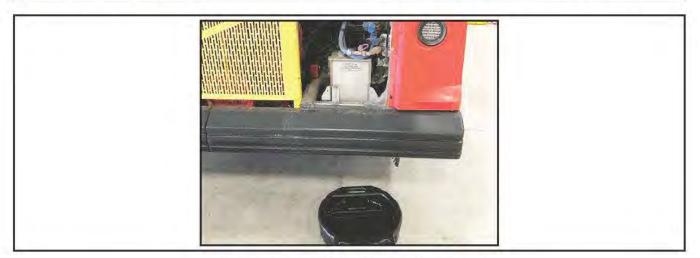
Figure 1 - Place Container to Collect Hydraulic Oil

- Open the rear engine access door. Locate the hydraulic reservoir and place a clean container to recover the oil (Figure 1).
- 1.5. Drain the oil. Keep the oil, it will be reused to fill the reservoir after the work has been completed.
- 1.6. Open the right front access door, locate the drain plug on the 90 deg fitting and place a clean container under it (Figure 2).
- 1.7. Remove plug and drain the remaining oil from the pipe. Keep the oil, it will be reused to fill the reservoir after the work has been completed.
