REFERENCE:	Nova Bus Manuals
SECTION:	09: Engine and Cooling
RS N°:	MQR 7621-2169
EFFECTIVE IN PROD.:	N/A
TC RECALL N°:	2021-568
NHTSA RECALL N°:	20V INFORMATION REDACTED PURSUANT TO THE FREEDOM OF INFORMATION ACT (FOIA), 5 U.S.C.552(B)(6)

SUBJECT:	Power steering
JUSTIFICATION:	Certain power steering pipes may separate at the connection joint. This may cause a power steering assist lost and power steering fluid spillage from the ceiling in the cabin.

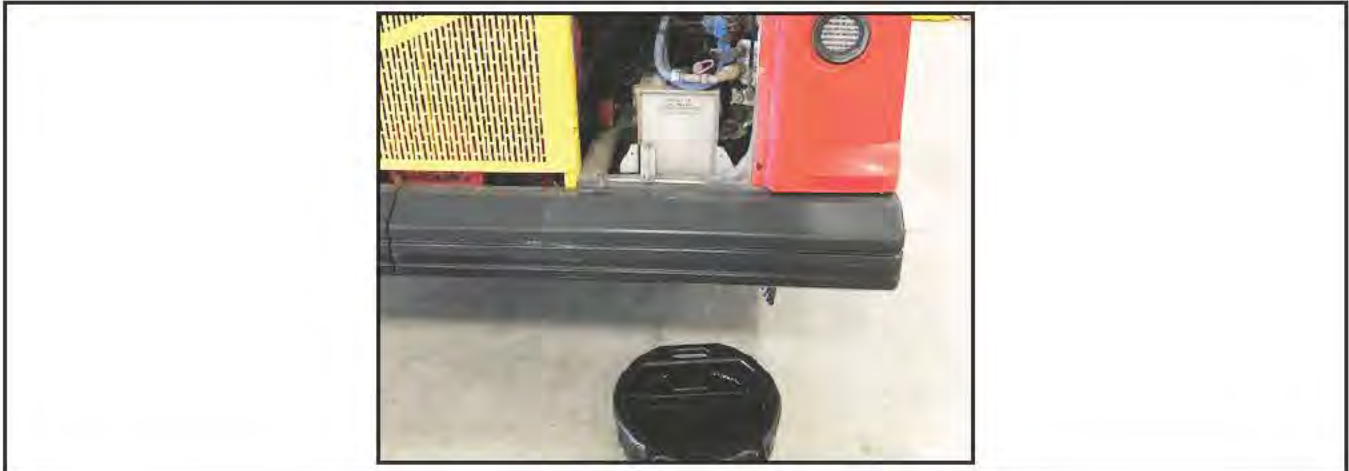
Figure 1 - Place Container to Collect Hydraulic Oil

- 1.4. Open the rear engine access door. Locate the hydraulic reservoir and place a clean container to recover the oil (Figure 1).
- 1.5. Drain the oil. Keep the oil, it will be reused to fill the reservoir after the work has been completed.
- 1.6. Open the right front access door, locate the drain plug on the 90 deg fitting and place a clean container under it (Figure 2).
- 1.7. Remove plug and drain the remaining oil from the pipe. Keep the oil, it will be reused to fill the reservoir after the work has been completed.

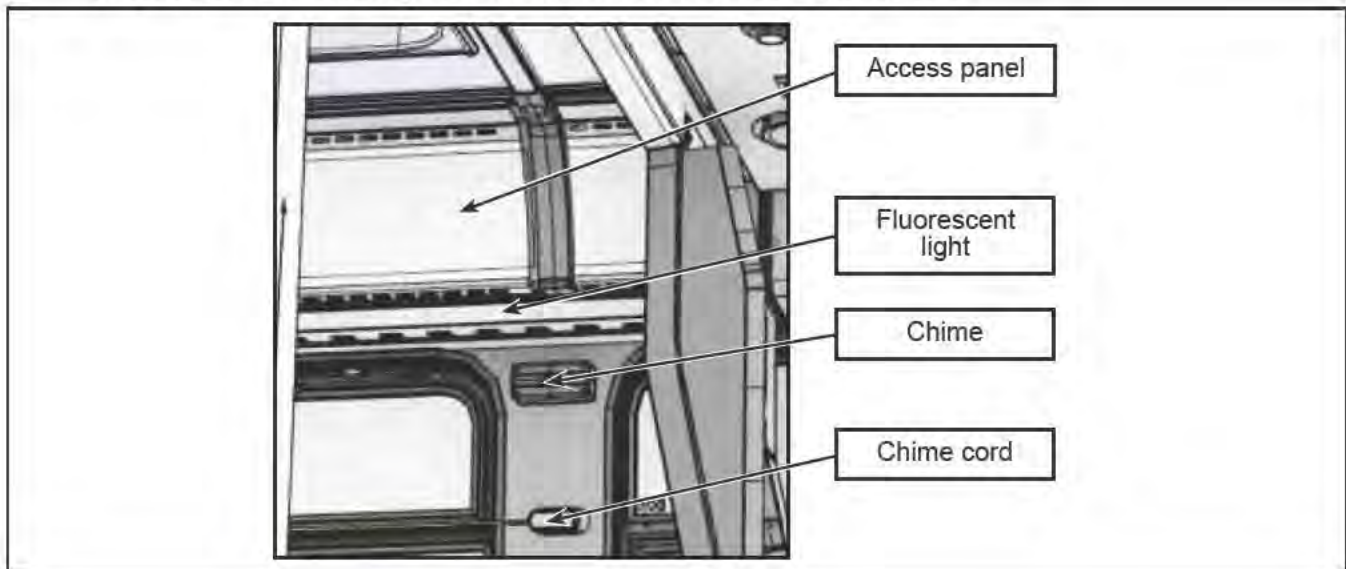
Figure 3 - Components to remove

- 1.9. Next to the ceiling, to access the hydraulic pipe N77549-01 (Figure 3), remove as needed:
 - a. Access panel.
 - b. Curtains.
 - c. Fluorescent light. If needed, loosen the top of the windows clamping.
- 1.10. Remove the chime (Figure 3).
 - a. Unscrew the 4 screws to remove the chime cover.
 - b. Disconnect the 2 rounds terminals.
 - c. Unscrew the 2 mounting screws and remove the chime (to not lose the spacers behind the chime, do not pull out the screws completely).
- 1.11. Remove the chime cord (Figure 3).
 - a. Unscrew the screws above and below and remove the cover.
 - b. Disconnect the 2 round terminals.
 - c. Unscrew the 2 mounting locknuts and remove the module and the cord.

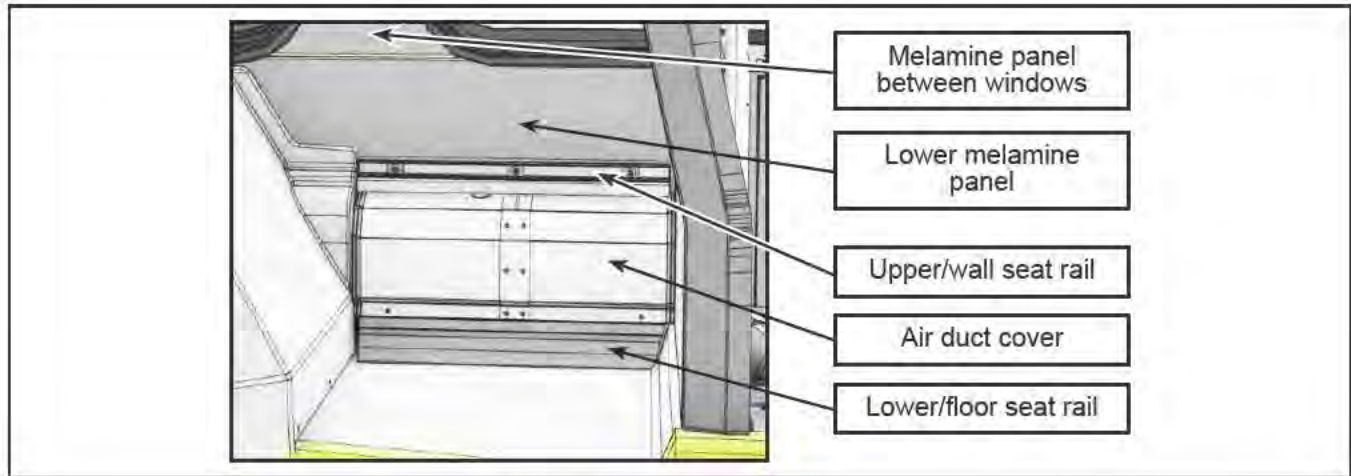
Figure 4 - Components to remove

- 1.12. Remove the upper/wall seat rail (Figure 4).
 - a. Cut sealant at each end.
 - b. Unscrew the 3 M10 bolts with a manual tool to avoid spinning the rivnuts.
 - c. Keep the rail, the 3 M10 bolts and the 3 rectangular retainers.
- 1.13. Remove the air duct plate (Figure 4).
- 1.14. Remove the lower/floor seat rail (Figure 4).
 - a. Cut sealant at each end.
 - b. Underneath the vehicle, unscrew the 3 nuts.
 - c. Keep the rail, the 3 bolts, the 3 square plates, the 3 washers and the 3 nuts.

- 1.15. Remove the melamine panels (Figure 4).
- Remove the melamine panel between the windows. If needed, loosen the windows clamping (the melamine panel is fragile, especially the corners).
 - Remove the trim and the lower melamine panel.

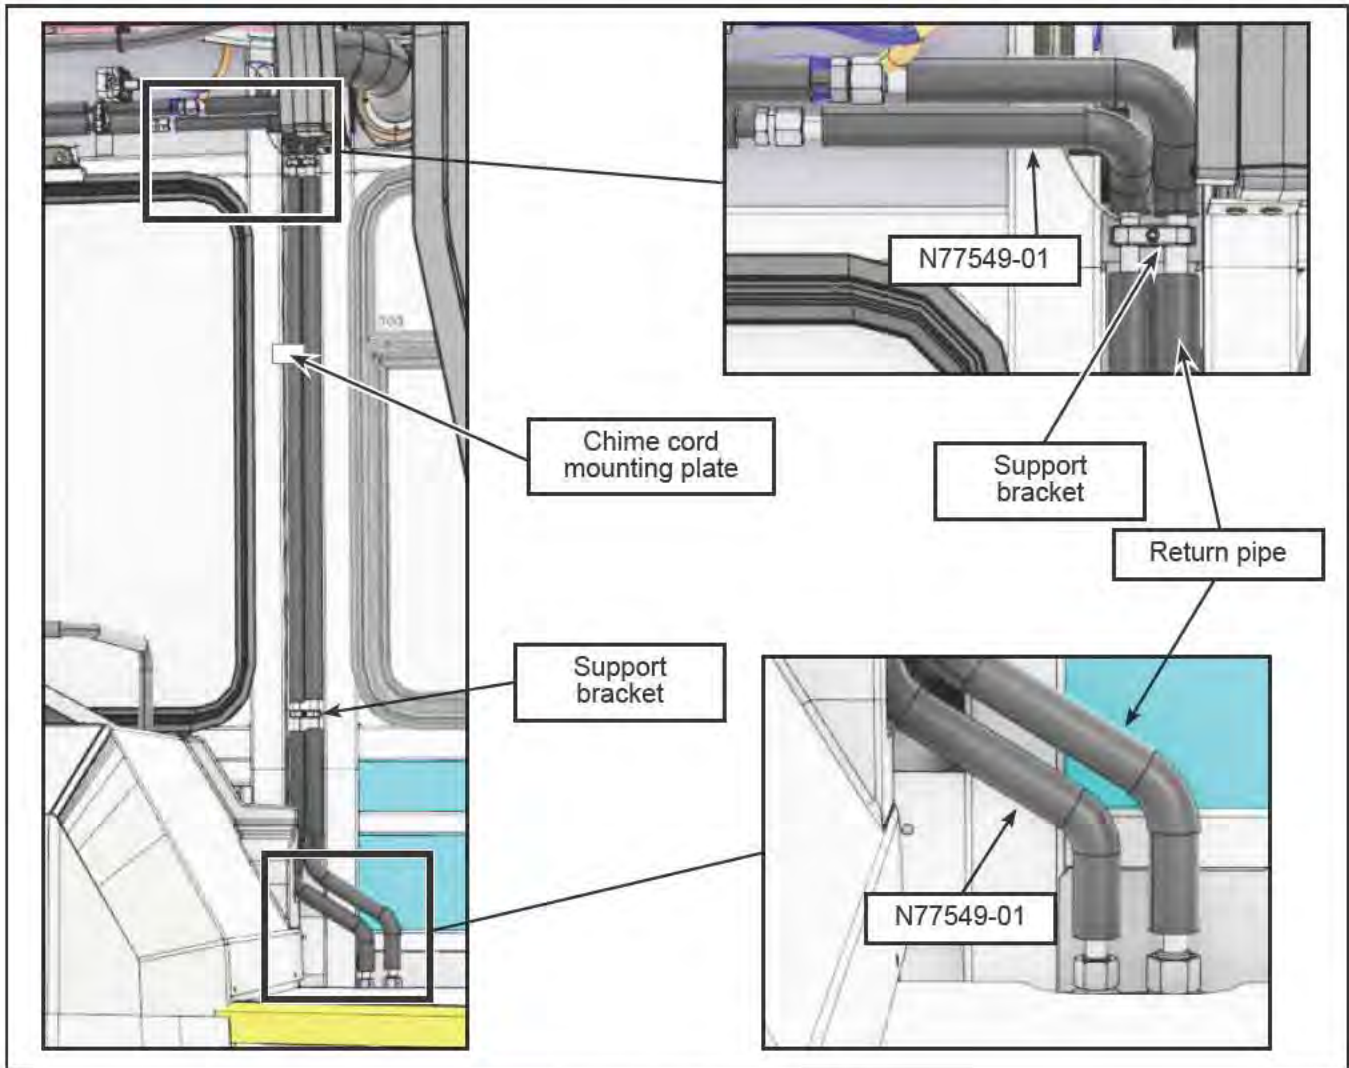
Figure 5 - Hydraulic Pipe N77549-01

- Locate hydraulic pipe N77549-01 (Figure 5).
- Remove the 2 support brackets.
- In order to remove the hydraulic pipe N77549-01, it is necessary to first remove the return hydraulic pipe located next to it because of the presence of the chime cord mounting plate (Figure 5).
 - Disconnect the ORS fitting at each end of both pipes (note: a small amount of oil will pour).
 - Remove the return pipe.
 - Remove the pipe N77549-01.

- Install new insulation N26360 on the new hydraulic pipe N77549-01 as on the old one.
- Install the pipe N77549-01 in the vehicle and hand tighten the ORS fittings.
- Reinstall the return hydraulic pipe and hand tighten the ORS fittings.
- Tighten the 4 ORS fittings to the torque value of 48 lb-ft (65 N·m).

- Reinstall the 2 support brackets.
- Discard the old hydraulic pipe N77549-01.

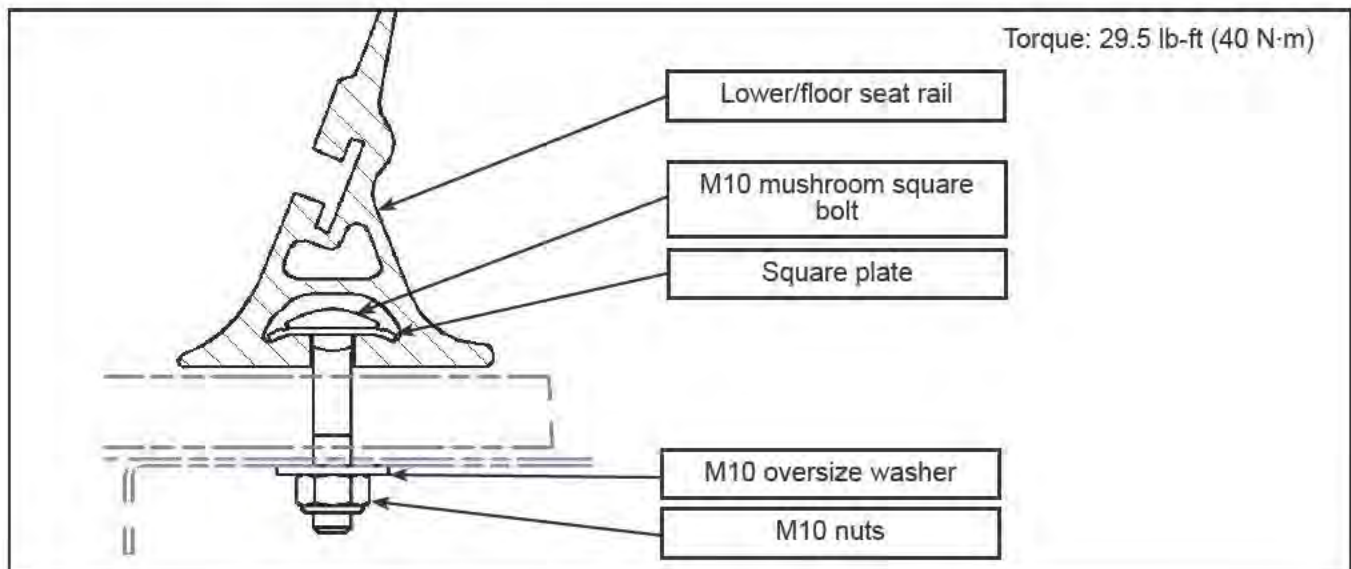
Figure 6 - Lower/Floor Seat Rail

- 1.35. Reinstall the floor rail in the same position with the removed hardware: 3 M10 mushroom square bolts, 3 square plates, 3 M10 oversize washers and 3 M10 nuts.

- a. Clean the 3 bolts to remove any old anti-seize compound and dirt.
 - b. Reinsert the 3 bolts and the 3 square plates into the rail.
 - c. Put the rail in place inserting the bolts into the floor. Position the rail like before.

- d. Underneath the vehicle, apply new anti-seize compound, NeverSeez (Nova Bus #R085023) or equivalent, on bolts and install the 3 washers and the 3 nuts.

- e. Torque the nuts to the torque value show in Figure 6 and apply torque seal on nuts.
 - f. Apply sealant Sikaflex 552 N35535-01 to both ends of the rail to fill in the gaps.

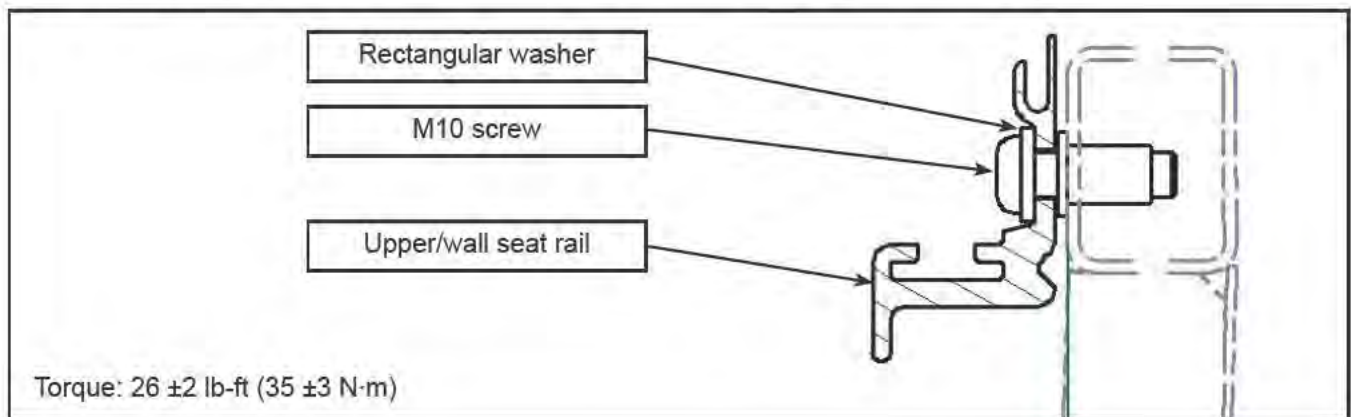
Figure 7 - Upper/Wall Seat Rail

- 1.36. Reinstall the air duct plate.
- 1.37. Reinstall the upper/wall rail with the removed hardware: 3 M10 screws and 3 rectangular retainers.
 - a. Clean the screws and the rivnuts to remove the old thread locker.

- b. Apply new thread locker, Loctite 242 (Nova Bus #9985283) or equivalent, on screws.
 - c. Install the rail with the 3 rectangular retainers and the 3 screws. Hand tighten.

- d. From the rear to the front, make a first tightening to the torque value shown in Figure 7.
 - e. Again from the rear to the front make a second tightening to the same torque value.

- f. Apply torque seal on bolts.
 - g. Apply sealant Sikaflex 552 N35535-01 to both ends of the rail to fill in the gaps.

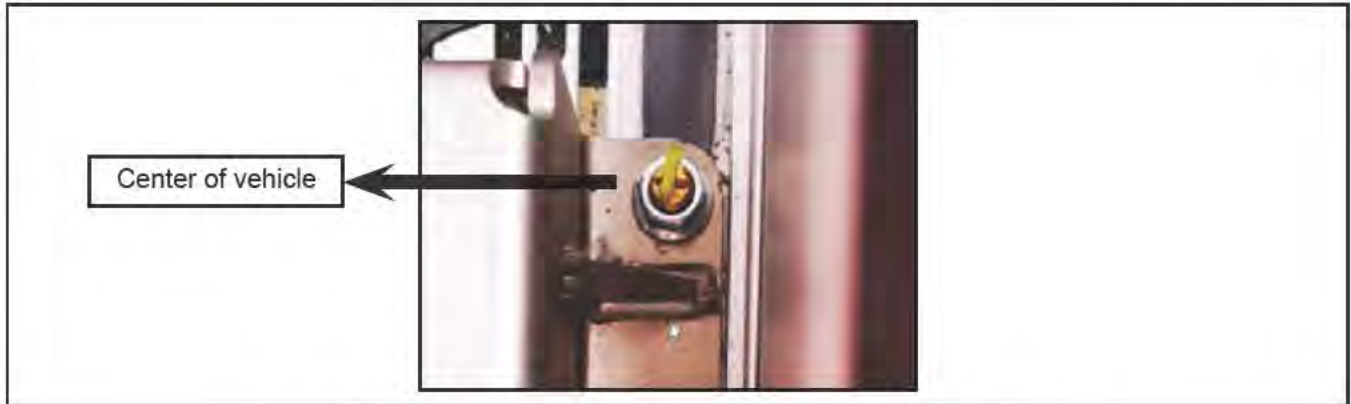
Figure 8 - The Notch of the T-Bolt Aligned Towards the Center of the Vehicle

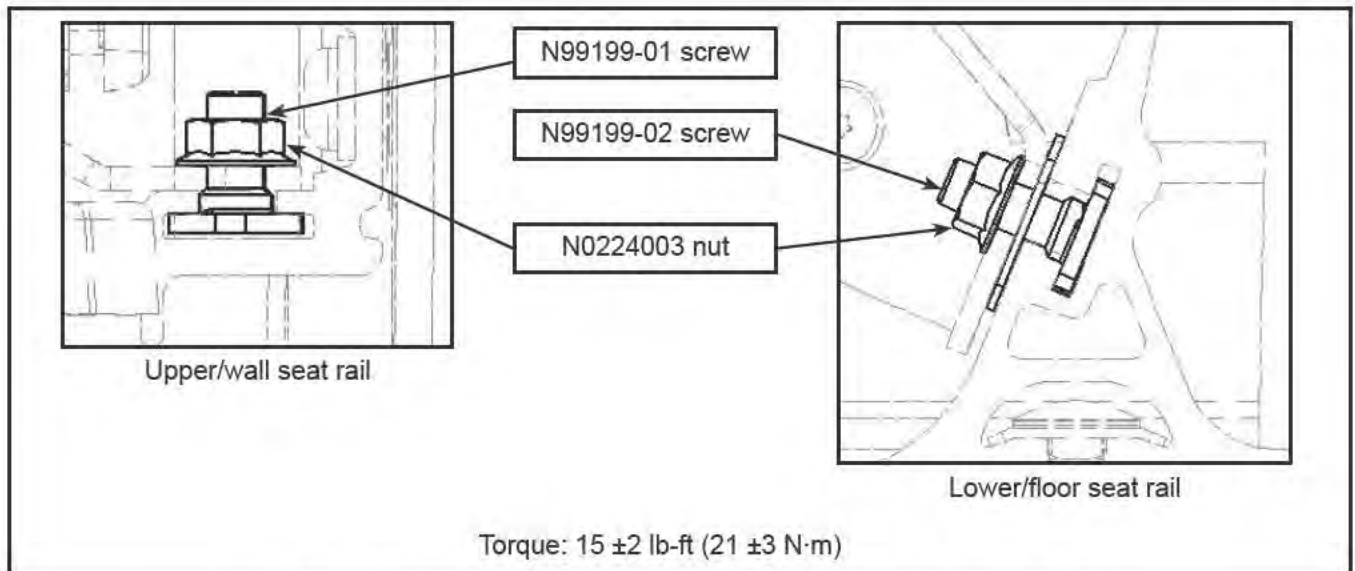
- 1.38. Reinstall the longitudinal seat.
 - a. Install 4 new T-Bolts N99199-01 into the upper/wall rail and install 4 new T-bolts N99199-02 into the floor rail.
 - b. Position the T-bolts on the marks made previously and install seat. If applicable, reinstall any shim between the seat floor rail and the seat cantilever leg.
 - c. Secure seat with 8 new flange serrated nuts N0224003 and hand tighten.
 - d. Validate that the T-bolts are locked in the rail with their notches aligned towards the center of the vehicle (Figure 8).
 - e. Torque the nuts to the torque value shown in Figure 9.
 - f. Apply torque seal on nuts.
 - g. If applicable, reconnect any electrical connection and secure with cable ties.

Figure 9 - Seats Fasteners and Torque on Upper/Wall and Lower/Floor Seat Rail
