SIM 61 02 21

## RECALL 20V-601: HIGH-VOLTAGE BATTERY

E-Series	Model Description	Production Date
F60	MINI Cooper SE Countryman ALL4– PHEV Only	March 12, 2020 – August 19, 2020

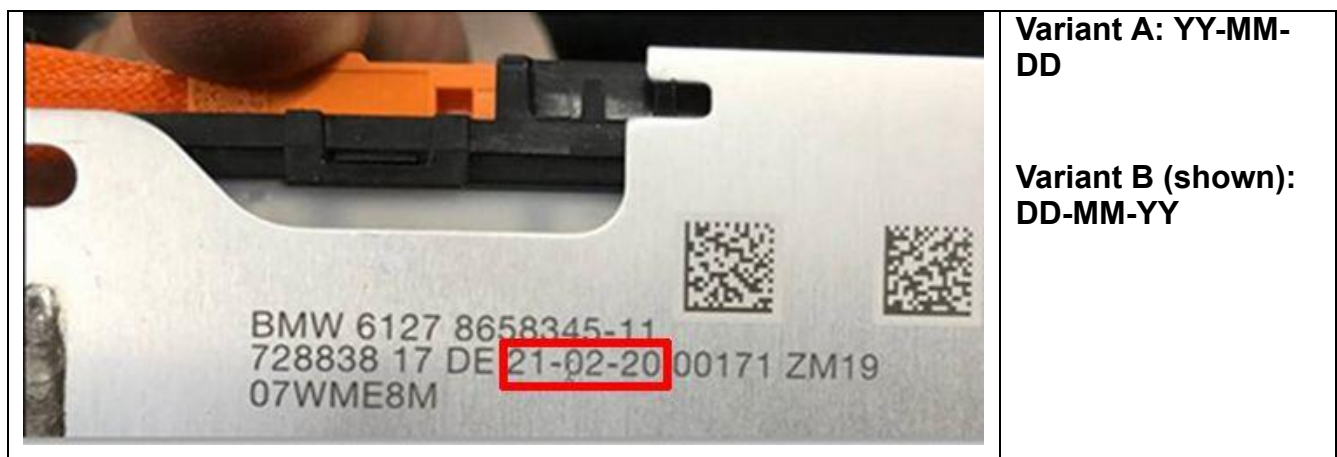
The date in the serial number of the high-voltage module can be displayed in two different formats.

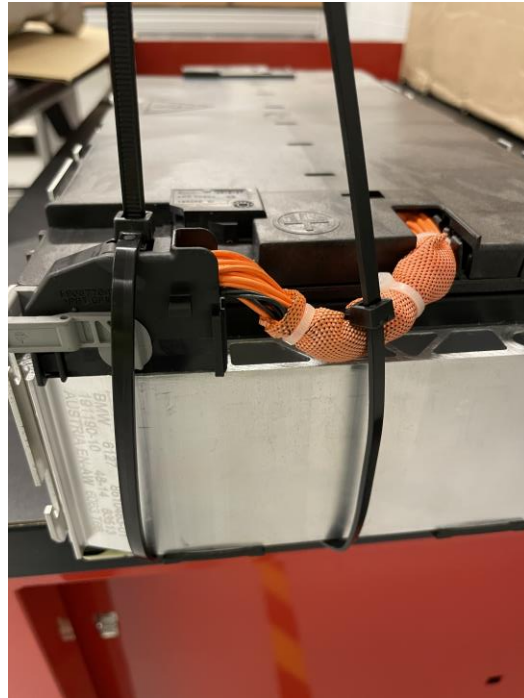
**(Photo 4c. #1 above)**

## **Section 4 continued: actual BMW module (4c. photos)**

- b. Ensure terminals are thoroughly covered with proprietary cover & electrically non-conductive tape to ensure no portion of terminals are exposed. **SEE PHOTO 4b. #1 & #2.**
- c. With electrically non-conductive tape, tape any cable leads that may be extending from the battery module. Attach cable to module with tie wrap/zip tie, like new module. **If the plastic cable end is intentionally “pinched”, it could create a short circuit.** Then cut off the excess length of tie wrap/zip tie. **SEE PHOTOS 4c #1 - #3.**

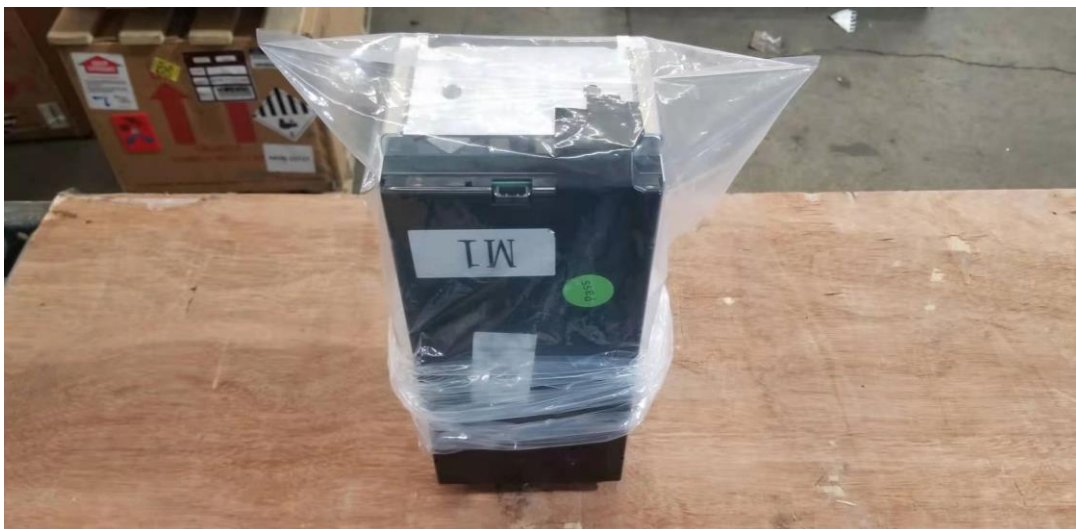
(Photo 6a. above)

**Section 6:** PER BAGGING/SEALING INSTRUCTIONS IN SECTION 6, WHEN POSITIONING THE MODULE VERTICALLY OR HORIZONTALLY, NEVER PLACE (1) THE CABLE LEAD SIDE OF THE MODULE, NOR (2) THE TOP SIDE (TERMINAL/PLASTIC SIDE) AT THE BOTTOM, BEARING WEIGHT OF MODULE. THIS PHOTO EXAMPLE CONTAINS A MODULE THAT DOES NOT HAVE A CABLE LEAD, SO IT WAS ABLE TO BE PLACED VERTICALLY ON BOTH SIDES. THAT IS NOT THE CASE WITH THIS PROJECT'S BATTERY MODULES.

- a. Lay the battery module vertically with cable lead side facing upward. Do not lay module where cable lead side is at the bottom bearing weight of module – there shouldn't be any unnecessary weight on this component that could cause damage to cable lead as mentioned in section 4.c. ***SEE PHOTO 6a. (Actual module in photos is not part of this project - only an example. Module in photos do not have a cable lead)***
