SIB 61 13 21

RECALL 20V-601: HIGH-VOLTAGE BATTERY RECALL

This Service Information Bulletin (Revision 3) replaces SI B61 13 21 **dated January 2022**.

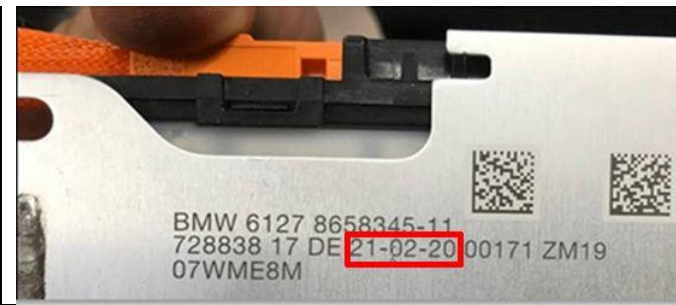
The date in the serial number of the High-voltage module can be displayed in two different formats:

Variant A: YYMMDD
--	-------------------

Variant B (shown here): DDMMYY

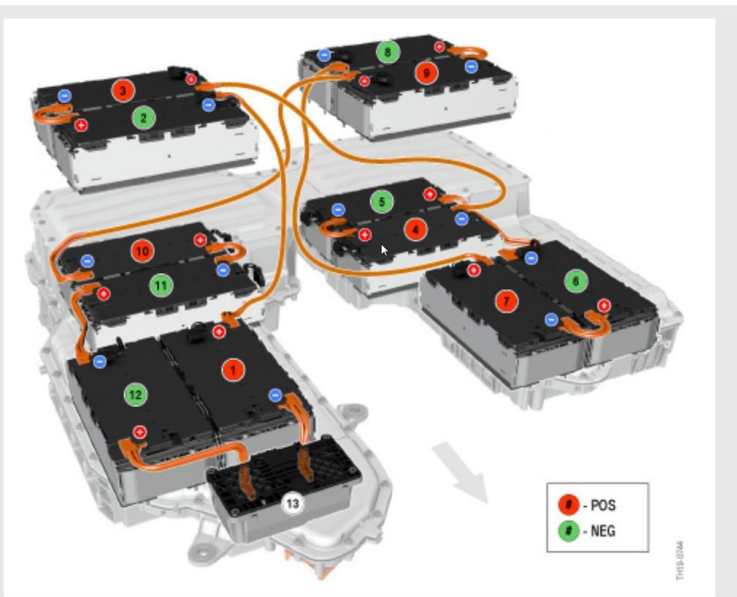
For example:

- Module 12 is **NEG (01)**
- Module 1 is **POS (02)**
- Module 11 is **NEG (01)**
- Module 10 is **POS (02)**
- Module 2 is **NEG (01)**
- Module 3 is **POS (02)**
- Module 8 is **NEG (01)**
- Module 9 is **POS (02)**
- Module 5 is **NEG (01)**
- Module 4 is **POS (02)**
- Module 6 is **NEG (01)**
- Module 7 is **POS (02)**

Please verify that the replacement cell modules you receive are the ones you ordered and were boxed correctly. The part numbers received must cross-reference to the EPC part# POS (positive) or NEG and install them in the correct position in the high-voltage battery as per the illustration below.

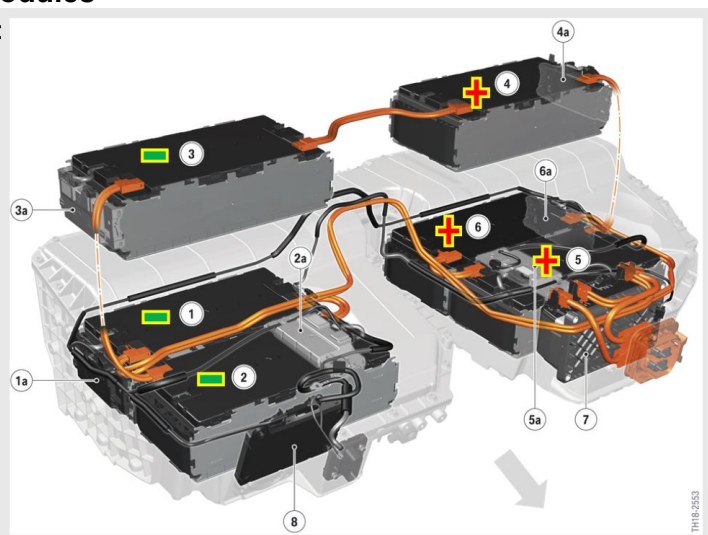
SP41 HV Battery (G01/G20/G20/G12) modules-

G01/G20/G30/G12 LCI modules (SP41 battery) are:

For example:

- Module 1 is **NEG (01)**
- Module 2 is **NEG (01)**
- Module 3 is **NEG (01)**
- Module 4 is **POS (02)**
- Module 5 is **POS (02)**
- Module 6 is **POS (02)**

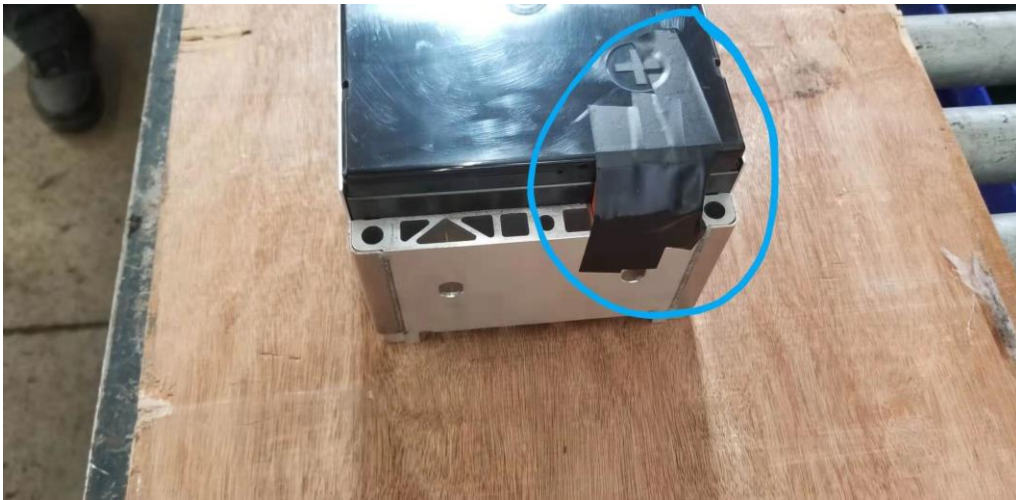
(Photo 4b. # 1 above)

- b. Ensure terminals are thoroughly covered with proprietary cover & electrically non-conductive tape to ensure no portion of terminals are exposed. **SEE PHOTO 4b. #1 & #2.**
- c. With electrically non-conductive tape, tape any cable leads that may be extending from the battery module. Attach cable to module with tie wrap/zip tie, like new module. **If the plastic cable end is intentionally “pinched”, it could create a short circuit.** Then cut off the excess length of tie wrap/zip tie. **SEE PHOTOS 4c #1 - #3.**

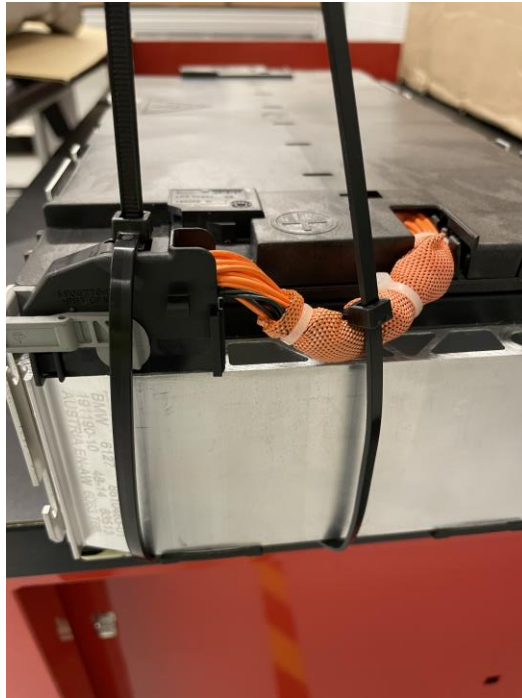
(Photo 4c. #1 above)

Section 4 continued: actual BMW module (4c. photos)

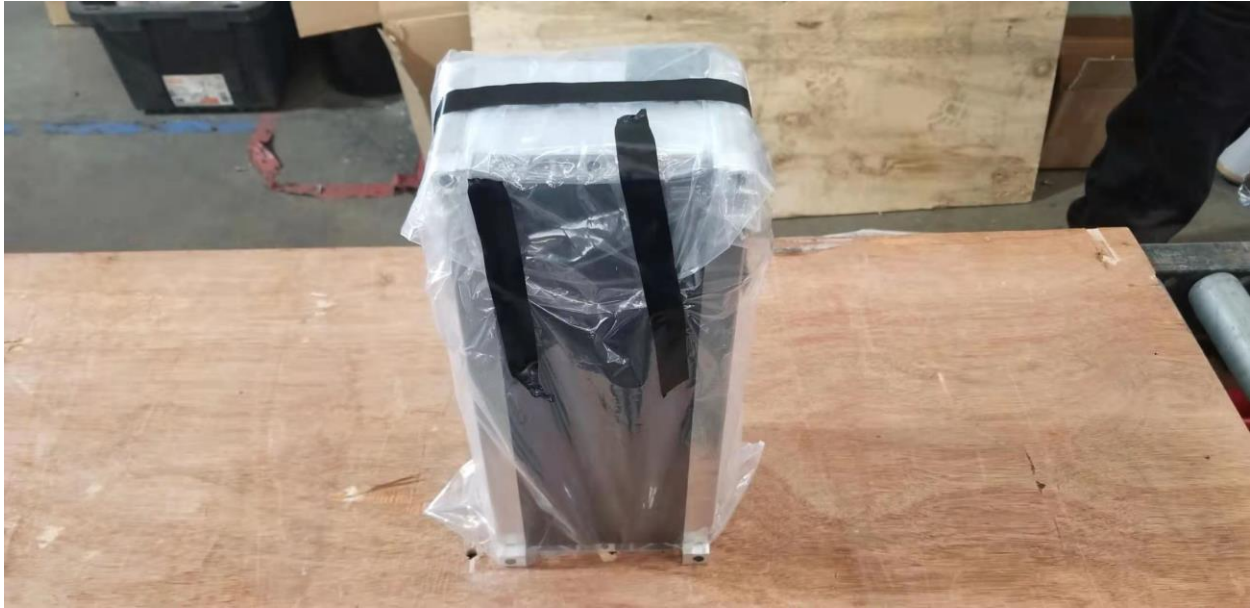
(Photo 6e. above)

- e. In its current horizontal position, proceed to closing/sealing bag. If using tape to seal bag, fold the battery bag where there is no longer an opening, and excess air has been removed from bag. Then tape it thoroughly so that it is sealed. If using a zip tie, place the zip tie at the center point of the excess portion of the bag opening to not stretch/rip bag, remove excess air from bag, & then zip tie the bag closed. Keep battery module laying horizontally. **SEE PHOTO 6e. (Module in photo does not include a cable lead. This photo is only an example of a closed/sealed bag. THE PROCESS OF CLOSING/SEALING MODULE NEEDS TO BE PERFORMED WHILE LAYING HORIZONTALLY AS DESCRIBED ABOVE).**
