SIM 61 02 21

RECALL 20V-601: HIGH-VOLTAGE BATTERY

This Service Information Bulletin (Revision 2) replaces SI M61 02 21 dated November, 2021.

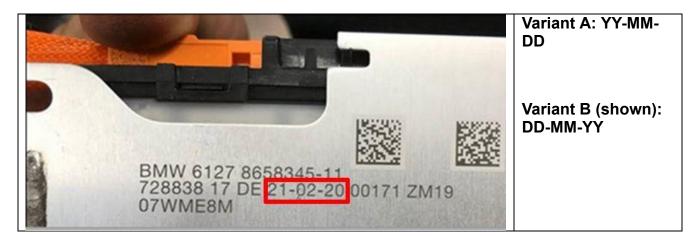
The date in the serial number of the high-voltage module can be displayed in two different formats.

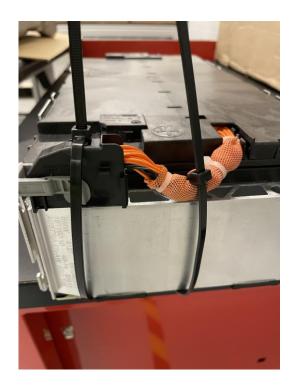
(Photo 4c. #1 above)

Section 4 continued: actual BMW module (4c. photos)

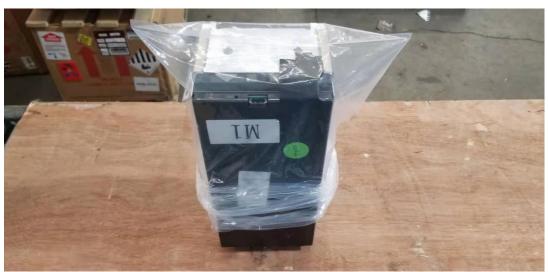
(Photo 6a. above)

Section 6: PER BAGGING/SEALING INSTRUCTIONS IN SECTION 6, WHEN POSITIONING THE MODULE VERTICALLY OR HORIZONTALLY, NEVER PLACE (1) THE CABLE LEAD SIDE OF THE MODULE, NOR (2) THE TOP SIDE (TERMINAL/PLASTIC SIDE) AT THE BOTTOM, BEARING WEIGHT OF MODULE. THIS PHOTO EXAMPLE CONTAINS A MODULE THAT DOES NOT HAVE A CABLE LEAD, SO IT WAS ABLE TO BE PLACED VERTICALLY ON BOTH SIDES. THAT IS NOT THE CASE WITH THIS PROJECT'S BATTERY MODULES.

- a. Lay the battery module vertically with cable lead side facing upward. Do not lay module where cable lead side is at the bottom bearing weight of module there shouldn't be any unnecessary weight on this component that could cause damage to cable lead as mentioned in section 4.c. SEE PHOTO 6a. (Actual module in photos is not part of this project only an example. Module in photos do not have a cable lead)

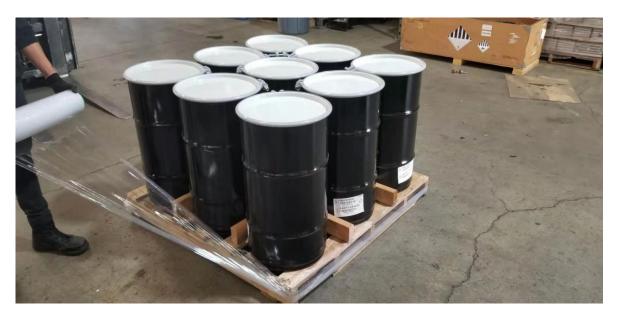
(Photo 11d. above)

Section 11 continued: photo illustration only of stretch wrapping/palletizing instructions. Per section 9, labels/markings need to be placed on each drum before stretch wrapping drums/pallet(s).

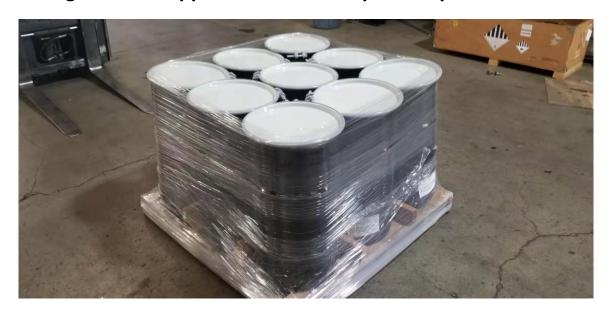
(Photo 11e. #2 above)

Section 11 continued: photo illustration of properly stretch wrapped/palletized pallet. Per section 12, additional labels and markings need to applied after this step is completed.
