# SAFETY RECALL

Date	Number	Page
10/20	RVXX2005	1 (13)

## **Sleeper Bunk Window, Repair VN**

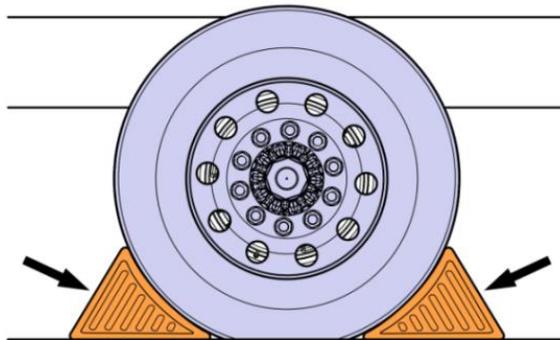
1. Secure the vehicle for service by parking on a flat and level surface.
2. Apply parking brake.
3. Place the transmission in neutral or park.
4. Install the wheel chocks.

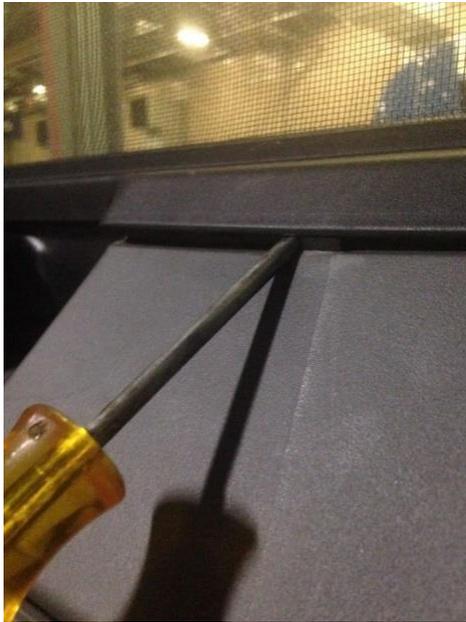
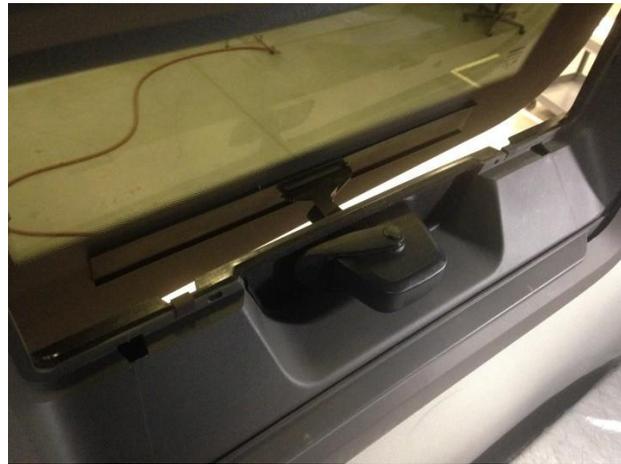
1. Remove the bug screens from the window.

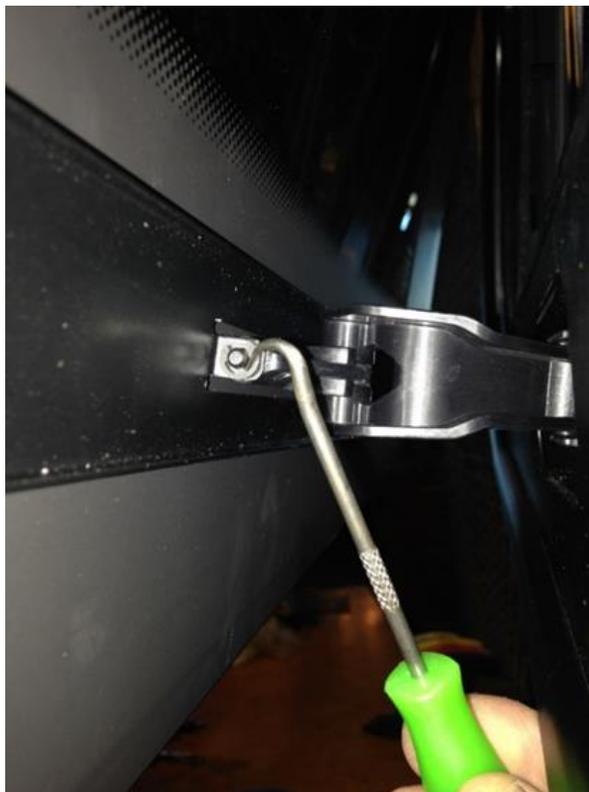
2. Safely place a ladder at the exterior of the window.
3. Remove the "E" clip from the window latch.

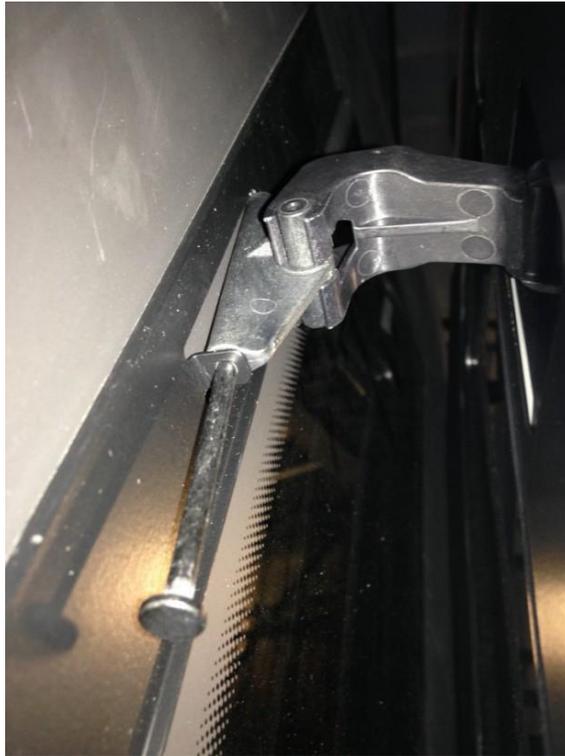
4. Remove the pin that secures the latch to the glass.

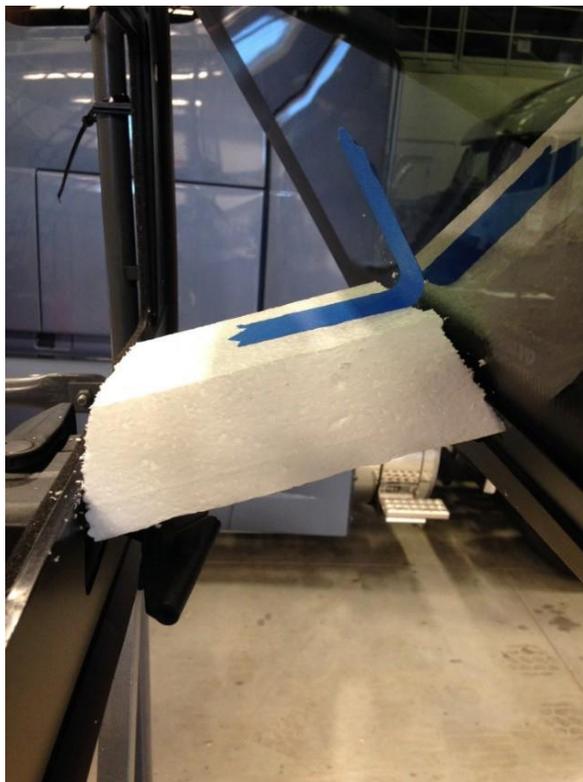
5. Make a window support that can be used for the window inspection/repairs.

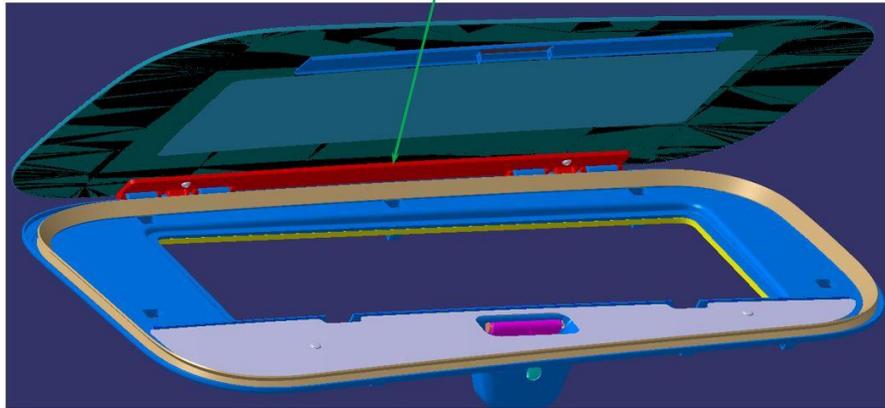
Figure 1. Plastic Hinge

The window hinge and mounting hardware are insufficient to hold the window in place if the truck is driven with the sleeper bunk windows open. If the window detaches from the vehicle, it may strike another vehicle or pedestrian increasing the risk of personal injury or a vehicle crash.

“Old” Hinge  
Single Plastic Piece Across  
Both Hinge Sites

7. If the truck is found with metal hinges, reassemble the window and claim inspection labor code.
8. If the truck is found with plastic hinges, proceed with repair and claim primary labor code.

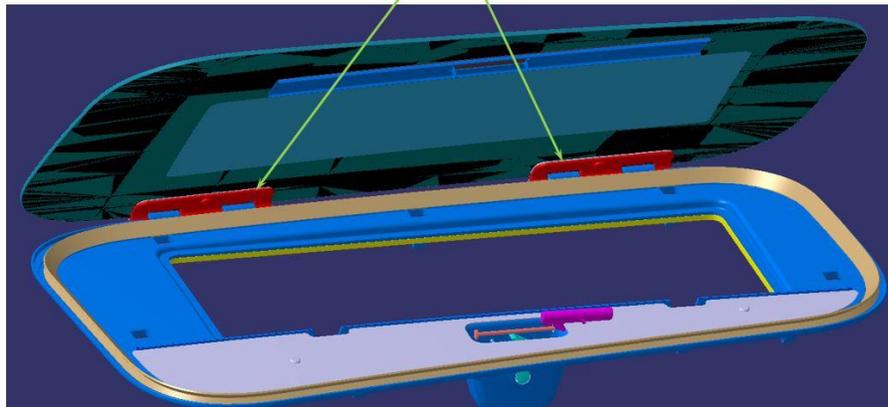
Figure 2. Metal Hinge

“New” Hinge  
Two Separate Aluminum Pieces  
One At Each Hinge Site

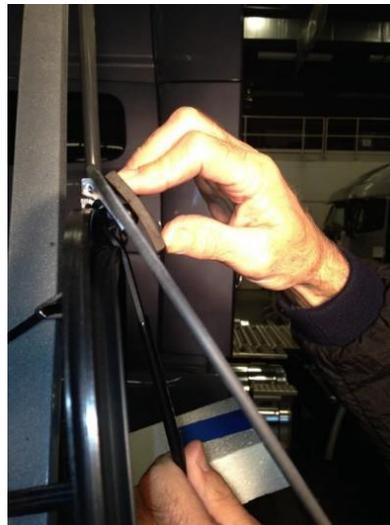
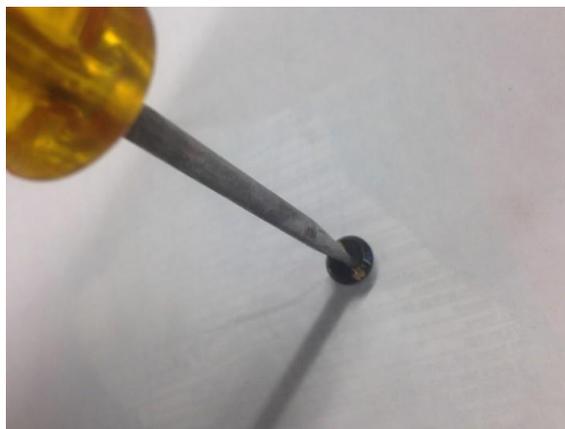
1. Remove the upper hinge screws using the special tool in the kit. Some nut inserts will stay in place when the screw is removed. Nut inserts that try to spin in place can be helped with the rubber pad included in the special tool kit. If a nut insert continues to spin, cut a slot in the head of the nut insert and use a flat head screwdriver to hold in place.

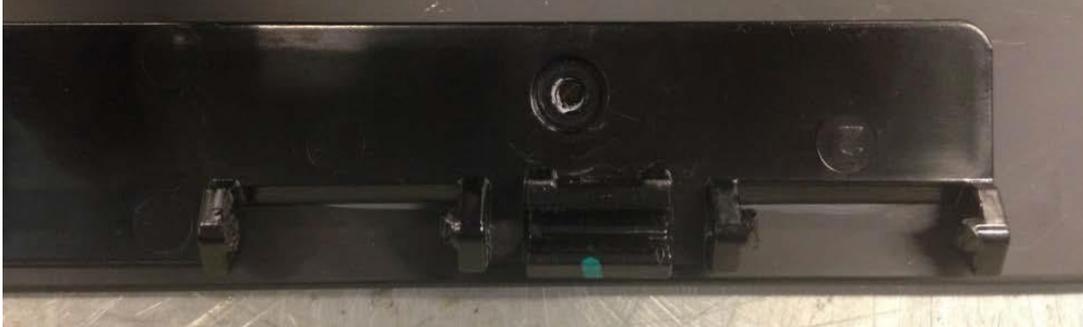
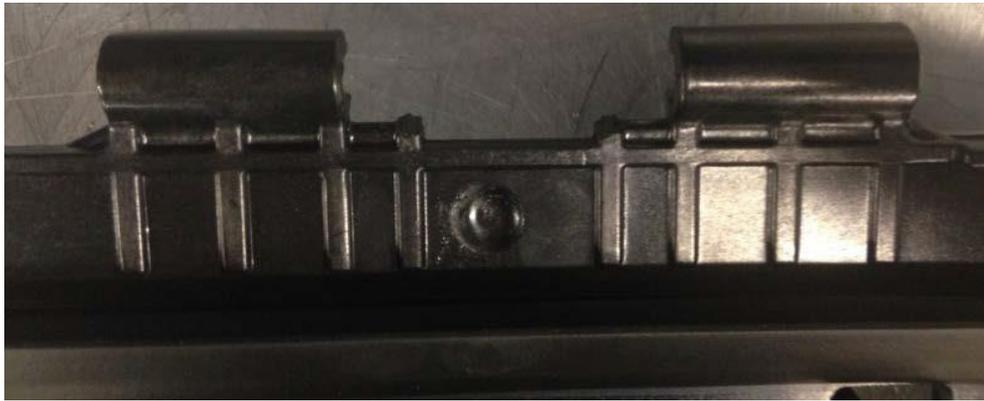
- Using thin tie strap cutters, cut the glass side of the hinge from the window cab side. With the glass removed, cut the center section of the hinge from the window frame as shown. This will provide the space that is needed to mount the new hinge.

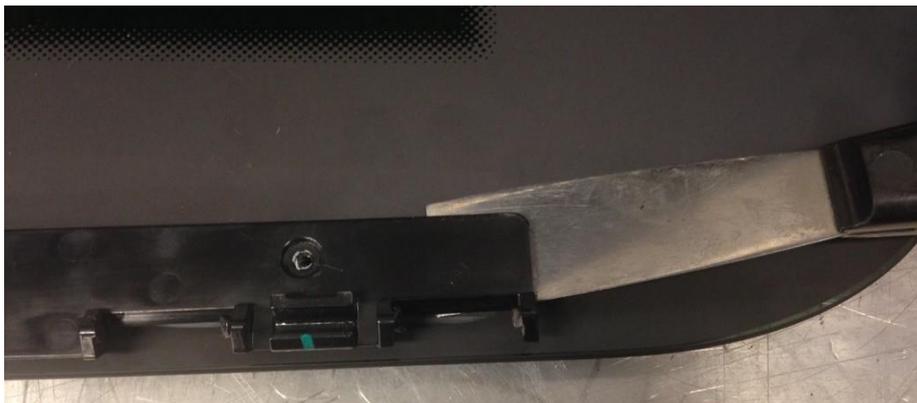
- Use a putty knife to de-bond the plastic hinge strip from the glass.  
**Note:** Be careful when removing the plastic hinge strip not to scratch the surface.

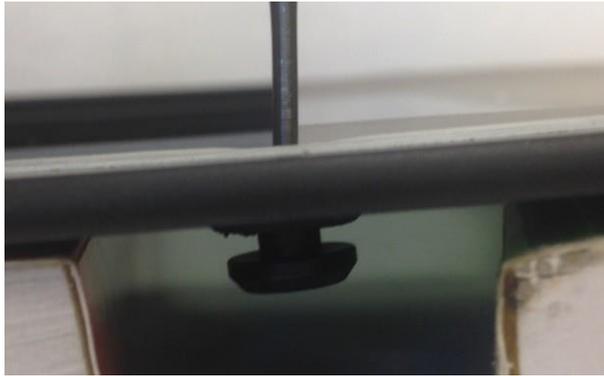
4. Remove the two nut inserts from the glass.

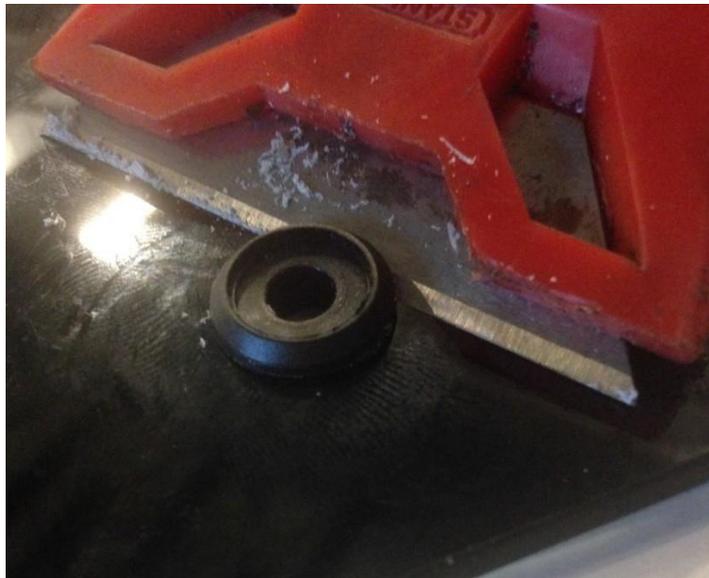
5. Remove the two insulators from the outside glass.

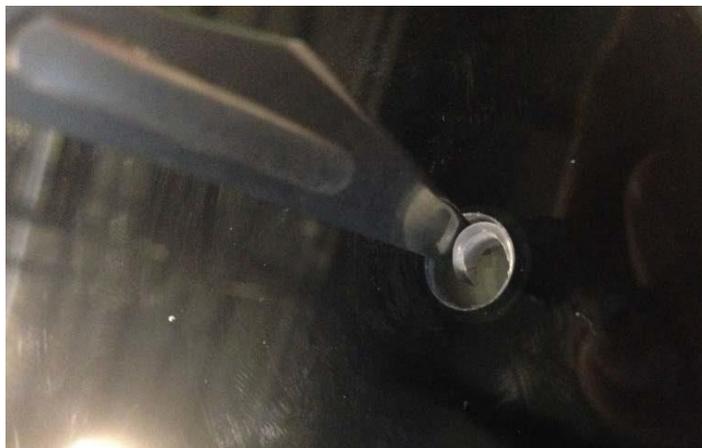
6. Remove the old glue from the mounting holes.

**Note:** Be careful removing the old glue from the mounting holes.

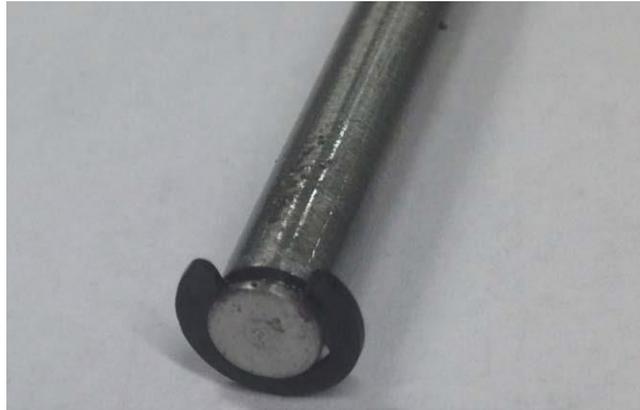
7. Install the “E” clip from the kit on one side of each new hinge pin. There should be 4 pins in total.

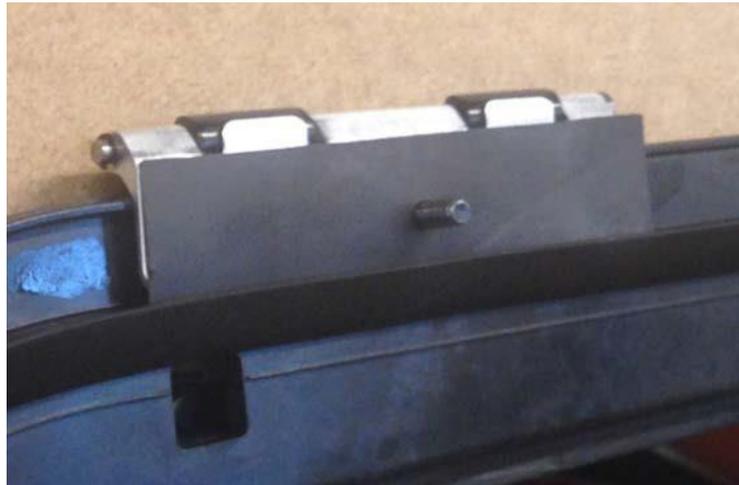
8. Place the two new metal hinges from the kit on the window frame and install the pins.

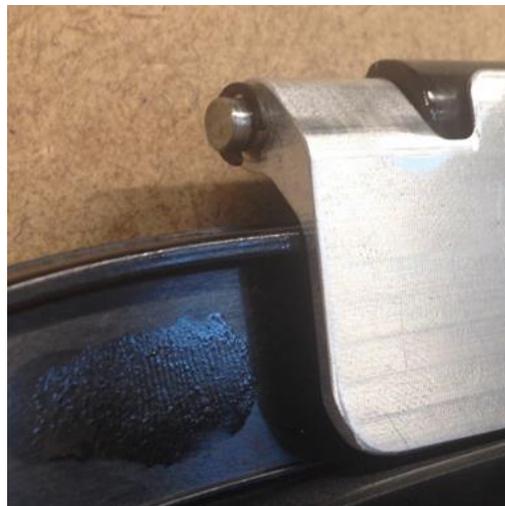
9. Install “E” clips onto the hinge pins.

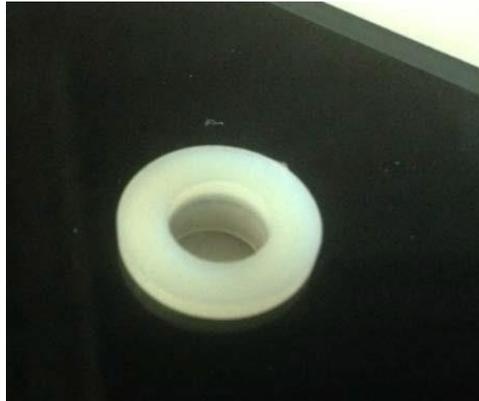
10. Install two plastic nut inserts into the glass mounting holes.

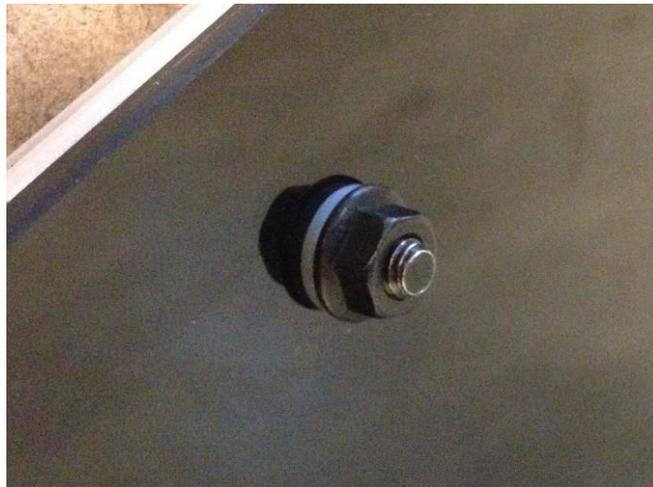
11. Install the glass. Install the nuts and torque (2 Nm +/- 0.1 Nm).

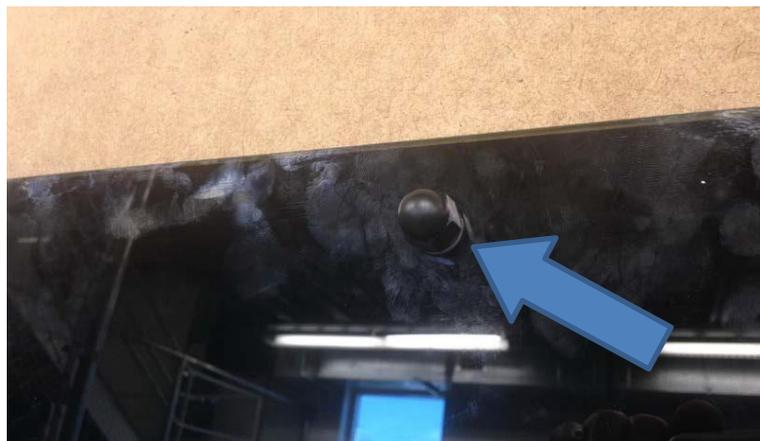
12. Install the two nut caps. Ensure the nut covers are fully seated.

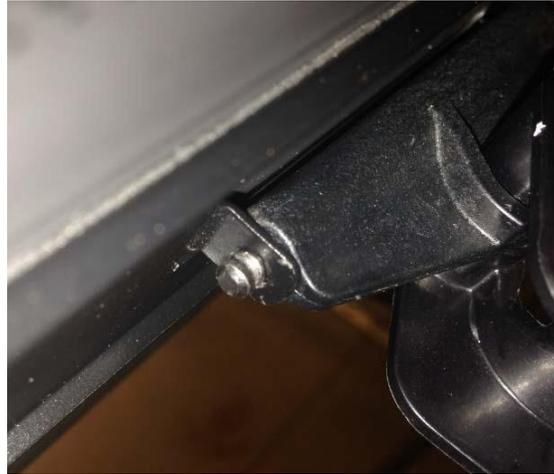
13. Install the latch pin.

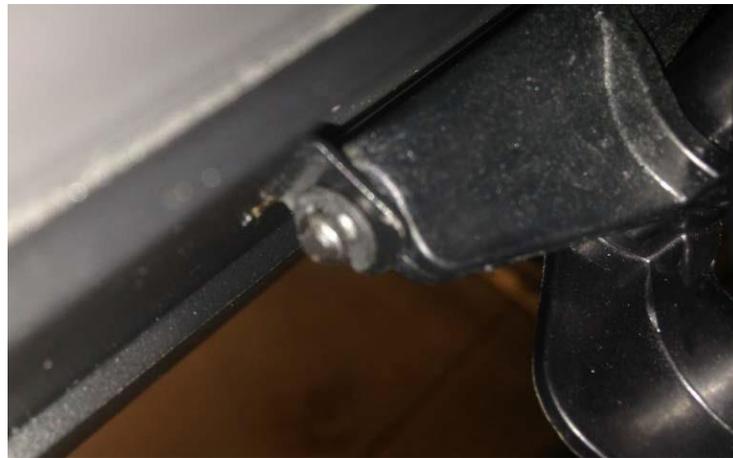
14. Install an "E" clip on the latch pin.

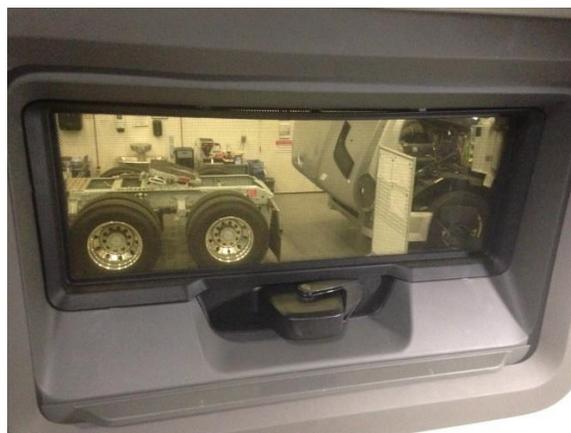
16. Close the windows and install the bug screens.

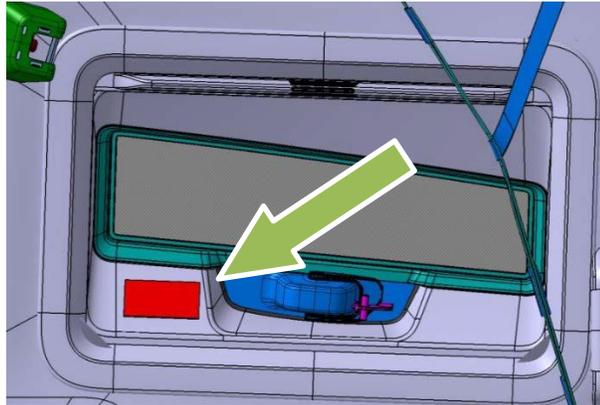
17. Install the safety sticker as shown.

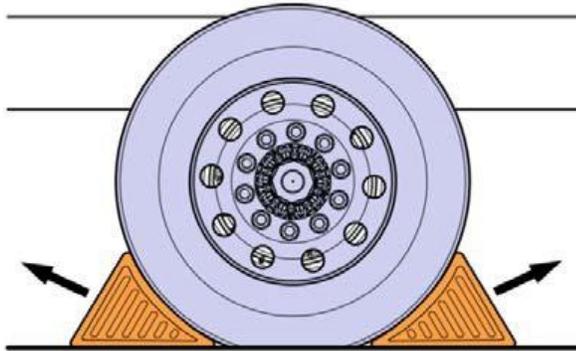
19. Remove the wheel chocks.
