October 2020

Dealer Service Instructions for:

Safety Recall W70 / NHTSA 20V- 622 Drivers Side View Mirror

**2020 (DS) Ram 1500 Pickup
(DJ) Ram 2500 Pickup**

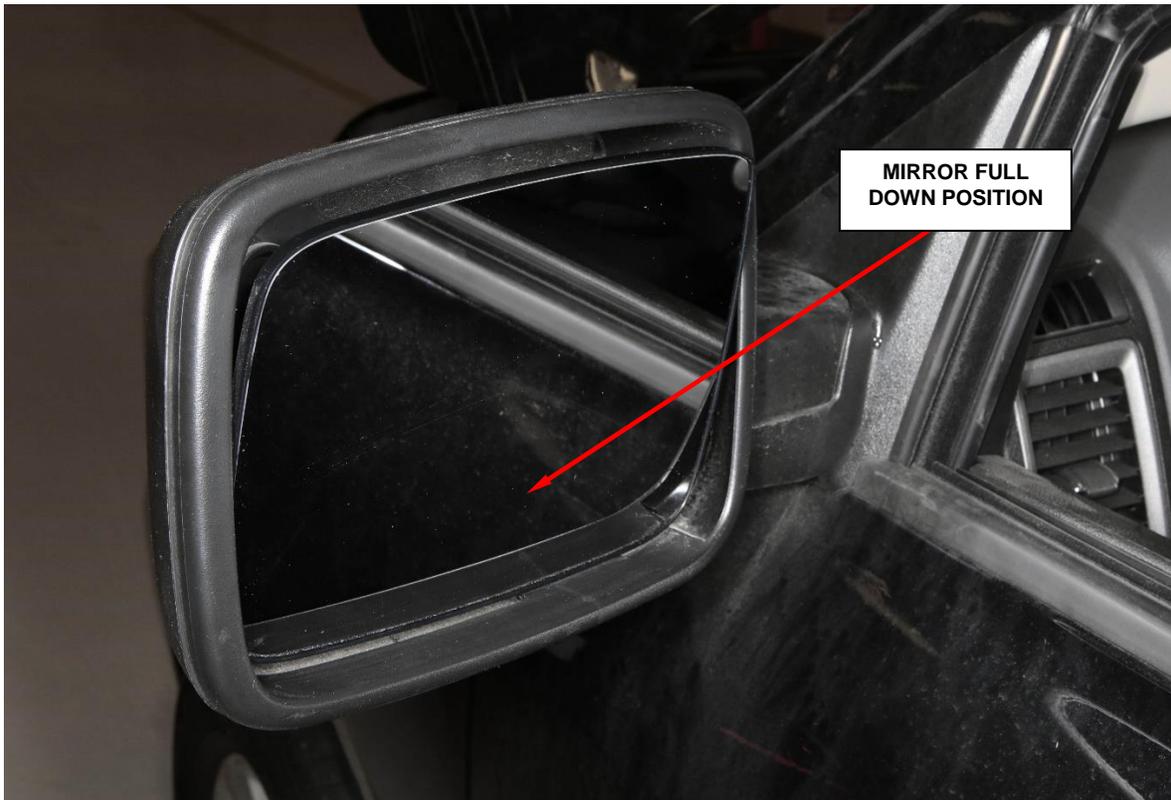
Figure 1 – Drivers Side View Mirror

1. Move the mirror into the full down position (Figure 1).

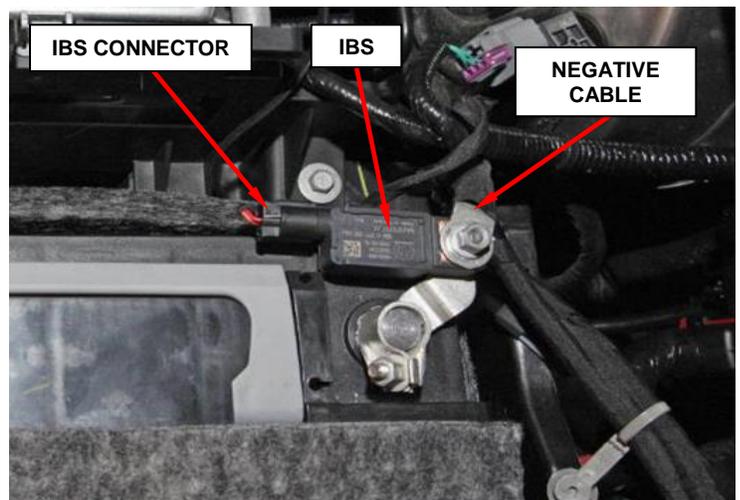
Figure 2 – Battery Ground Terminal and IBS

2. Disconnect the Intelligent Battery Sensor (IBS) wire harness connector (Figure 2).

NOTE: Failure to disconnect the IBS wire harness connector can lead to damage of the IBS wire harness connector.

3. Loosen the ground terminal nut and remove the negative battery cable with IBS from the battery and isolate it (Figure 2).

5. Install the negative battery cable with IBS to the negative post and tighten to 7N·m (62In. lbs.) (Figure 2).
6. Connect the IBS wire harness connector and close the hood (Figure 2).
7. Verify the mirror is operational in all directions.
8. Clean the mirror with glass cleaner.
9. Return the vehicle to the customer.

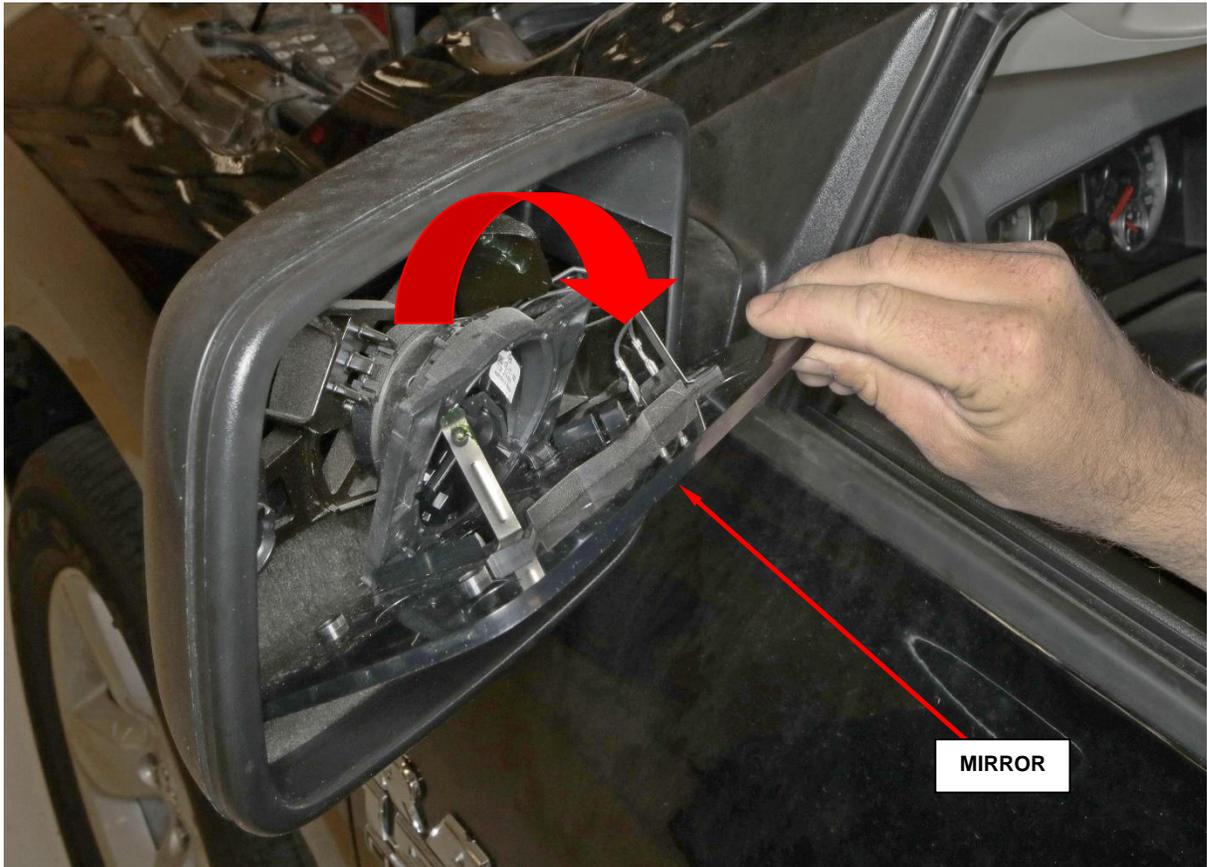
Figure 3 – Mirror Glass

4. Firmly and carefully grasp the mirror at the top and pull out to separate the upper mounting clips (Figure 3).

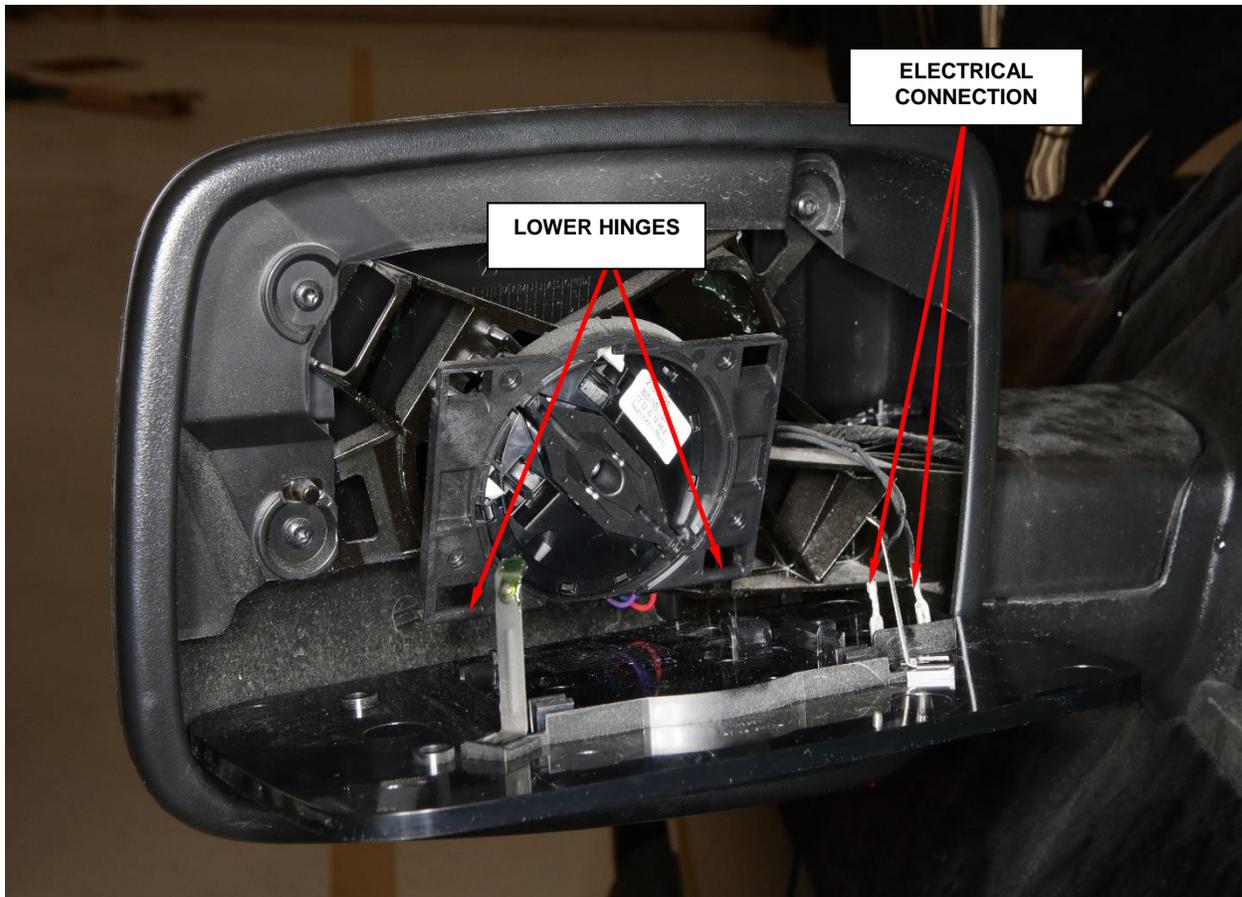
Figure 4 – Electrical Connection

5. Separate the lower hinge type clips from the mirror glass assembly (Figure 4).
6. Disconnect the electrical connectors and **DISCARD** the mirror (Figure 4).

1. Remove the metal inserts from the package and insert them on the **NEW** mirror (Figure 5).
2. Connect the electrical connectors (Figure 4).
3. Position the **NEW** mirror glass assembly into the housing and seat the lower hinge type clips fully (Figure 6).

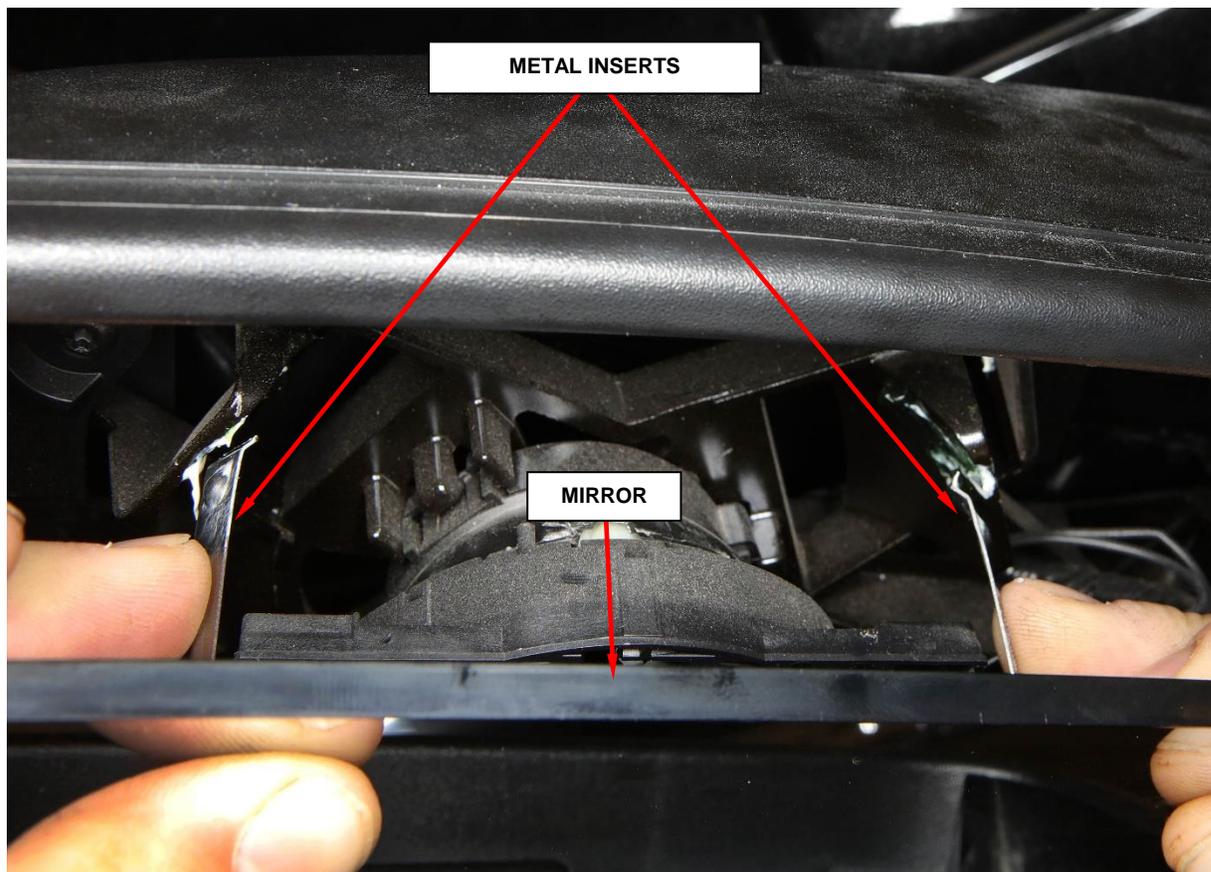
Figure 7 – Mirror Metal Inserts

4. Push the top of the glass back into the housing and seat the mounting clips fully (Figure 7).

NOTE: Assure the metal inserts are positioned on the inside of the mirror housing prior to fully positioning the mirror back into the housing.
