TECHNICAL INSTRUCTIONS

SAFETY RECALL 20TA14

POTENTIAL IMPROPER DEPLOYMENT OF SEAT MOUNTED SIDE AIR BAG

CERTAIN 2020 HIGHLANDER

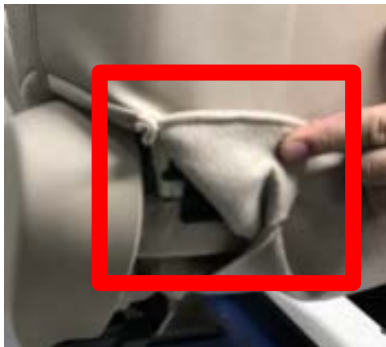
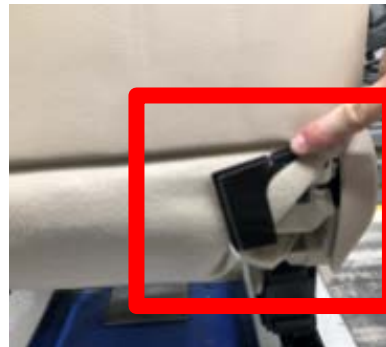
DRIVER SEAT INSPECTION

- From behind the front driver seat, inspect the lower seat carpet for a plastic patch by removing the carpet from the seat side trim panels as shown below.
- Confirm which side the plastic patch is on.
- Note: The plastic patch will either be on the outboard or inboard side.

Use your hand to feel for the plastic patch as it may be hard to see on certain seat colors

Which side is the plastic patch on?

NG
Seat cover replacement **IS**
REQUIRED for the drivers seat. Move
onto passenger seat inspection

OK
Move onto passenger seat inspection

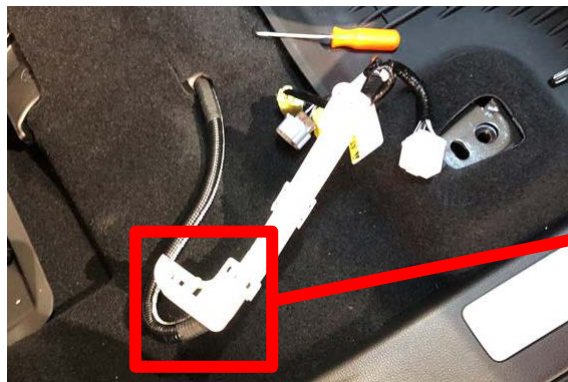
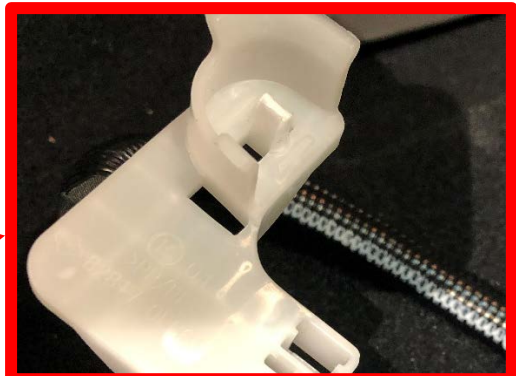
When removing the wire harness from the seat frame take extra care when disengaging the clips as they are very fragile.

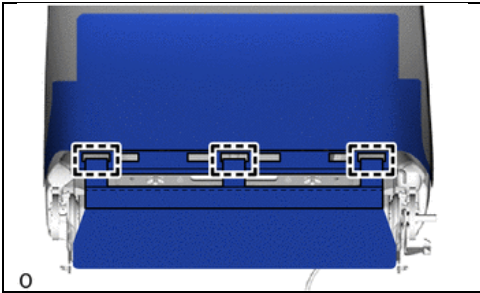
a. Undo the elastic band from underneath the seat

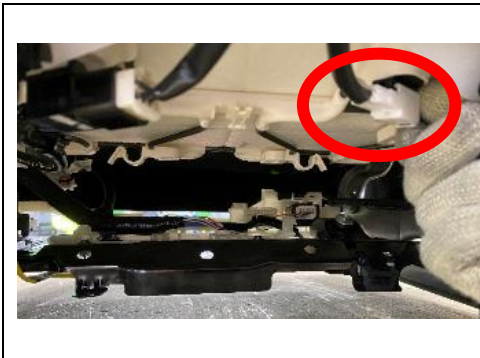
b. Unclip the 3 lower skirt clips from the upper skirt

c. Unzip both sides of the seatback cover

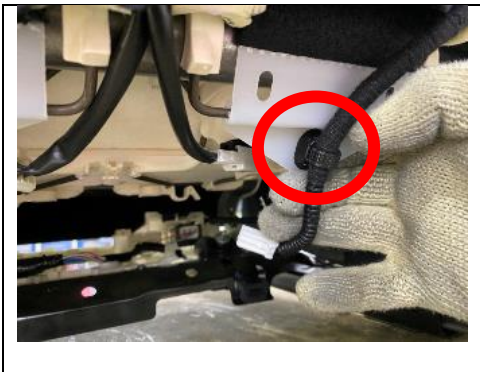
d. Disconnect the seat heater connection (if equipped)

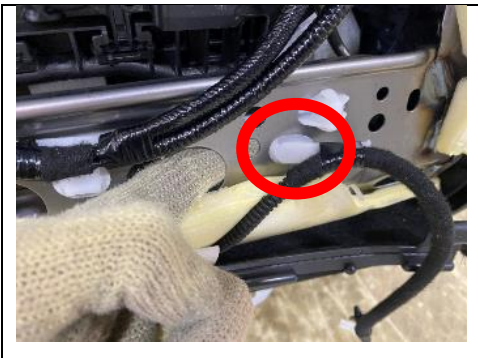
e. Unclip the seat heater wire harness from the seat frame (if equipped)

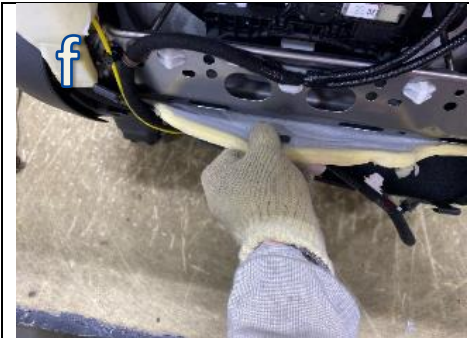
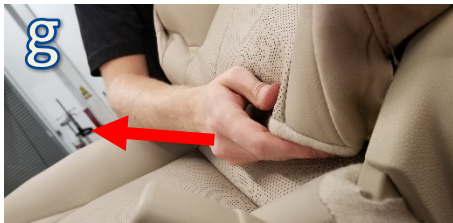
f. Pinch and hold the foam in place

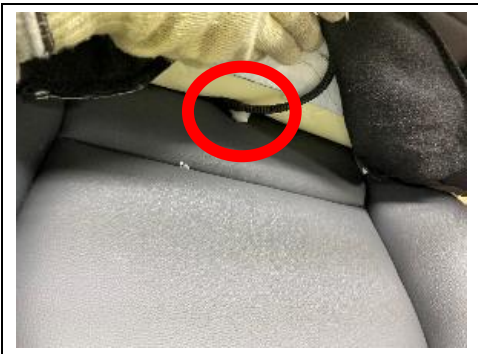
h. Push the lower skirt clips through the seatback and cushion as you pull the lower skirt out. The final outcome should look like the picture to the left

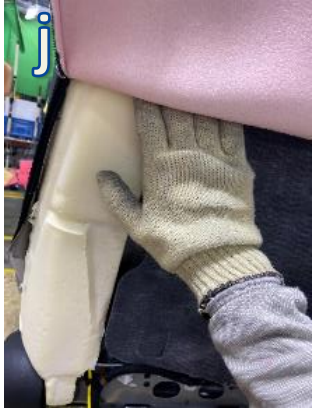
i. Feed the seat heater wire harness through the middle of the seatback and cushion (If equipped)

Use your hand to prevent the clips from damaging the seat cover when feeding it through the middle of the seatback and cushion

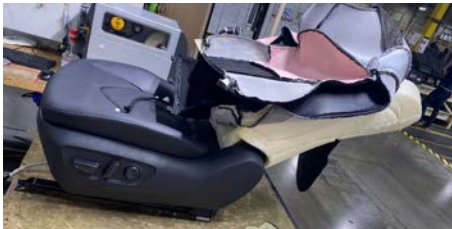
k. Push the tabs in to remove the headrest posts

NOTE: The head rest posts are specific to side and position. Keep record of location of headrest post when removing

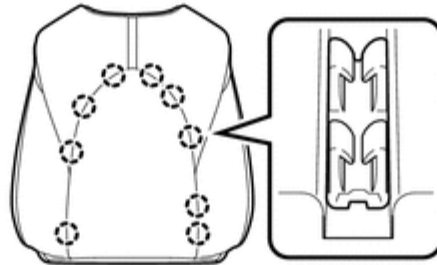
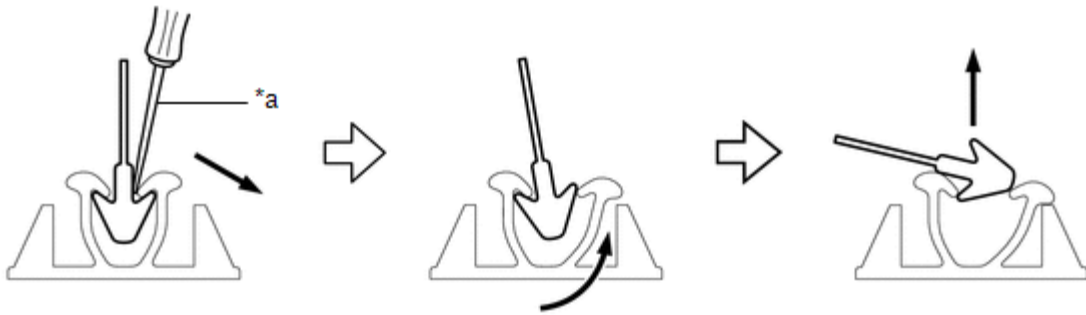
l. Fold seatback cover to the front of the seat by sliding your hand up the side of the seat cushion

STOP Do not try to completely remove the seat cover as it is still attached by clips on the front side

m. Using a screwdriver, disengage the 9 claws and remove the seat cover from the seat cushion

NOTE: Watch the video at the bottom of this page to see how to disengage the claws

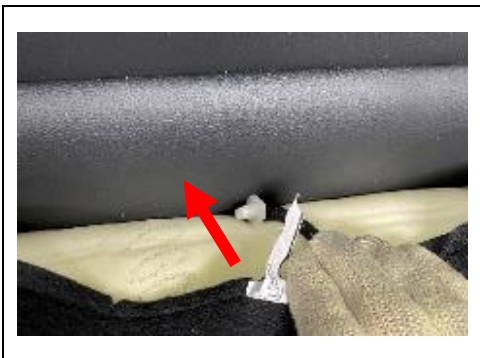
f. Fold the rest of the seatback cover over the seatback cushion. Keep tension on the seatback cover to prevent wrinkles

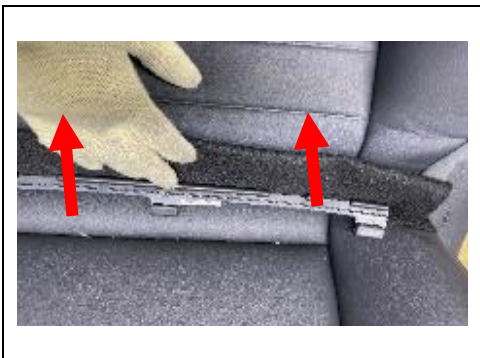
g. Feed the seat heater wire harness through the middle of the seatback and cushion

STOP Use your hand to prevent the clips from damaging the seat cover when feeding it through the middle of the seatback and cushion

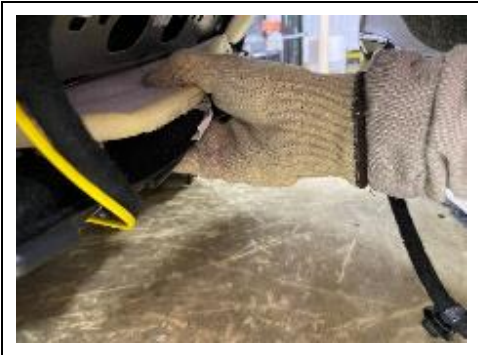
h. Feed the lower skirt through the middle of the seatback and cushion

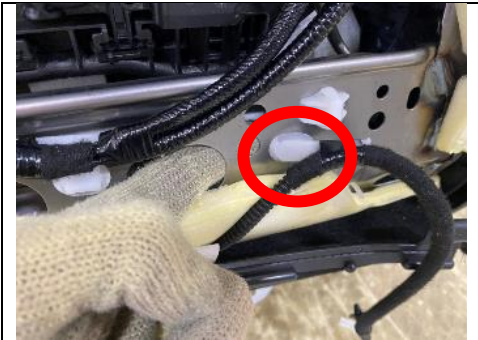
- i. Pull the lower skirt tight to remove any wrinkles in the lower portion of the seatback cover

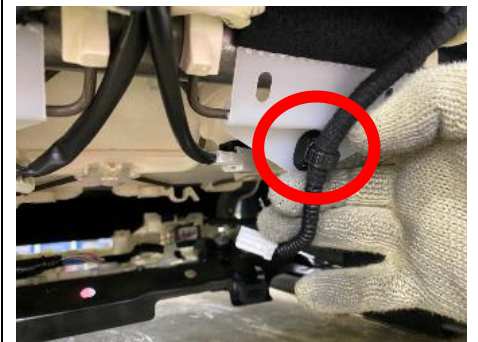
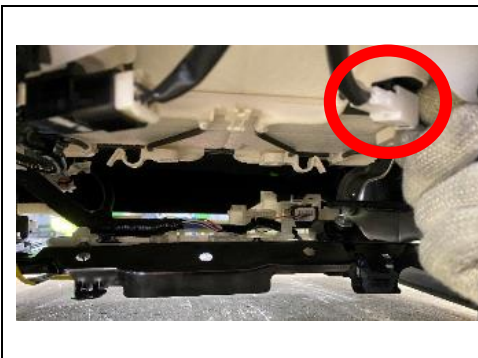
- j. Attach seat heater wire harness clips to the seat frame (if equipped)

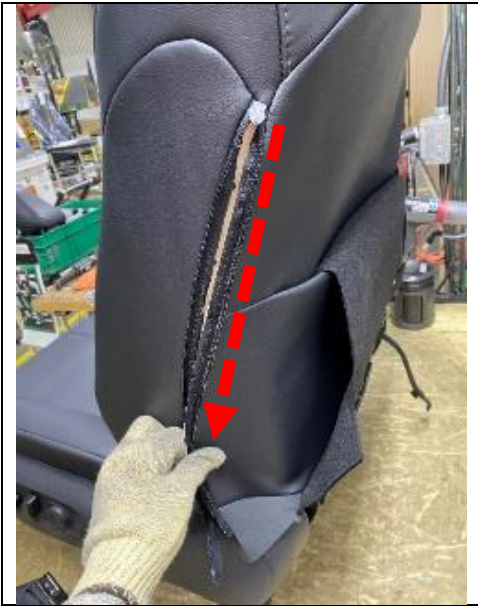
- l. Attached the lower skirt to the upper skirt using the 3 j-clips

NOTE: The seat heater wire should be on the inside of the skirt clips
