Dealer Service Instructions for:

Safety Recall W81 / NHTSA 20V-657

Front Lower Control Arm

2021 (KL) Jeep® Cherokee

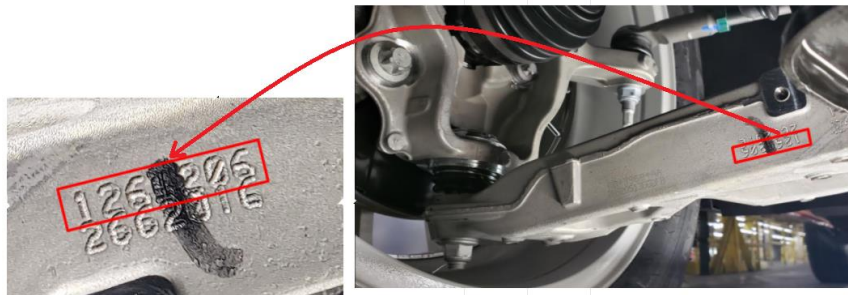
Figure 1 – Lower Control Arm Lot Number Inspection

2. Inspect the marking on each control arm for lot #1264206. If neither arm is part of this lot, lower the vehicle, and return it to the owner. If either

arm is from this lot, the arm(s) must be replaced. Proceed to **B. Remove Control Arm** (Figure 1).

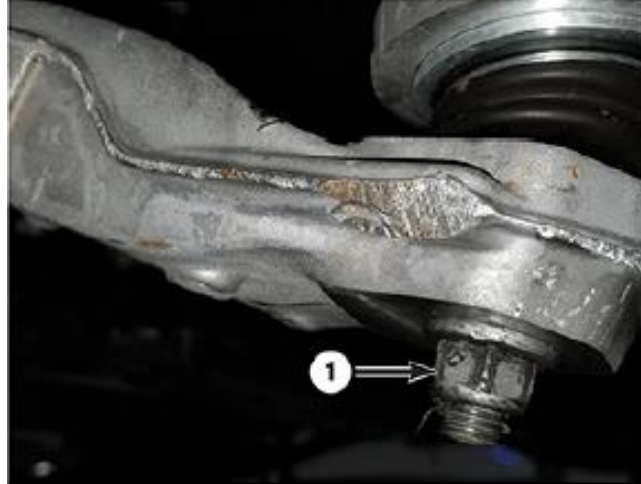
Figure 2 – Ball Joint Nut

3. Remove and DISCARD the lower ball joint nut (1) (Figure 2).
4. Using the Ball Joint Press C-4150A, separate the lower ball joint stud from the control arm.

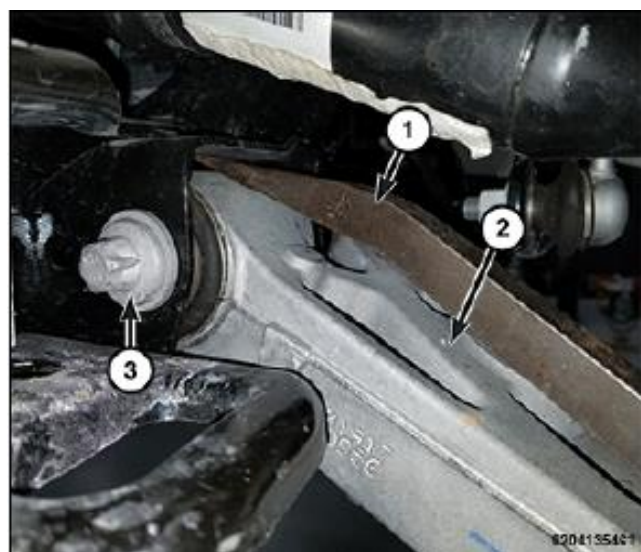
Figure 3 – Pry Lower Control Arm

5. Insert a pry bar (1) in the opening between the control arm front mounting bolt and the front fascia support beam (Figure 3).
6. Pry down on the control arm (2) until the ball joint stud is clear of the control arm, then push the knuckle assembly to the side when it is clear of the ball joint stud and slowly release the control arm (Figure 3).

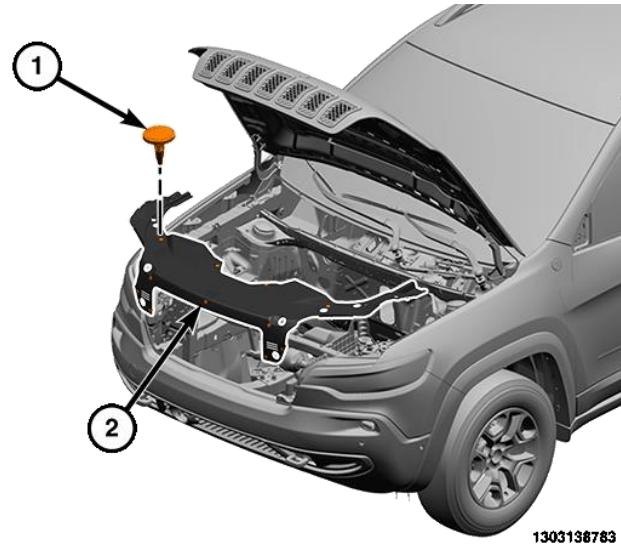
Figure 4 – Radiator Closeout Panel

8. Remove the push pin fasteners (1) and remove the radiator closeout panel (2) (Figure 4).

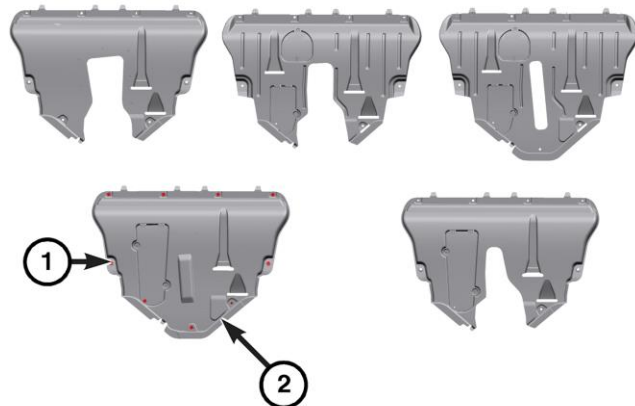
Figure 5 – Engine Belly Pan

9. Raise and support the vehicle.
10. Remove the fasteners (1) securing the engine belly pan (2) (Figure 5).
11. Remove the engine belly pan (2) from the underside of the vehicle (Figure 5).

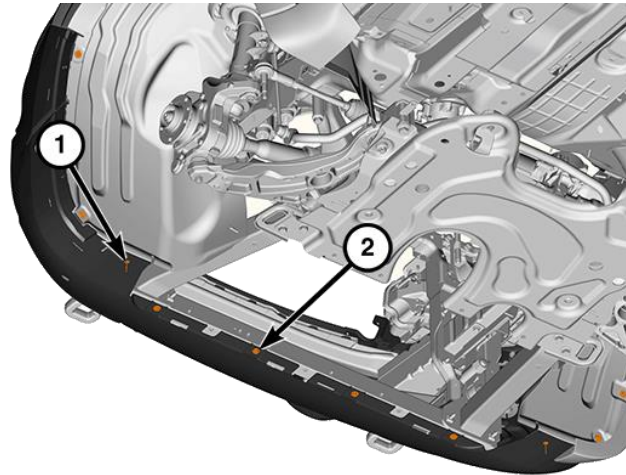
Figure 6 – Lower Fascia Fasteners

12. Remove the two rivets (1) (Figure 6).
13. Remove the four lower support fasteners (2) (Figure 6).

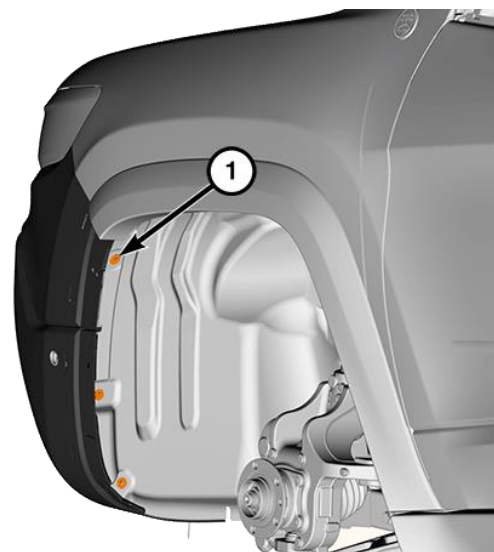
Figure 7 – Wheelhouse Splash Shield Fasteners

14. Remove the three screws (1) and position aside the wheelhouse splash shields (Figure 7).

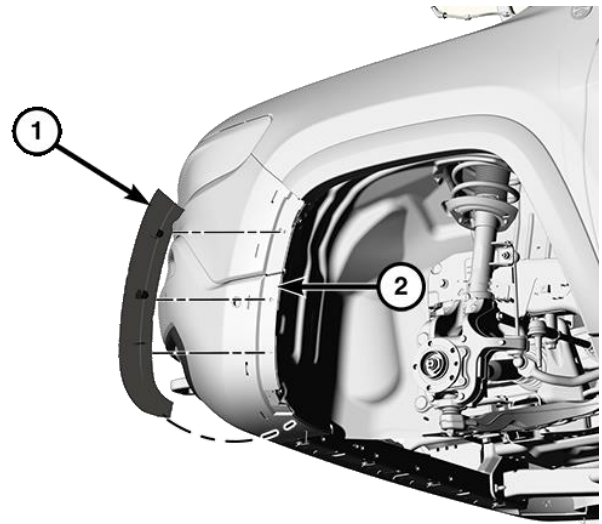
Figure 8 – Front Flare Moldings

15. From inside the wheel well, release the clips and remove the front flare moldings (1) (Figure 8).

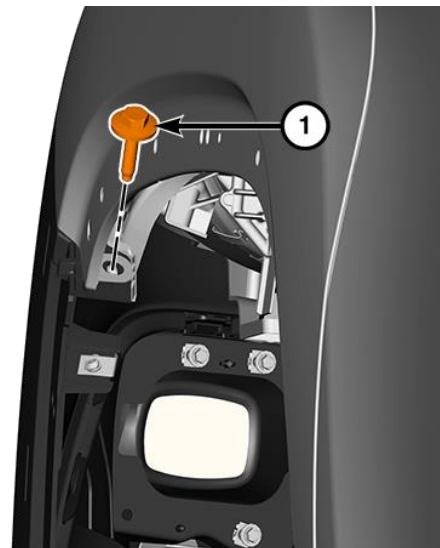
Figure 9 – Fascia to Fender Fasteners

16. Remove the fasteners (1) attaching the sides of the fascia to the fenders (Figure 9).

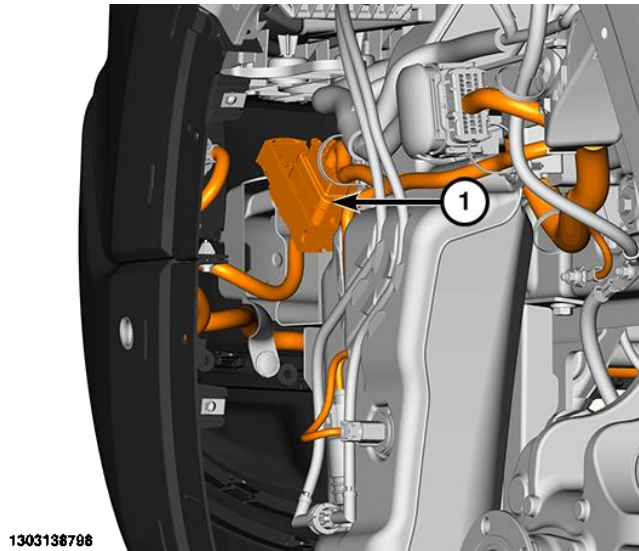
Figure 10 – Wire Harness Connector

17. Disconnect the wire harness connector (1) (Figure 10).

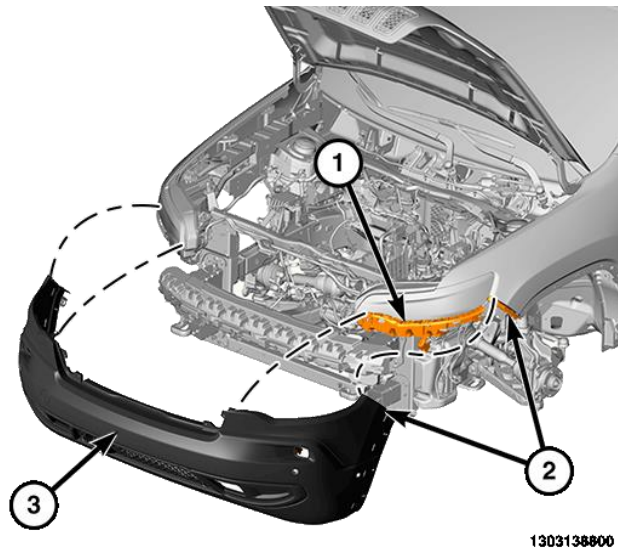
Figure 11 – Wire Harness Connector

18. Carefully pull out on the upper and lower fascia sides to release the fascia retaining tabs at the fender (2) and below the headlight (1). Repeat on the opposite side (Figure 11).

19. Remove the fascia (3) from the vehicle (Figure 11).

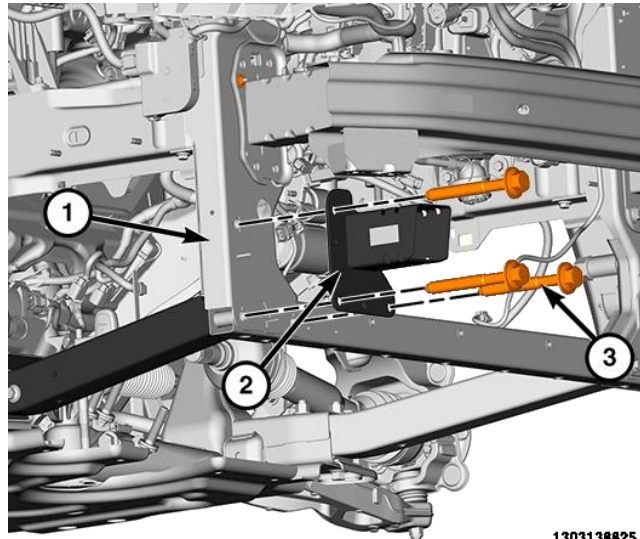
Figure 12 – Lower Load Beam Extension Bolts

20. Remove the bolts (3) and the lower load beam extensions (2) (Figure 12).

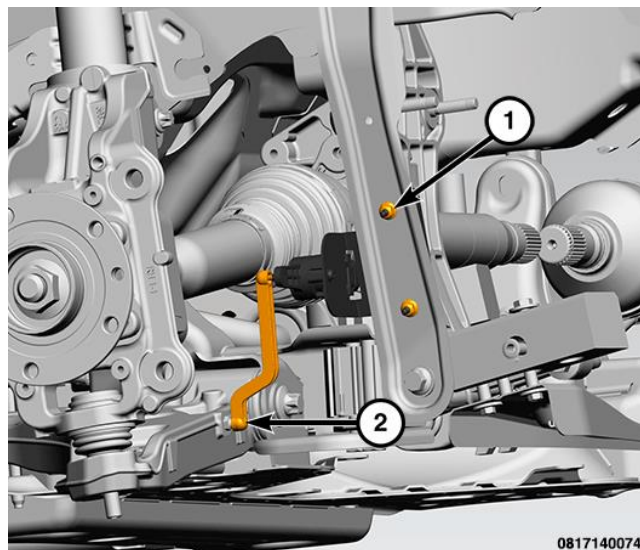
Figure 13 – Vehicle Height Sensor Actuator Rod

21. If equipped, locate the front axle vehicle height sensor from within the right front fender wheel house (Figure 13).
22. Disconnect the actuator rod (2) (Figure 13).
23. Remove the fasteners (1) and separate the sensor from the vertical bracket (Figure 13).

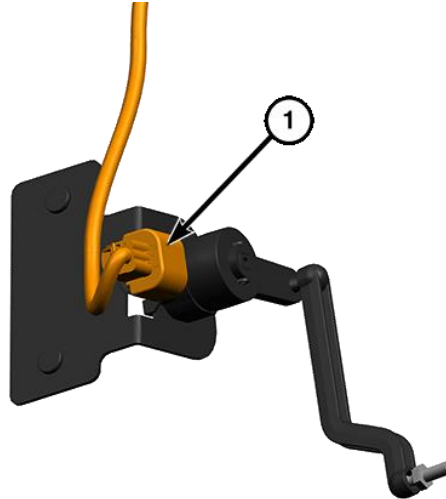
Figure 14 – Vehicle Height Sensor Connector

- 24. Disconnect the wire harness connector (1) from the axle sensor (Figure 14).

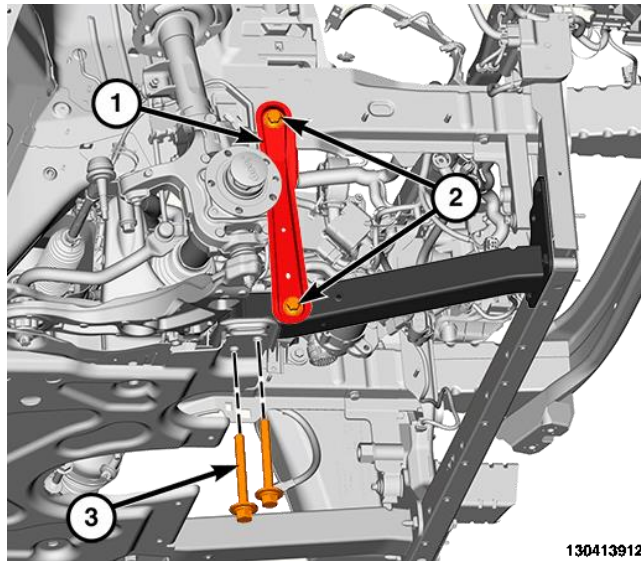
Figure 15 – Vertical Bracket

- 25. Remove the bolts (2) and remove the vertical bracket (1) from the side of the lower load beam (Figure 15).
- 26. Remove the two bolts (3) (Figure 15).

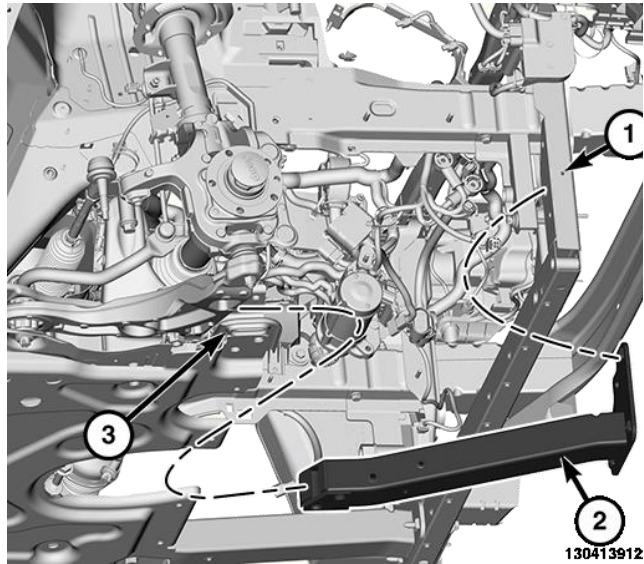
Figure 16 – Lower Load Beam

27. Remove the lower load beams (2) (Figure 16).

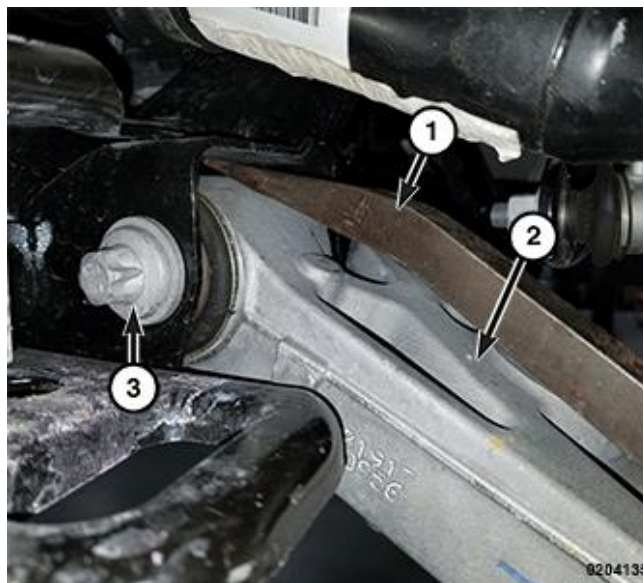
Figure 17 – Lower Load Beam

28. Remove and DISCARD the front lower control arm bolt (3). Then remove the bolt attaching the lower control arm to the front suspension crossmember (Figure 17).

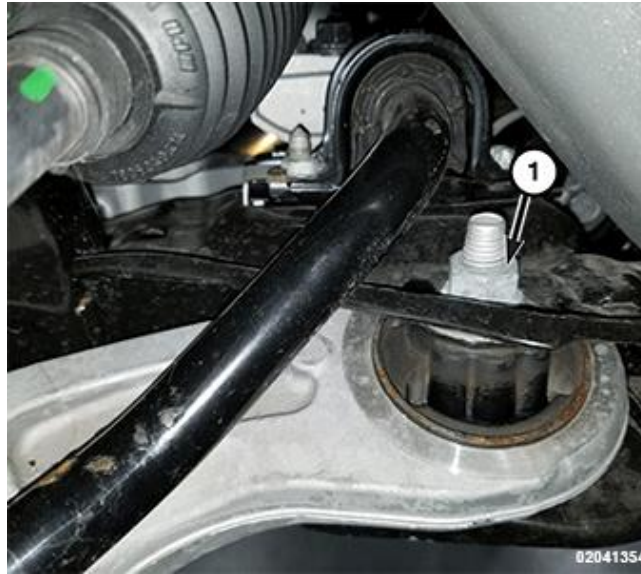
Figure 18 – Lower Control Arm Nut

29. Remove and DISCARD the rear lower control arm nut (1). Then remove the lower control arm bolt (Figure 18).

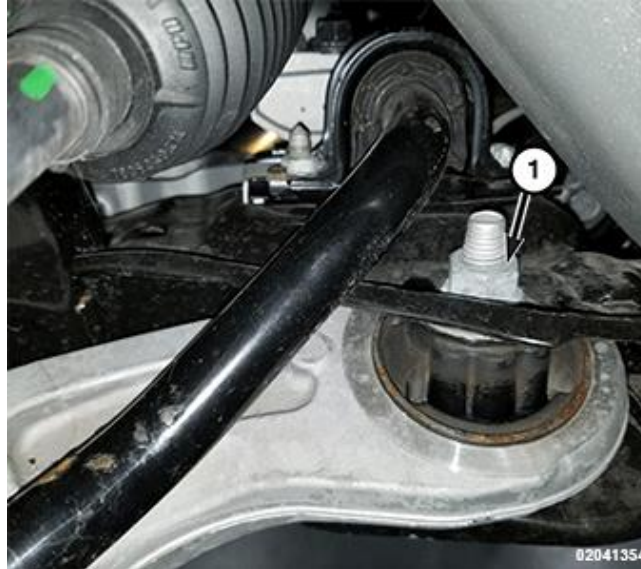
**Figure 19 – Lower Control Arm Nut**

1. Position the lower control arm in the front suspension crossmember.
2. Install a NEW lower control arm rear vertical bolt and a NEW lower control arm rear vertical nut (1). Do not tighten to specification at this time (Figure 19).

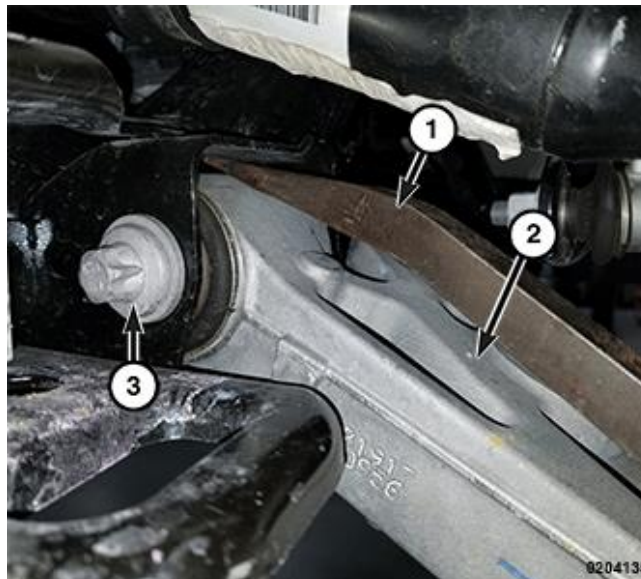
**Figure 20 – Lower Load Beam**

3. Install a NEW lower control arm front horizontal pivot bolt (3). Do not tighten to specification at this time (Figure 20).

4. Insert a pry bar (1) in the opening between the control arm front mounting bolt and the front fascia support beam (Figure 20).
5. Pry down on the control arm (2) until the ball joint stud is clear of the control arm, align the stud with hole in control arm then slowly release the control arm (Figure 20).
6. Lower the vehicle and install a floor jack under the control arm. Raise the jack until the lower control arm is at ride height.
7. Tighten the lower control arm front horizontal pivot bolt to 47 N·m plus 300 degrees (35 ft. lbs. plus 300 degrees).
8. Tighten the lower control arm rear vertical bolt to 37 N·m plus 106 degrees (27 ft. lbs. plus 106 degrees).
9. Raise the vehicle back up to the original position.
10. Position a lower load beam (2) on into the crossmember (3) and against the front end module (1) (Figure 21).

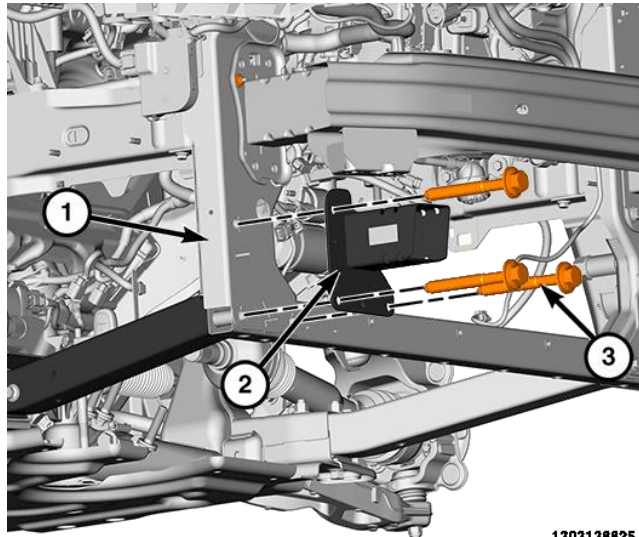
Figure 22 – Lower Load Beam Extension Bolts

11. Position the lower load beam extensions (2) and install the bolts (3) (Figure 22).
12. Tighten the lower load beam extension bolts (3) to 45 N·m (33 ft. lbs.).

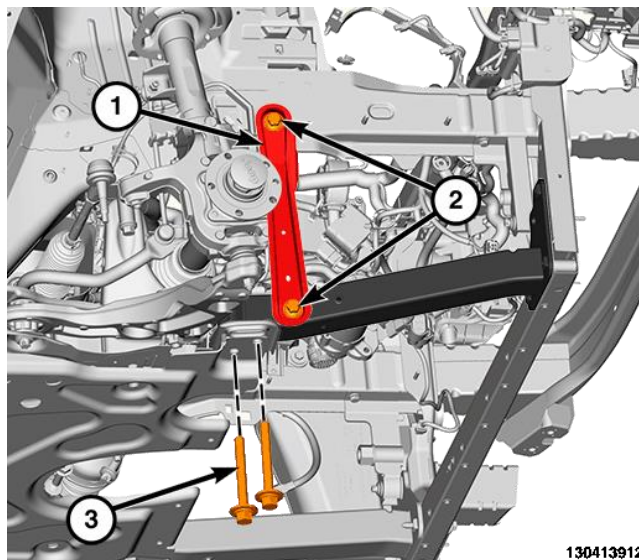
Figure 23 – Vertical Bracket

13. Install the two lower bolts (3) and tighten to 89 N·m (66 ft. lbs.) (Figure 23).
14. Install the vertical bracket (1) and install the bolts hand tight (2) (Figure 23).

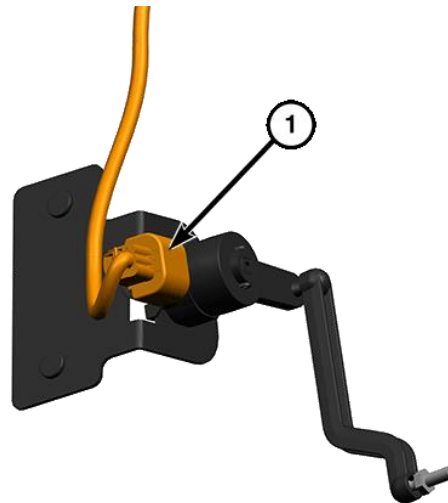
Figure 24 – Vehicle Height Sensor Connector

15. Connect the wire harness connector (1) for the axle sensor (Figure 24).

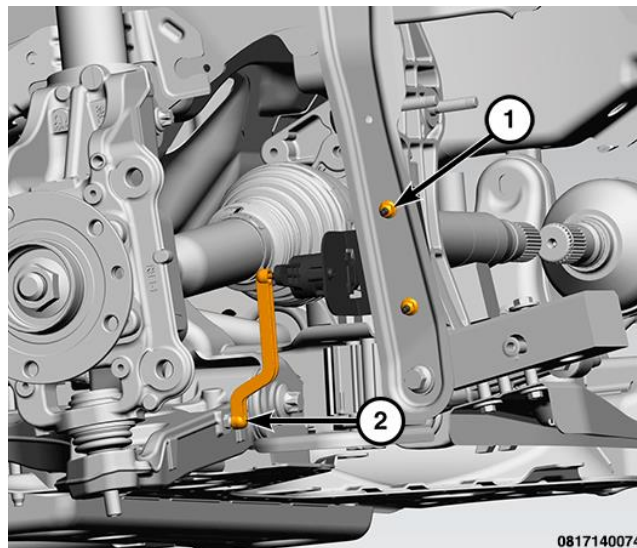
Figure 25 – Vehicle Height Sensor Actuator Rod

16. Install the sensor onto the vertical bracket and install and securely tighten the fasteners (1) (Figure 25).
17. Seat the actuator rod (2) onto the ball stud fully (Figure 25).

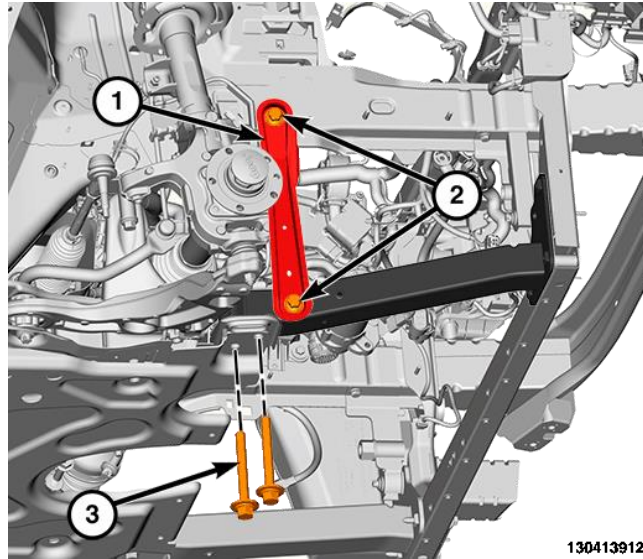
Figure 26 – Vertical Bracket

18. Tighten the bolts (2) to 27 N·m (20 ft. lbs.) (Figure 26).

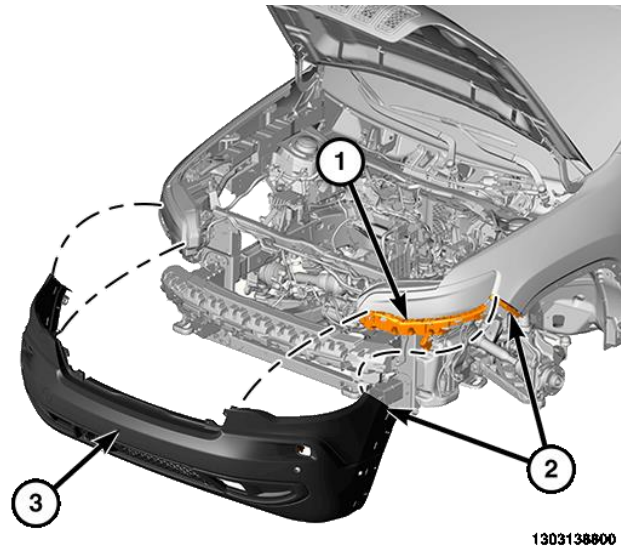
Figure 27 – Wire Harness Connector

19. With the help of an assistant, position the fascia to the vehicle (Figure 27).
20. Seat the fascia onto the clips under the headlights (1) fully (Figure 27).
21. Seat the sides of the fascia onto the fender clips (2) fully (Figure 27).

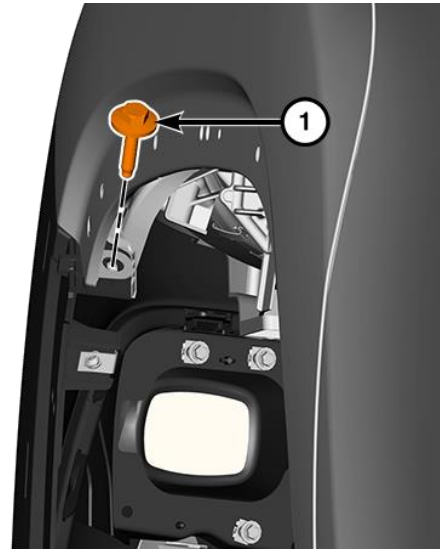
Figure 28 – Fascia to Fender Fasteners

22. Install the fasteners (1) attaching each side of the fascia to the fenders (Figure 28).

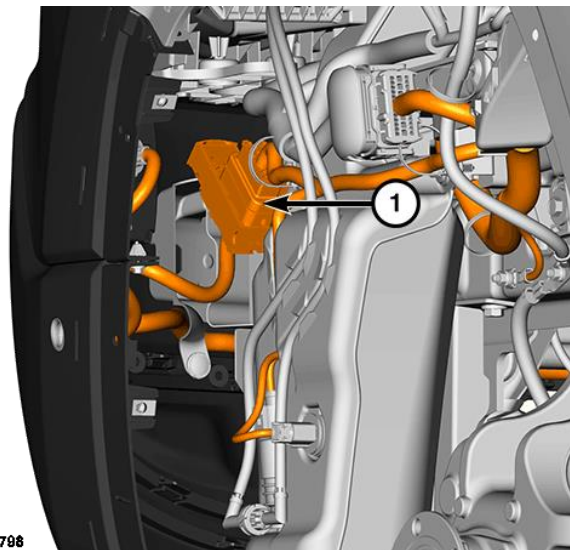
Figure 29 – Wire Harness Connector

23. Connect the wire harness connectors (1) (Figure 29).

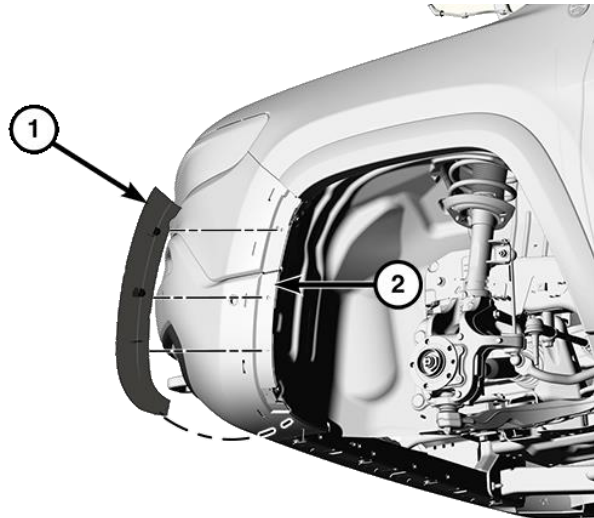
Figure 30 – Front Flare Moldings

24. Position the front flare moldings (1) back and seat the fasteners fully onto the fascia (2) (Figure 30).

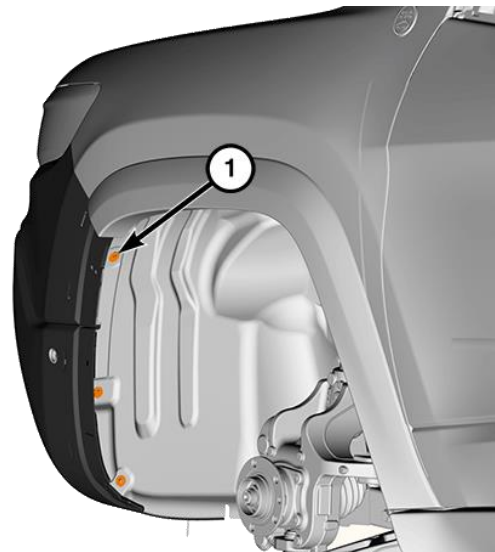
Figure 31 – Wheelhouse Splash Shield Fasteners

25. Position the wheelhouse splash shields back and install the three screws (1) (Figure 31).

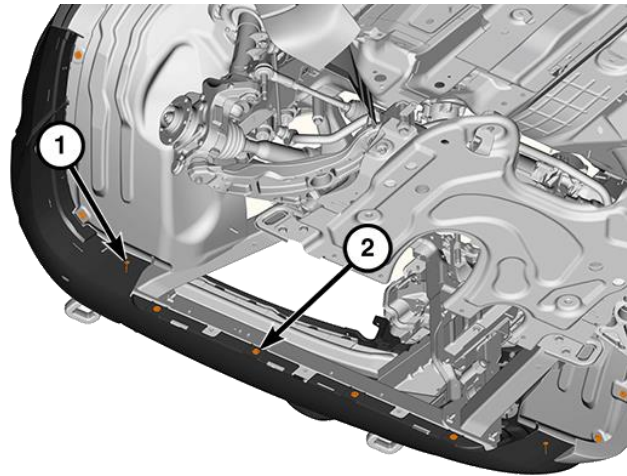
Figure 32 – Lower Fascia Fasteners

- 26. Install two new rivets (1) and install the four lower fasteners (2) (Figure 32).

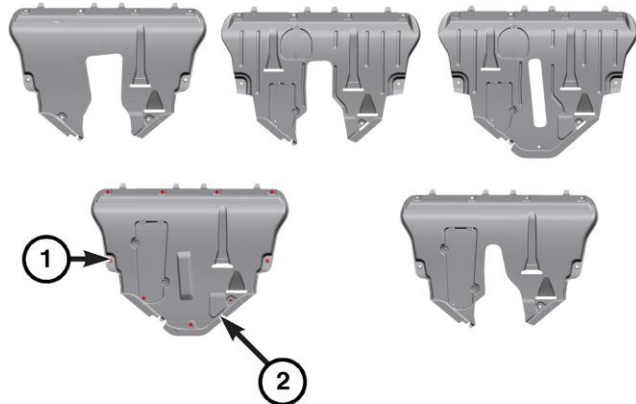
Figure 33 – Engine Belly Pan

- 27. Insert the tabs into the slots on the fascia and position the engine belly pan (2) to the underside of the vehicle (Figure 33).
- 28. Install the fasteners (1) securing the engine belly pan (2) and tighten to 20 N·m (15 ft. lbs.) (Figure 33).

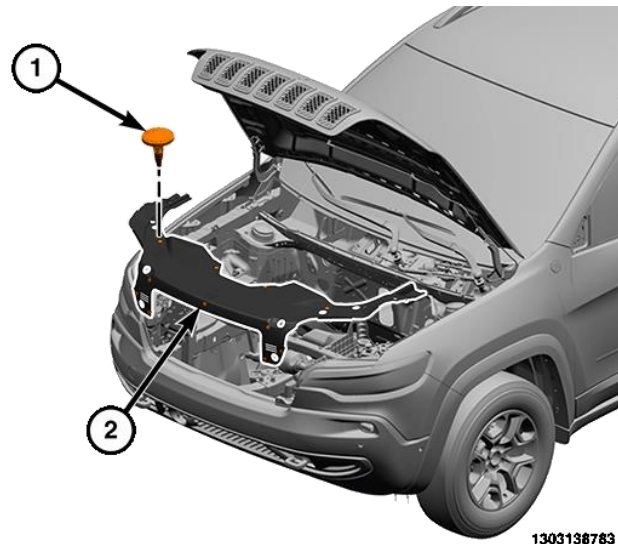
Figure 34 – Radiator Closeout Panel

29. Install the radiator closeout panel (2) and install the push pin fasteners (1) (Figure 34).
