Safety Recall - USA

Code: 70H8

Deformation Element

November 13, 2020

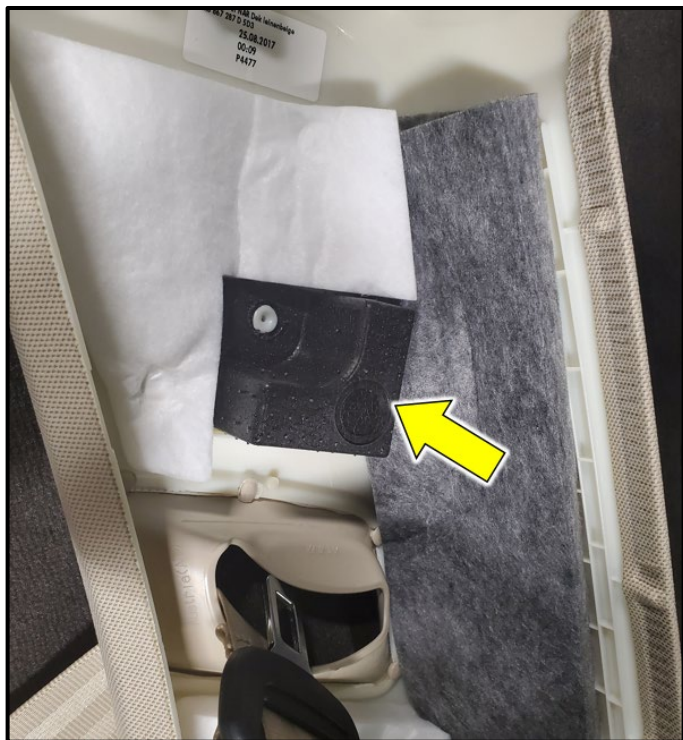
Repair Overview

- Replace deformation element in left and right C-pillar trim.

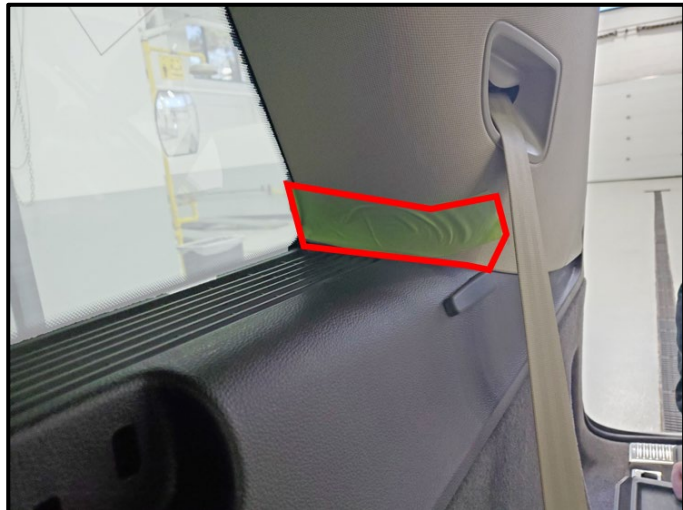
Tape off D-pillar trim:

- Tape off D-pillar trim in the area shown.

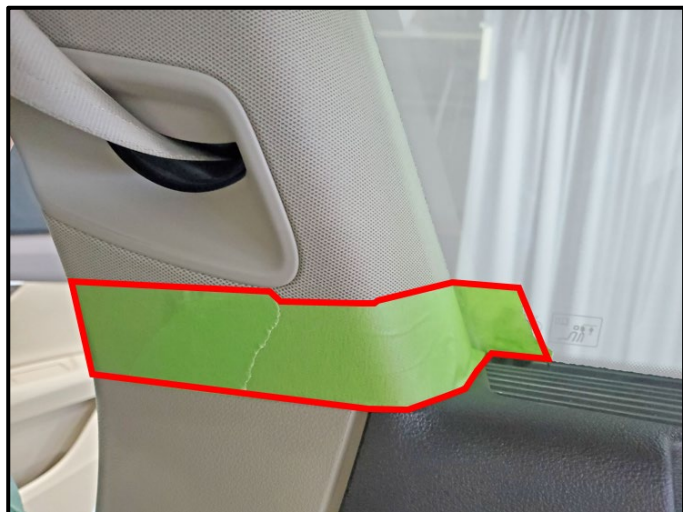
Tape off C-pillar trim:

- Tape off C-pillar trim in the area shown.

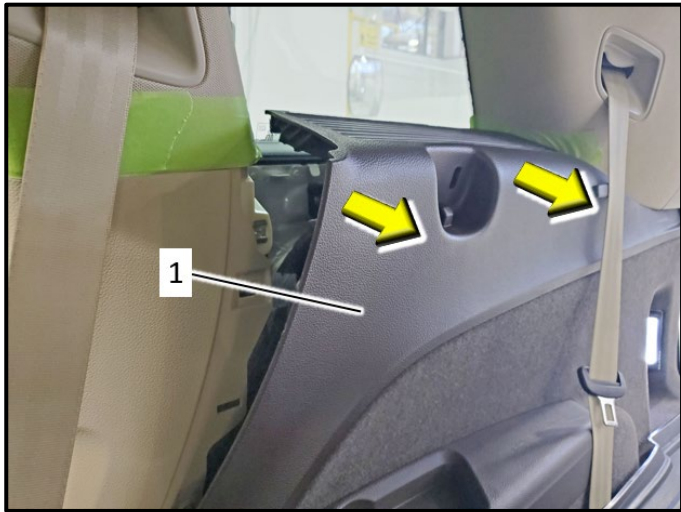
Detach luggage compartment trim panel:

- Fold the second row seats down.
- Detach upper portion of the luggage compartment trim <1> in direction of <arrows>.

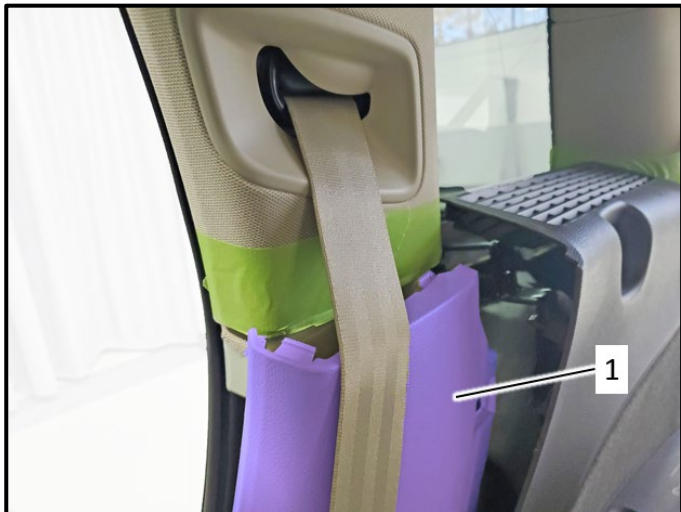
Detach upper sill trim:

- Detach upper portion of sill trim <1> from the C-pillar trim.

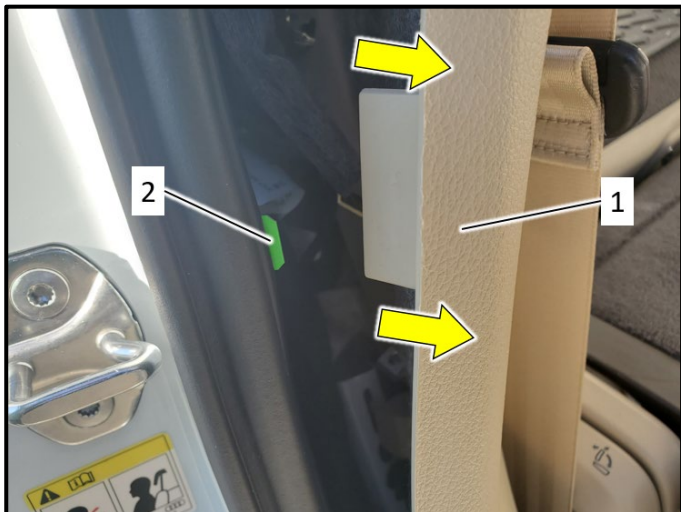
- Pull the upper sill trim <1> away from the body and out of clip <2> in direction of <arrows>, ensuring that clip <2> is not bent inward.

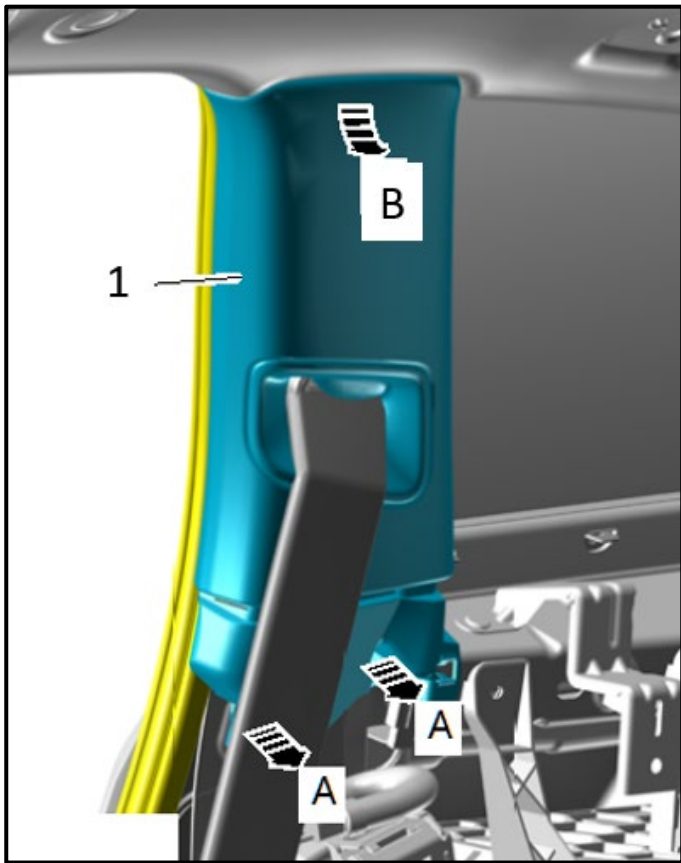
Remove C-pillar trim:

- Free up the C-pillar trim panel <1> near the door seal, disengage it from the front of the C-pillar and unclip it from the C-pillar at <A arrows>.
- Remove the C-pillar trim panel from the mount on the body <arrow B> by moving the trim panel inward and pulling it downward at the same time.
- Remove the C-pillar trim panel with the seat belt webbing still threaded through it.

Luggage compartment trim and rear sill trim shown removed for clarity.

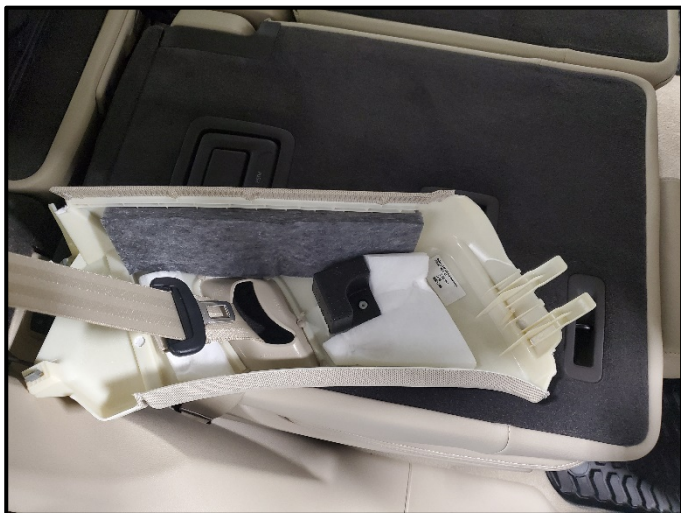
- Set the C-pillar trim down on the back of the seat as shown.

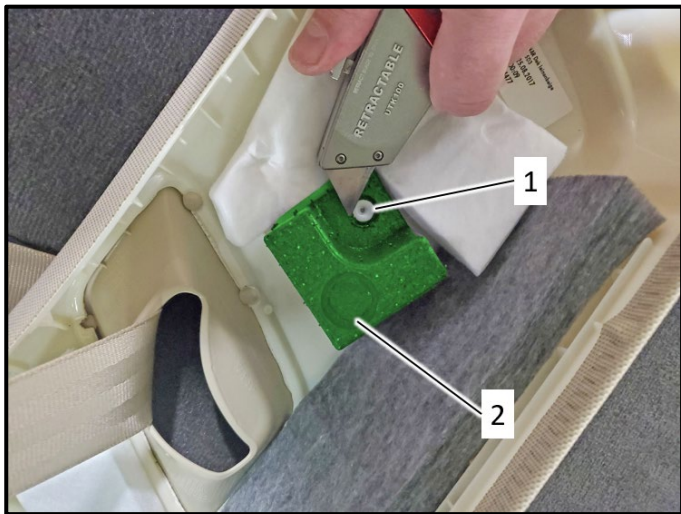
Remove deformation element:

- Carefully cut off the top of the plastic rivet <1>.
- Remove the deformation element <2>.

In some cases, it may be possible to pry off the deformation element using a small amount of pressure, which will break off the top of the plastic rivet. Do not use excess force when doing this, otherwise the C-pillar trim could be damaged.

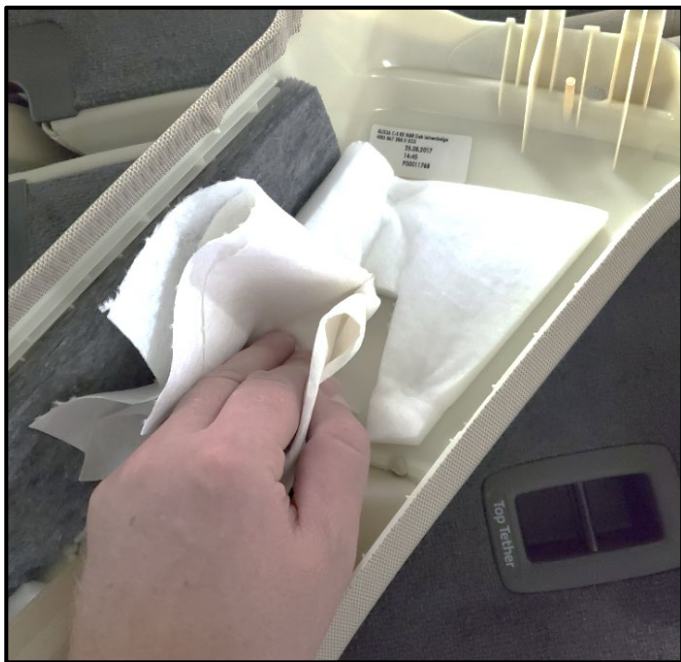
Clean C-pillar trim:

- Clean the contact area of the deformation element with isopropyl alcohol and a lint free rag.

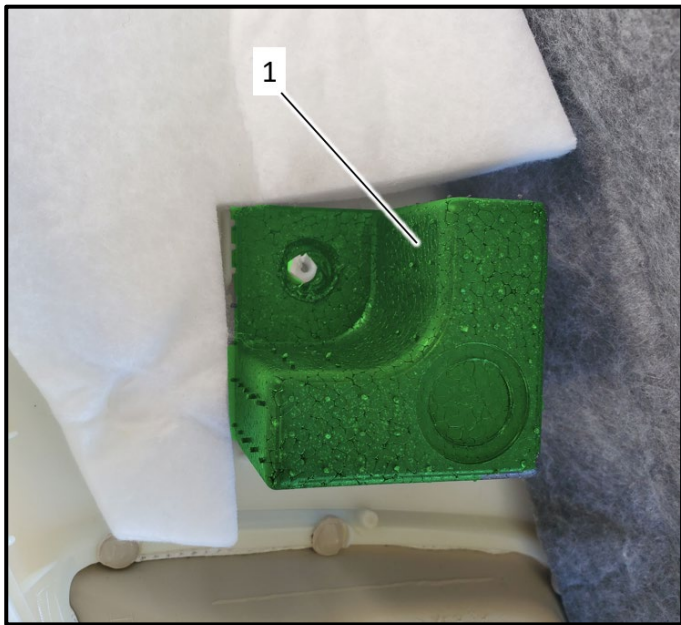
Install new deformation element:

- **The deformation element is being replaced on the left and right C-pillar trim.**
- Peel off protective backing from the tape on the deformation element.
- Line up the hole in the deformation element with the plastic peg on the C-pillar trim.
- Install new deformation element <1>.
- Press down firmly on deformation element.
