INSTRUCTIONS TO PERFORM RECALL CAMPAIGN 163

Models Affected 2012 - 2021 Era 170X

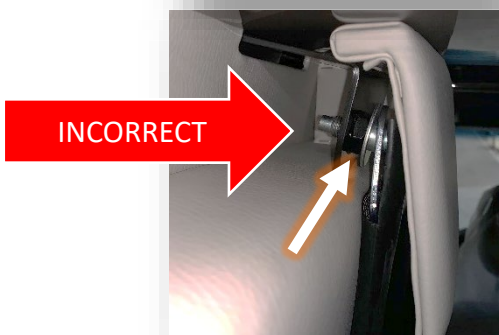
Inspect the assembly and attachment. The correct assembly will have a weld nut attached on the outside surface.

****Apply torque to the nut****

Using the following chart, apply the corresponding torque value which matches your wrench size.
