LION		
Date:	2020-11-25	Version:	00
Subject:	RETROFIT: RETRO – 0057		
Year / Make / Models affected:	2016 -02019 Lion LionC/Lion360	NHTSA Recall#:	20V-697
Problem:	The seatbelt support for the wheelchair user are installed on the bow with metal screws. This is not acceptable because this type of screw is not certified. This procedure will show how to install the seat belt support on the bow with rivets.		
Remedy:	The metal screw will be replaced with rivets.

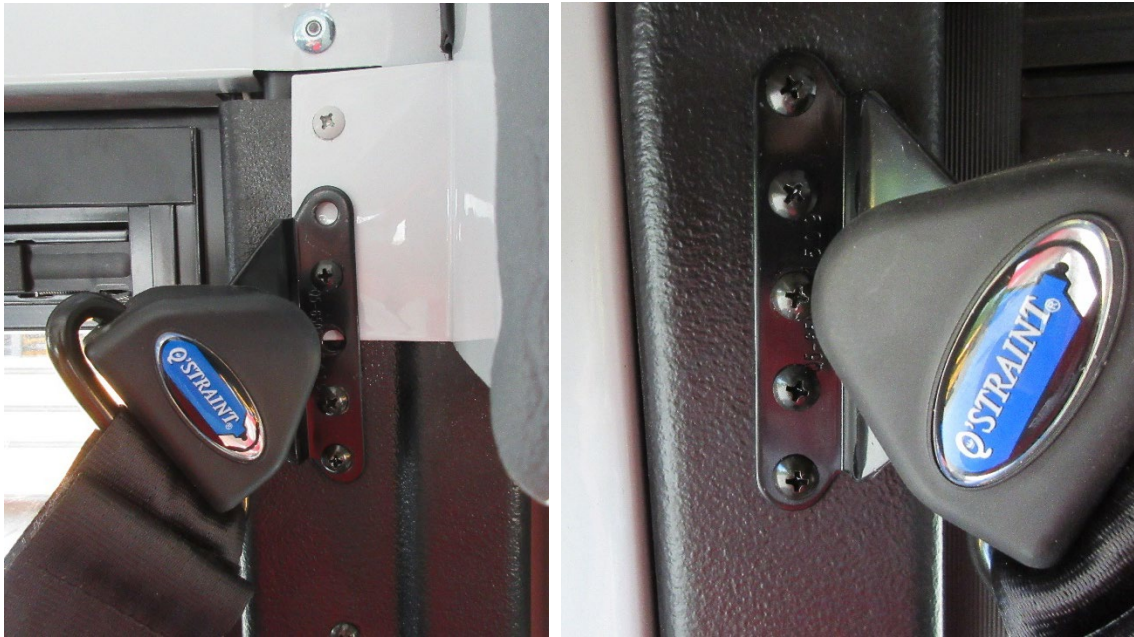
Now, the support is at 62.75 in of the floor.

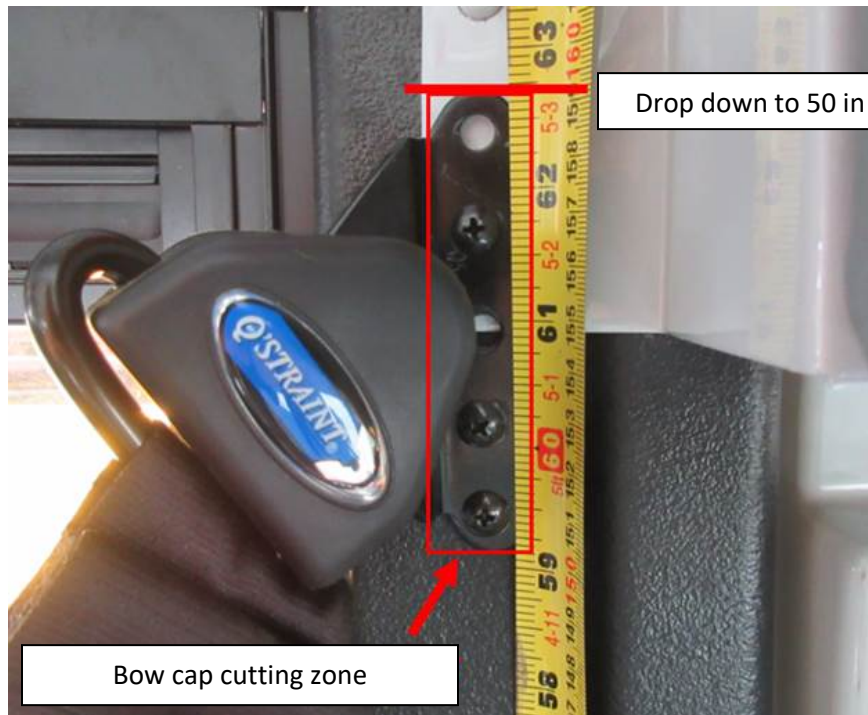
We need to drop down the top of the support to 50 in of the floor.
