# Safety Recall

## Code: 40Q6

**Subject** Steering Knuckle(s) – STOP DRIVE

**Release Date** November 17, 2020

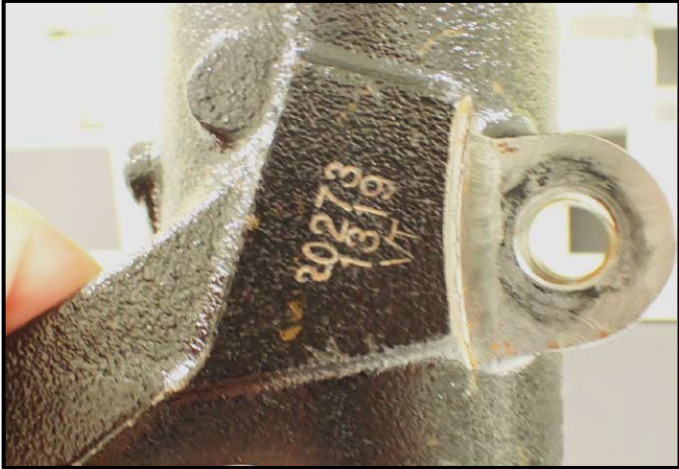
- Inspect left front and right front wheel bearing housings and replace if necessary.

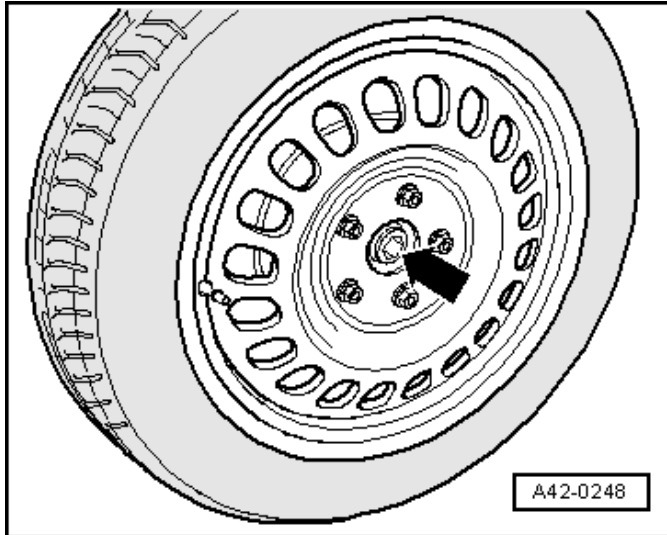
### Loosen front drive axle bolt:

- Secure the front wheels from turning.
- Loosen the front axle bolt <arrow>.

- The wheel bearing must not be under load when the drive axle threaded connection on the wheel side is loose.
- If the wheel bearings are under the load of the vehicle weight, the wheel bearing will be damaged. This reduces the service life of the wheel bearings.
- The drive axle bolt may be loosened maximum 90° when the vehicle is standing on its wheels.
- Vehicles without a drive axle must not be moved, otherwise the wheel bearing will be damaged. If a vehicle must be moved, be sure to note the following:
  - Install an outer joint in place of the drive axle.
  - Tighten the outer joint to 120 Nm.
