Dealer Service Instructions for:

Safety Recall W86 / NHTSA 20V-714

Rear Brake Discs

2020 (GA) Alfa Romeo Giulia

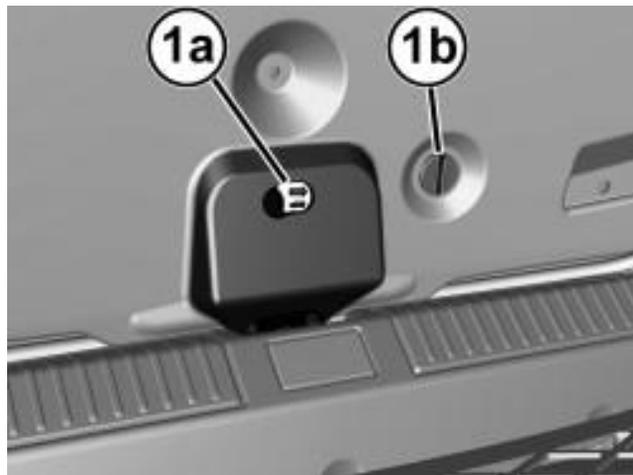
Figure 1 – Lid Lock Release

13. To be able to reopen the luggage compartment lid, even if it accidentally closes with the battery disconnected, before disconnecting the battery it is necessary to unscrew the cap (1b), release the pull cord hooked onto it and leave it hanging out of the luggage compartment. Then, by working on the pull cord, an emergency luggage compartment lid lock release can be obtained. The pull cord operates on the lever (1a) inside (Figure 1).

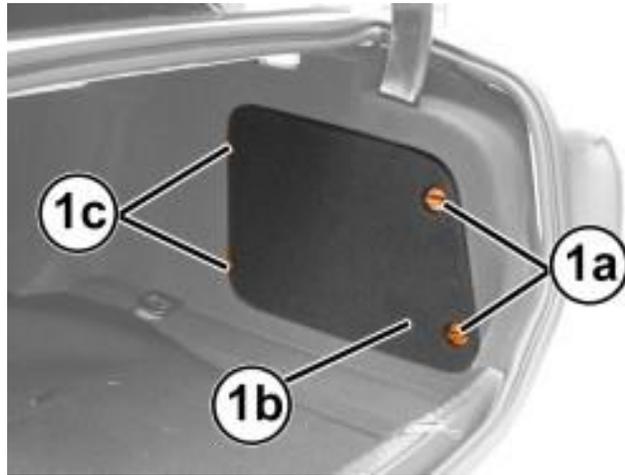
Figure 2 – Battery Cover

16. Working on the right side of the luggage compartment, turn the retainers (1a) counterclockwise to the end of their travel to release them, then remove the cover (1b) releasing the retainers in the areas (1c) (Figure 2).

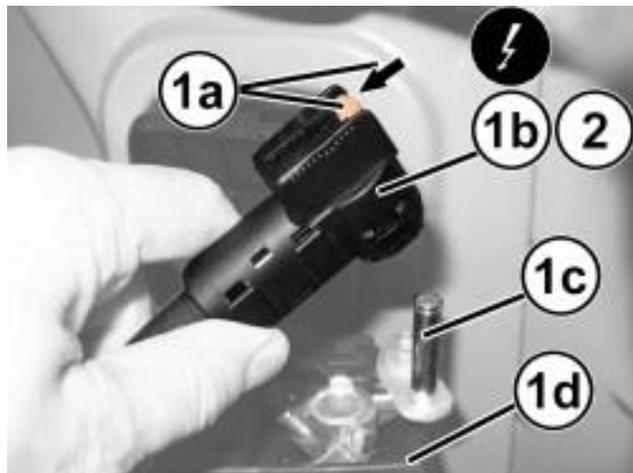
Figure 3 – Battery Negative Cable

17. Press the release button (1a) and disconnect the negative cable (1b) from the battery post (1c) (Figure 3).

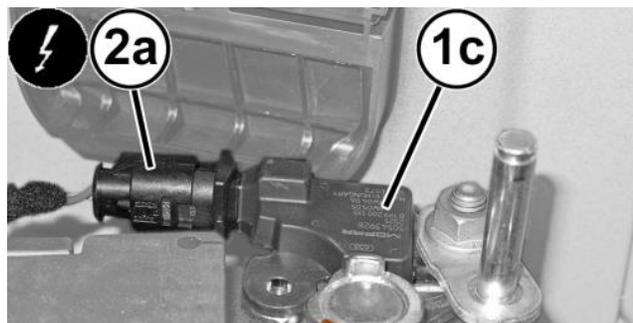
Figure 4 – Intelligent Battery Sensor

19. If equipped with an Intelligent Battery Sensor (IBS), disconnect the wire harness connector (2a) from the IBS (1c) (Figure 4).

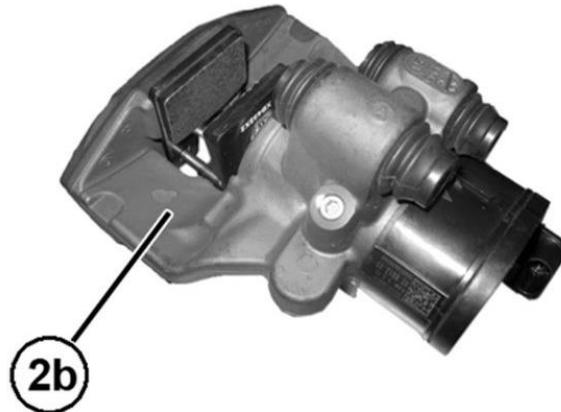
Figure 5 – Electronic Parking Brake

20. Remove both rear tire and wheel assemblies.
21. Disconnect the electrical harness connector (1) to the electric parking brake gear motor (Figure 5).
22. Remove and **DISCARD** the mounting bolts (2a) and remove the electric parking brake caliper (2b) (Figure 5).

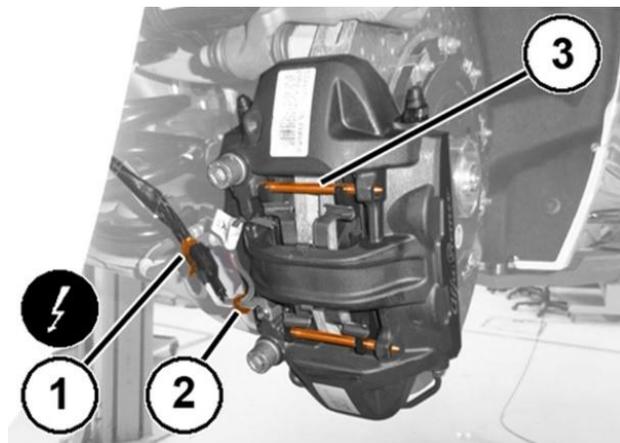
Figure 6 – Brake Caliper

23. Disconnect the brake pad wear indicator electric harness connection (1) (Figure 6).
24. Cut the tie strap and release the electrical harness from the support bracket (2) (Figure 6).
25. Using a suitable punch, retract and remove the pad retaining pins (3) (Figure 6).

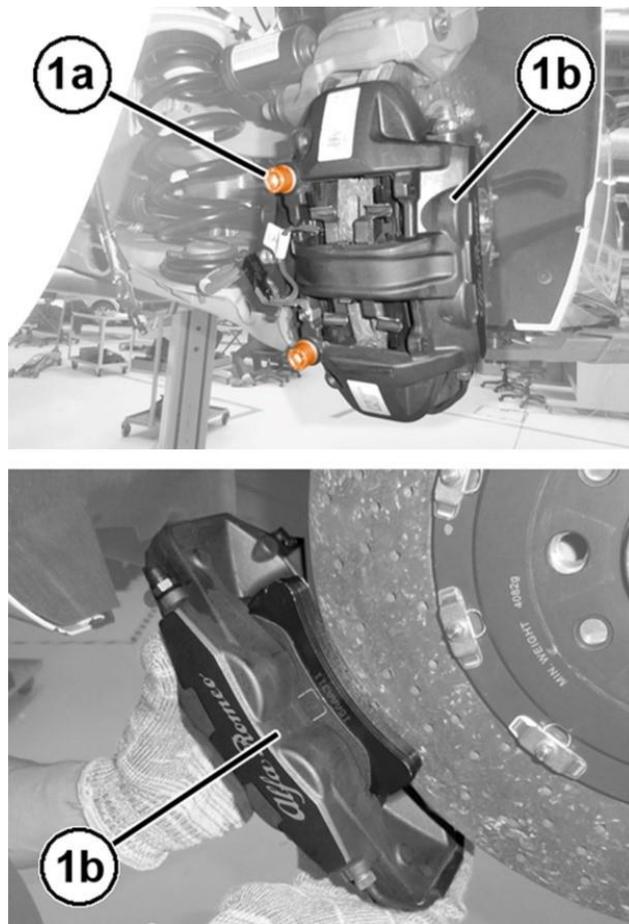
Figure 7 – Brake Caliper

28. Remove the mounting bolts (1a) and remove the brake caliper (1b) complete with pads, without disconnecting the brake hose (Figure 7).

CAUTION: Securely support the brake caliper so it does not put stress on the brake hose.

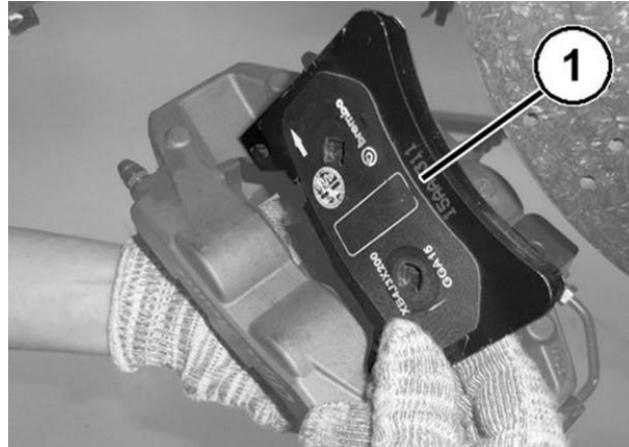
Figure 8 – Outer Brake Pad

- 29. Remove the outer brake pad (1) (Figure 8).
- 30. Remove the inner brake pad (1) (Figure 9).

NOTE: If the pads are stuck to the pistons, use a spatula or screwdriver and then extract the pads from the caliper. Be careful not to damage the pistons and the dust boots.

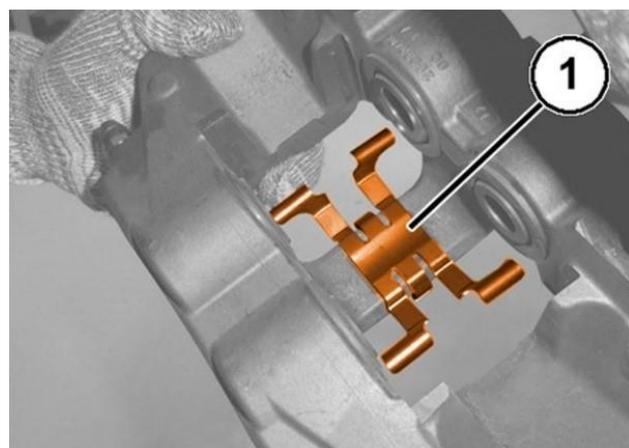
Figure 10 – Retaining Spring

- 31. Remove and **DISCARD** the brake caliper retaining clip (1) (Figure 10).

NOTE: The spring must always be replaced.

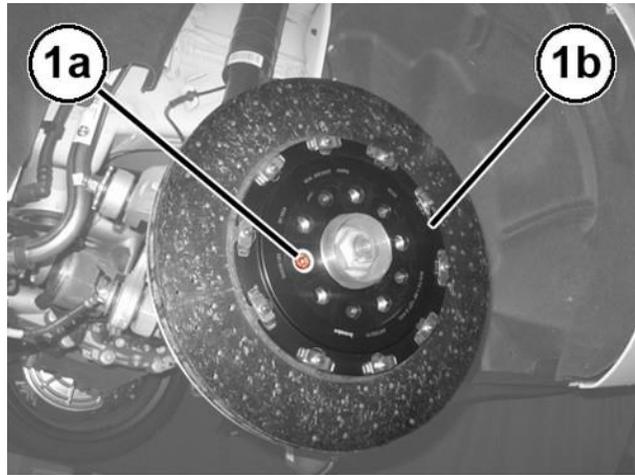
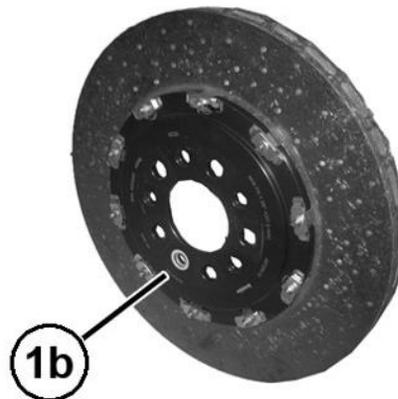
Figure 11 – Rear Brake Disc

34. Remove the mounting bolts (1a) and remove the rear brake disc (1b) (Figure 11).

NOTE: Use the packaging from the NEW brake discs to return the recalled brake discs to Brembo. Failure to return the recalled brake discs will result in the cancellation of the refund claim.

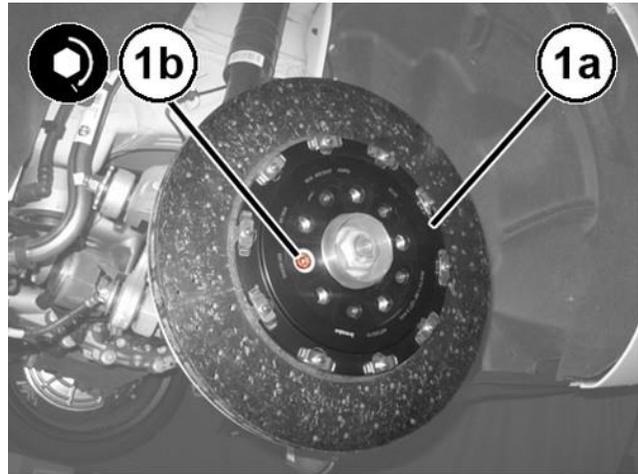
Figure 12 – Rear Brake Disc

35. Place the NEW rear brake disc (1a) onto the wheel hub and tighten the M10 bolt (1b) to 7 N·m (62 In. Lbs.) (Figure 12).

NOTE: After install the CCM discs, measure the eccentricity of the disc-wheel hub assembly with a dial indicator. An eccentricity of more than 0.10 mm is not acceptable.

NOTE: If the eccentricity is greater than 0.10 mm, rotate the disc to another position (there are 5 available positions) to achieve the smallest eccentricity possible.

NOTE: The eccentricity must be measured 10 mm from the disc's outer edge, on the braking side. The correct eccentricity value is vital for stabilizing braking. If the eccentricity values are too high, it will result in abnormal wear and strong vibrations.

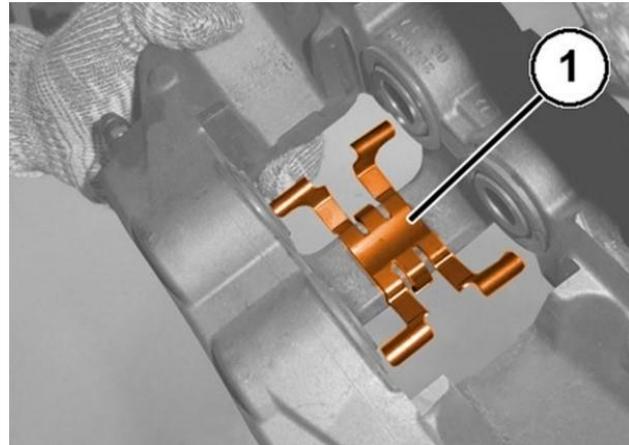
Figure 13 – Retaining Spring

36. Install some “MOLYKOTE Cu-7439 Plus” grease to the brake pad sliding shoulders and a **NEW** brake caliper retaining spring in its housing (Figure 13).

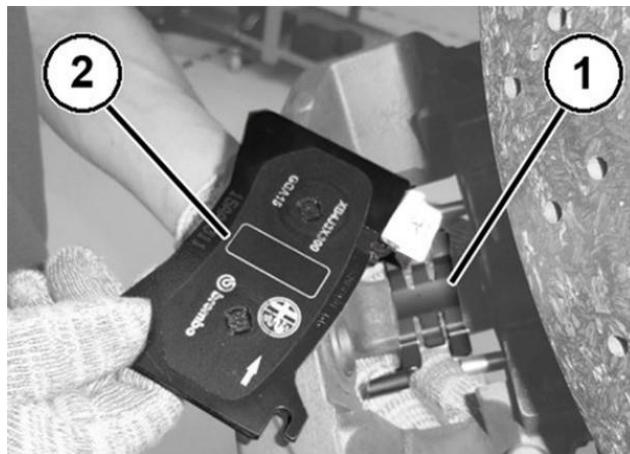
Figure 14 – Inner Brake Pad

37. Install the **NEW** inner brake pad (2) in its housing, complete with wear sensor (2) (Figure 14).

NOTE: The arrow printed on the brake pad must be oriented in the direction of rotation of the disc when travelling forwards.

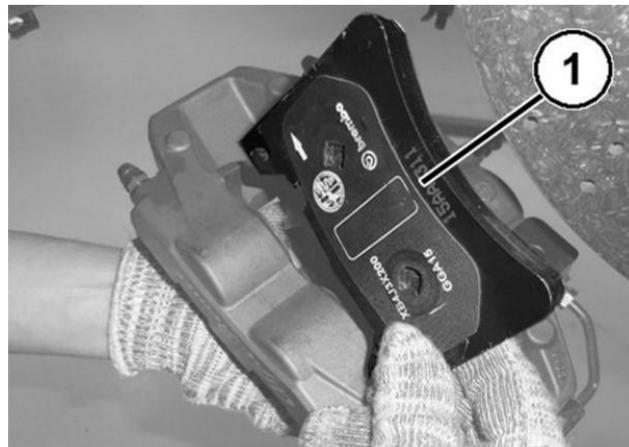
Figure 15 – Outer Brake Pad

38. Install the **NEW** outer brake pad (1) in its housing (Figure 15).

NOTE: The arrow printed on the brake pad must be oriented in the direction of rotation of the disc when travelling forwards.

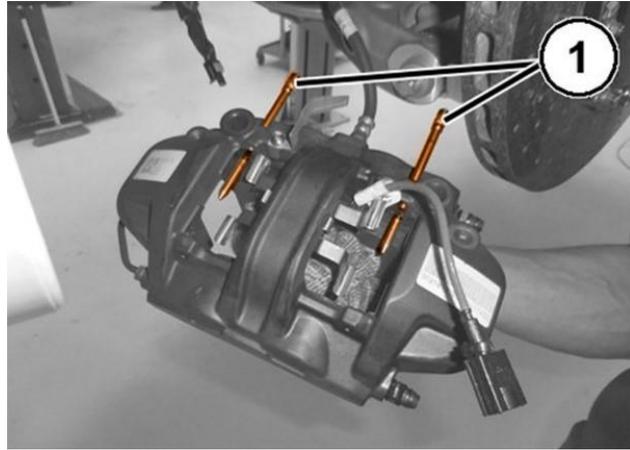
**Figure 16 – Brake Pad Retaining Pins**

39. Install the brake pad retaining pins (1) (Figure 16).
40. Position the brake caliper (1a) in its housing and set the brake pad retaining pins (1b) (Figure 17).
41. Install the brake caliper M12 mounting bolts (2) and tighten the bolts to 105 N·m (77 Ft. Lbs.) (Figure 17).

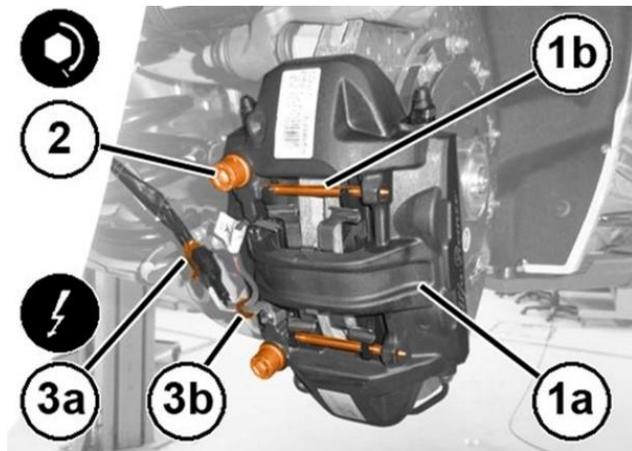
**Figure 17 – Brake Caliper**

42. Connect the electrical harness connector to the pad wear sensor (3a), secure it to the bracket with a **NEW** cable tie (3b) (Figure 17).
43. Pump brake pedal several times to set pads to caliper and brake rotor.

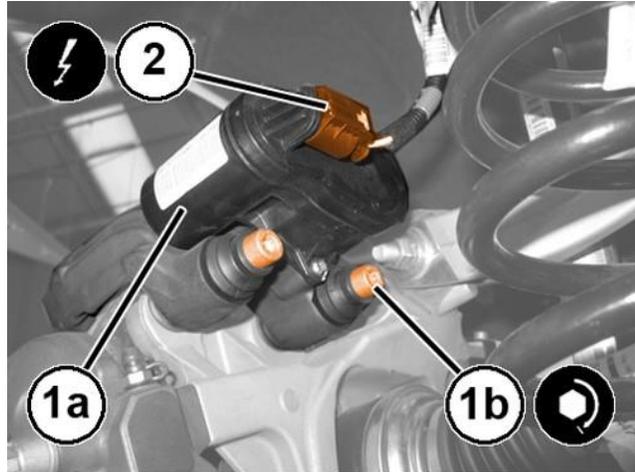
**Figure 18 – Electronic Parking Brake**

46. Position the electric parking brake caliper (1a) in its housing and tighten the **NEW** M10 mounting bolts (1b) to 30 N·m + 45 degrees (22 Ft. Lbs. + 45 degrees) (Figure 18).
47. Connect the electrical connection of the gear motor (2) (Figure 18).

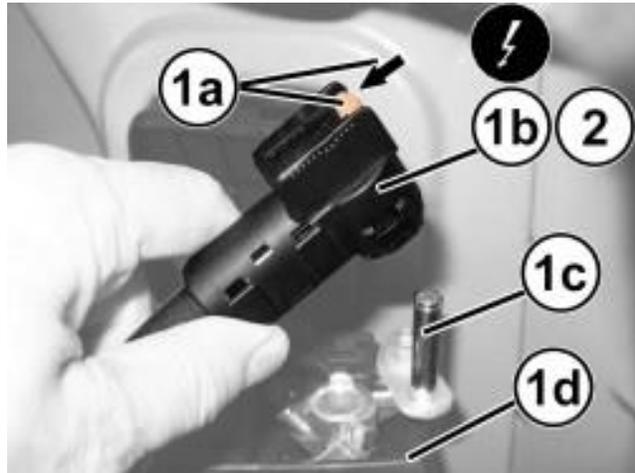
Figure 19 – Battery Negative Cable

49. Connect the battery negative cable (1b) onto the post (1c) (Figure 19).

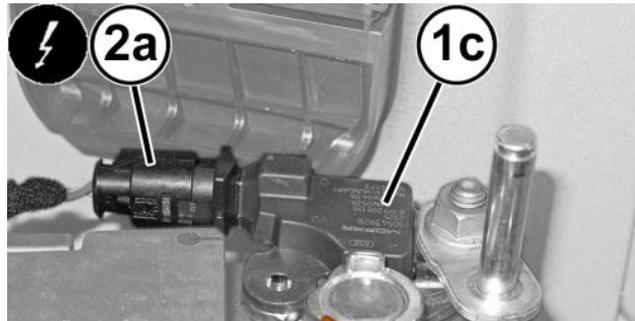
Figure 20 – Intelligent Battery Sensor

50. If equipped with an Intelligent Battery Sensor (IBS), connect the IBS connector (Figure 20).

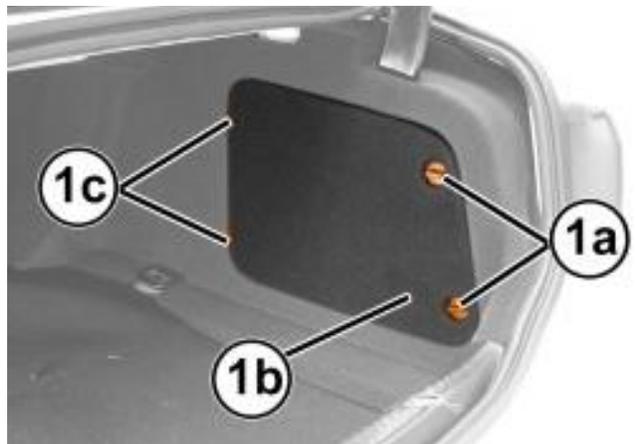
Figure 21 – Battery Cover

51. Position the battery cover (1b) while engaging the retainers (1c), then turn the retainers (1a) clockwise to the end of their travel to secure them (Figure 21).
