# SAFETY RECALL BULLETIN

SUBJECT:  <h2 style="text-align: center;">PARKING BRAKE CALIPER – SAFETY RECALL CAMPAIGN - REVISION</h2>		No: <b>SR-20-005REV</b> DATE: <b>May 2021</b> MODEL: <b>See Below</b>	
CIRCULATE TO:	<input checked="" type="checkbox"/> GENERAL MANAGER	<input checked="" type="checkbox"/> PARTS MANAGER	<input checked="" type="checkbox"/> TECHNICIAN
<input checked="" type="checkbox"/> SERVICE ADVISOR	<input checked="" type="checkbox"/> SERVICE MANAGER	<input checked="" type="checkbox"/> WARRANTY PROCESSOR	<input checked="" type="checkbox"/> SALES MANAGER

This campaign bulletin instructs dealers to inspect the rear brake caliper and, if necessary, replace the parking brake caliper body with the countermeasure part.

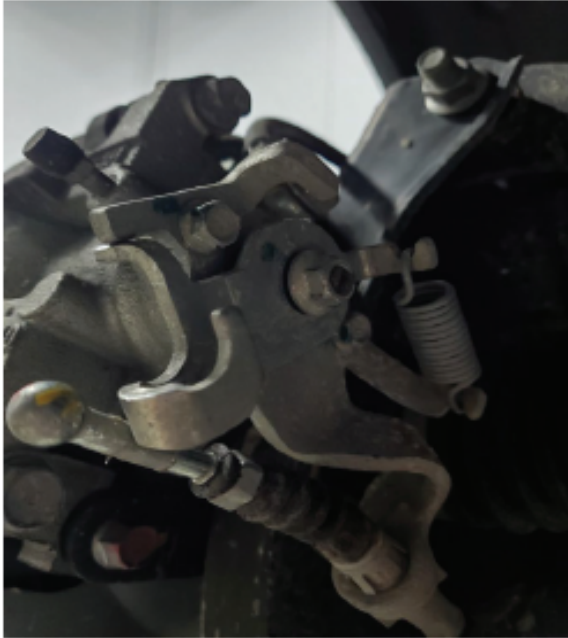
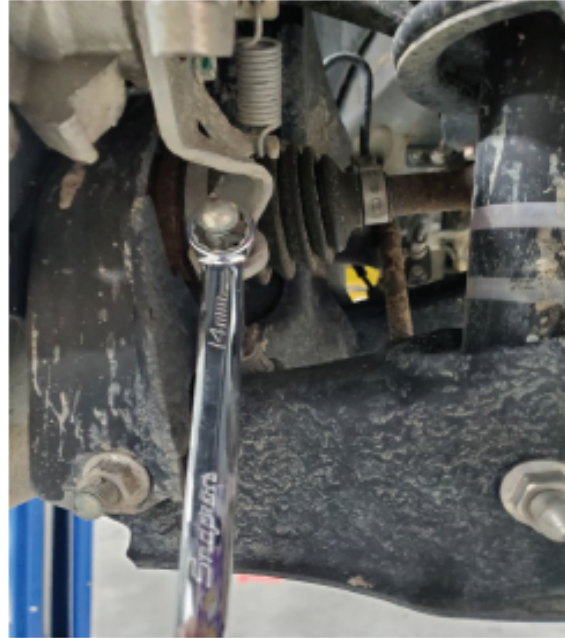
Be careful to not damage the boot while pulling the parking brake rear cable off of the parking brake bracket.

**NOTE:** Use 14 MM wrench to compress cable retainer

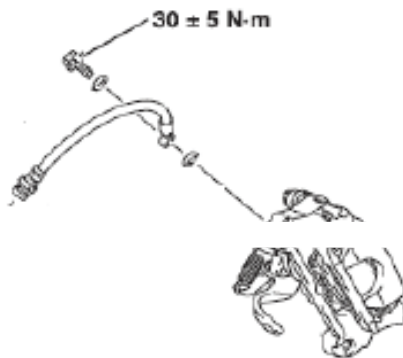
- a) Remove the brake hose from the Caliper Body Assembly.

Remove the brake fluid and be careful not to let the fluid adhere to the vehicle or peripheral parts. After disconnecting the callper from the hose, use a protective cover to avoid the spillage or debris.

Do not bend or damage the hose.

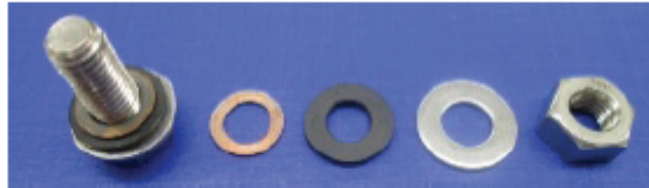
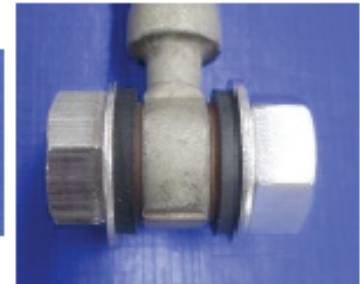
Use this method to help prevent brake fluid leakage during operation:  
Bolt (M10 \* 25), 2 Plain washer (M10 10.5\*21), Rubber seal (M10:10\*18\*2mm), 2 Gaskets (from the vehicle), and 2 nuts (M10) to prevent fluid leakage (as indicated in the pictures below).
