**Safety Recall: 2009-13 Fit Driveshaft Inspection**

Supersedes 21-009, dated April 8, 2021, to update the information highlighted in **yellow**.

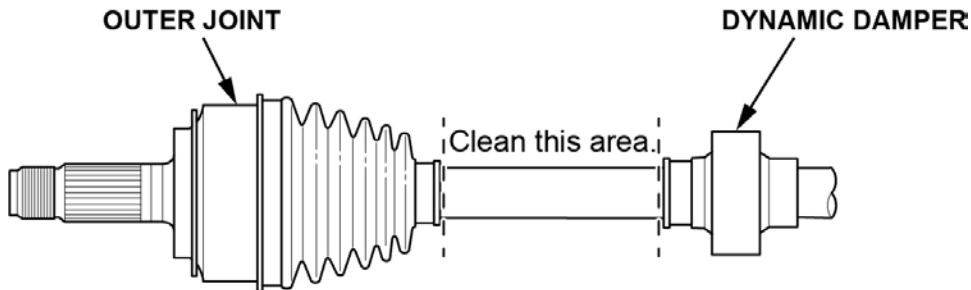
1. Raise and support the vehicle.
2. Use a clean shop towel to wipe any excess dirt and debris from the driveshafts between the outer joint and the dynamic damper.

NOTE: Paint chips may be sharp and could cut bare hands. Use gloves when wiping the driveshaft.

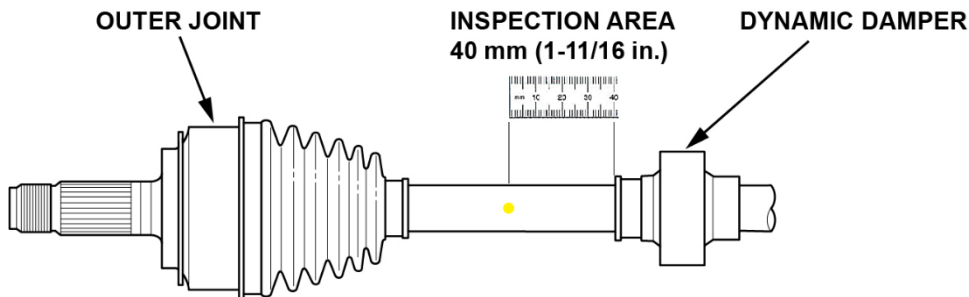
3. Using a ruler and yellow paint marker, measure **40 mm (1-11/16 in)** away from the dynamic damper, and mark the driveshaft with a dot. Click [HERE](#) to view a video on how to do the inspection procedure.

NOTE: Do not scribe or damage the painted surface of the driveshaft. Any replaced driveshafts may be called in for inspection.

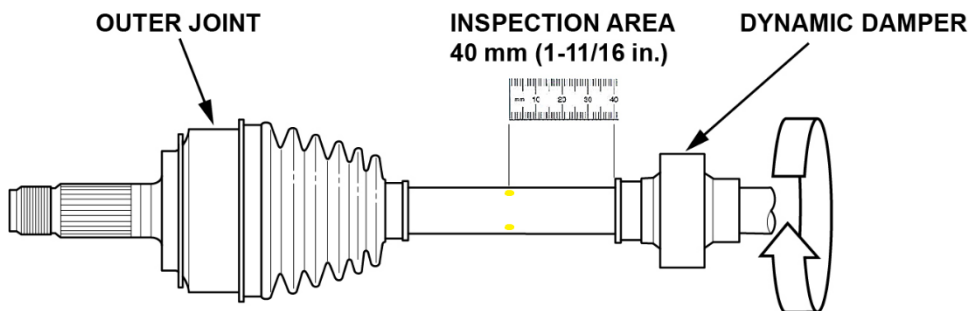
4. Rotate the axle 1/4 turn and repeat the step above **three times** until there are four paint dots on the axle.

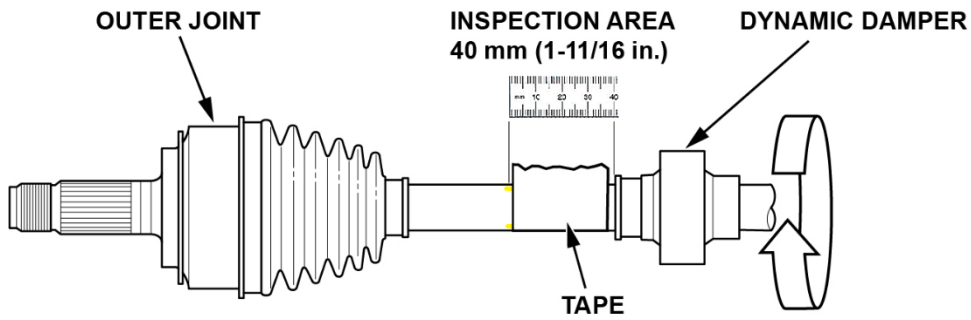
5. Connect the four painted dots around the axle using masking tape.

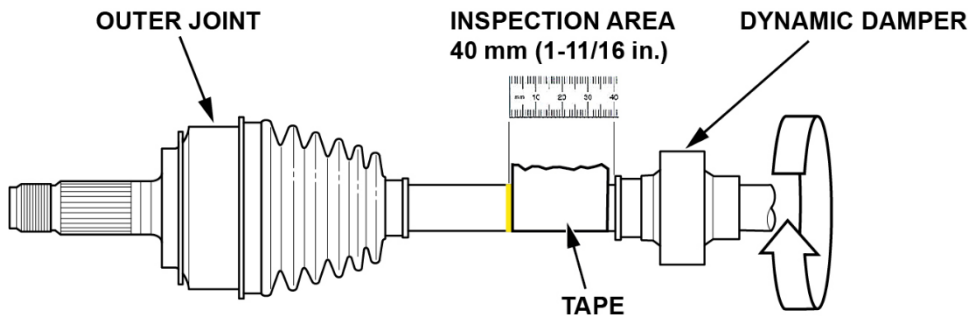
6. Using the masking tape as a guide, trace a line all around the axle using the yellow paint marker. Marking the line accurately is important, especially if there is damage close to or inside the 40 mm line.

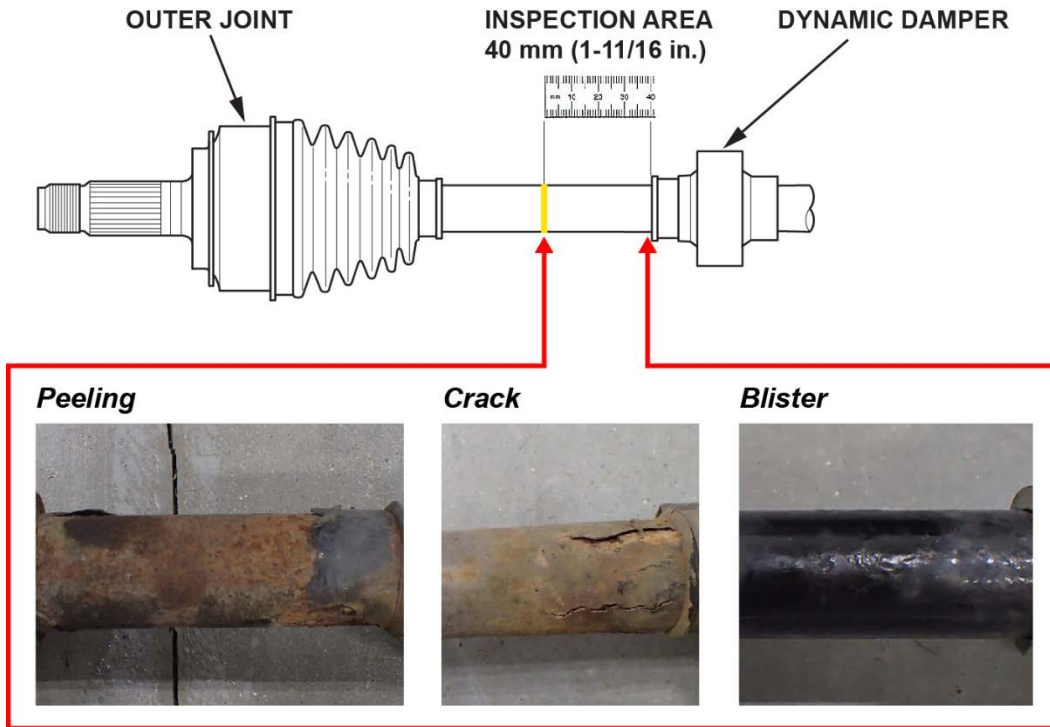
- Inspect the driveshaft surface between the dynamic damper and the line for peeling paint, cracks, or blisters. Corrosion or paint defects between the outer joint and the yellow line are OK.

Is there peeling paint, cracks, or blisters on either driveshaft within **40 mm (1-11/16 in)** of the dynamic damper?

Yes - Go to **REPAIR PROCEDURE**.

No - The driveshafts are OK. Return the vehicle to the customer.

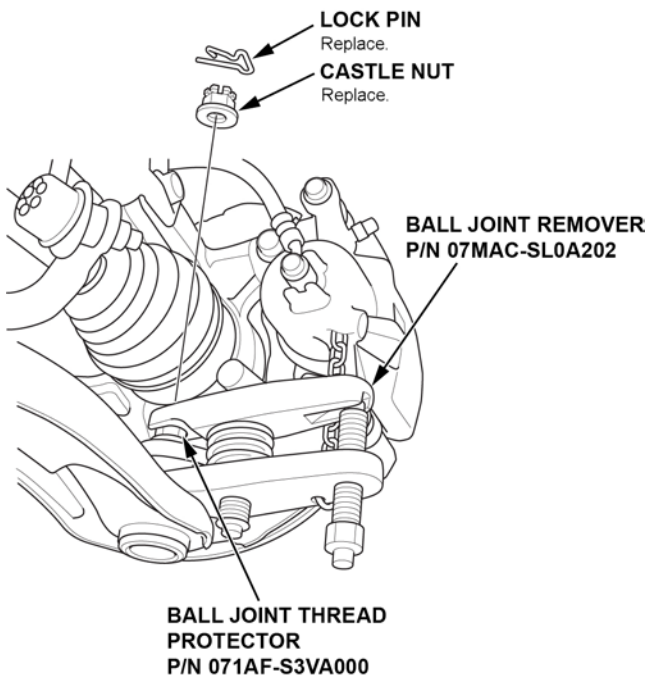
4. Separate the ball joint from the knuckle using the Ball Joint Thread Protector (T/N: 07AAF-SDAA100) and Ball Joint Remover (T/N: 07MAC-SL0A202). Grease the threads and tip of the pressure bolt on the ball joint remover, and make sure the pivot bolt is not parallel to the ball joint remover arms. For additional information on how to use the tools, refer to the service information.

- To avoid damaging the ball joint, install the ball joint thread protector onto the threads of the ball joint.
- Be careful not to damage the ball joint boot when installing the remover.
- Do not force or hammer on the lower arm, or pry between the lower arm and the knuckle to prevent damage.

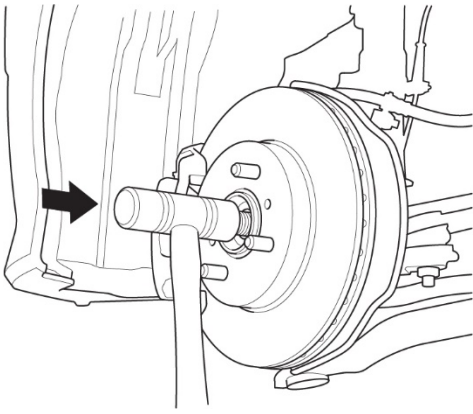
5. Use a soft-face hammer to separate the outboard joint from the front hub.

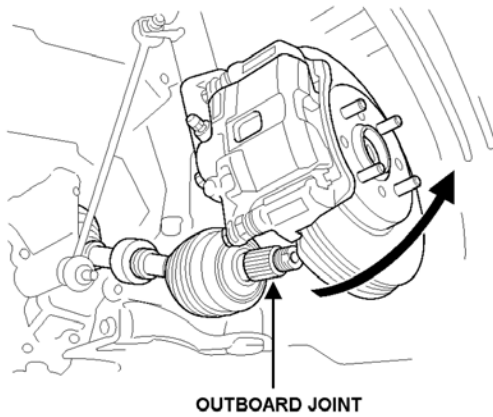
6. Pull the knuckle outward to separate the outboard joint from the front wheel hub.

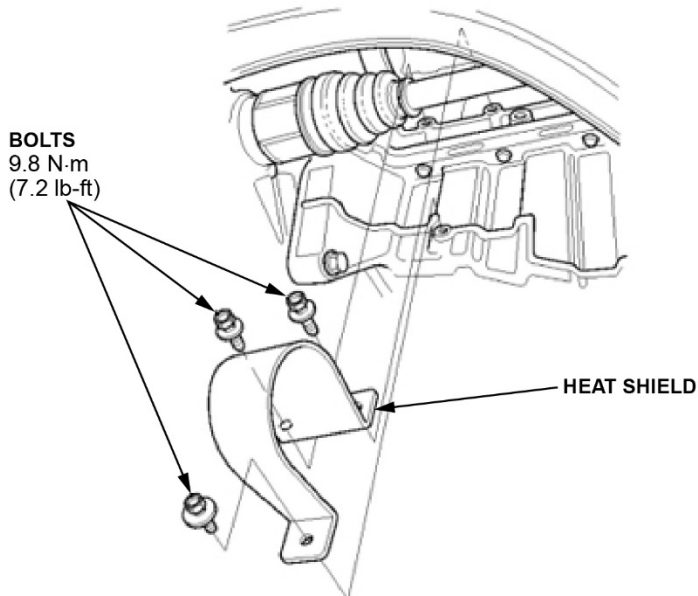
7. *M/T only*: Remove the heat shield.

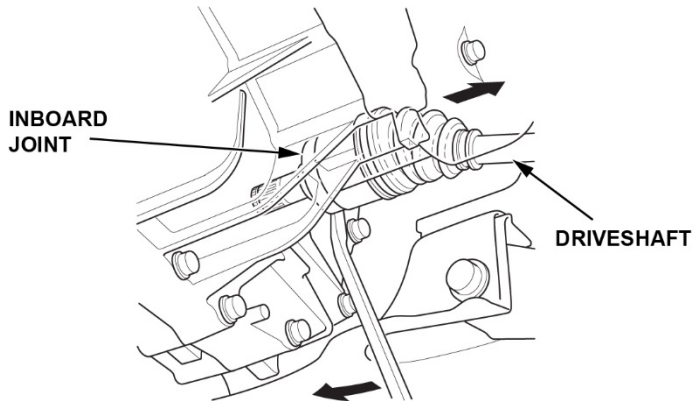
8. *Driver's side driveshaft only:* Use a pry bar to pry the inboard joint from the transmission housing. Then, remove the driveshaft as an assembly.

- Do not pull on the driveshaft, or the inboard joint may come apart.
- Pull the inboard joint straight out to avoid damaging the oil seal.
- Be careful not to damage the transmission oil seal with the pry bar.

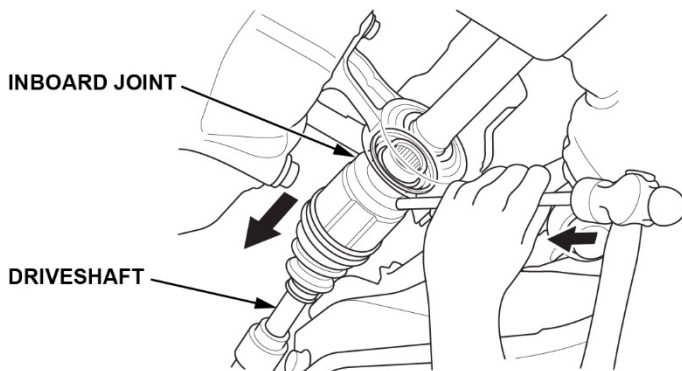
9. *Passenger's side driveshaft only:* Using a punch and hammer, drive the inboard joint off of the intermediate shaft. Then, remove the driveshaft as an assembly.

- Do not pull the assembly by the driveshaft, the inboard joint may come apart.
- Be careful not to damage the transmission oil seal with the pry bar.

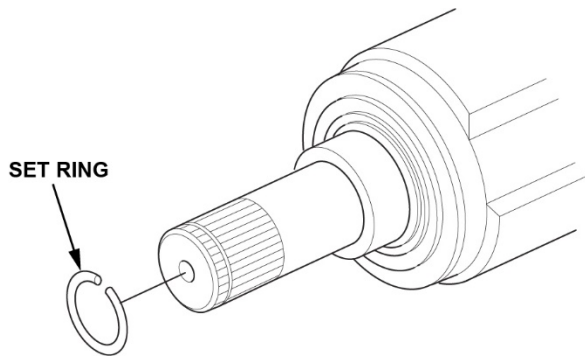
10. *Driver's side driveshaft only:* Replace the set ring on the inboard joint.

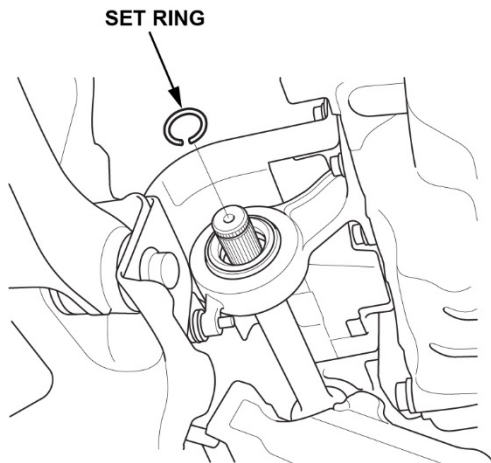
11. *Passenger's side driveshaft only:* Replace the set ring on the intermediate shaft.

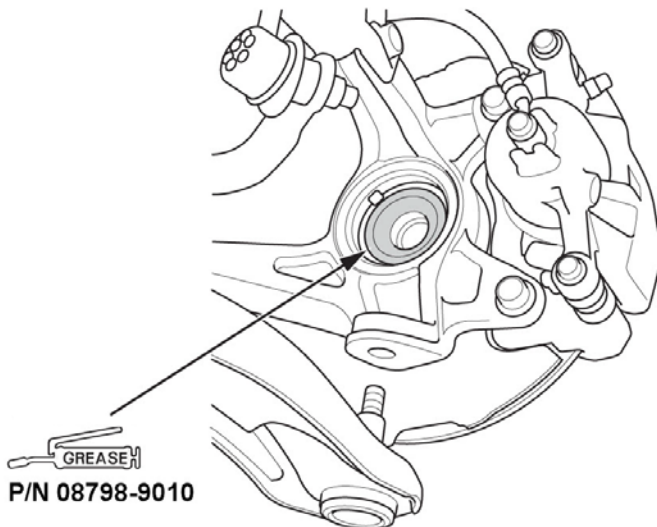
13. Apply about **5 g (0.18 oz)** of M-77 Assembly Paste (P/N 08798-9010) to the contact area of the outboard joint and front wheel bearing.

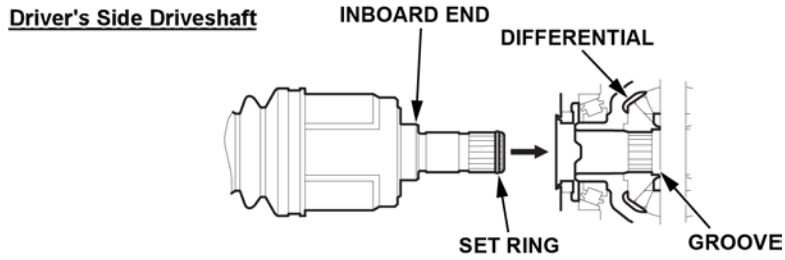
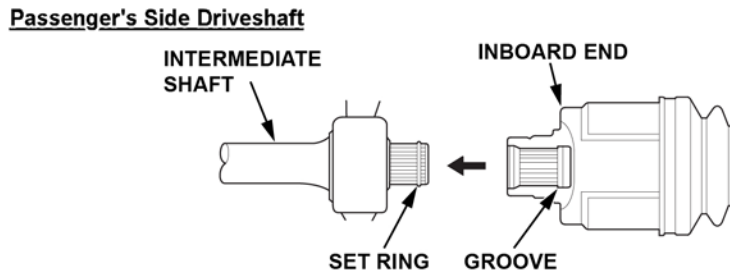
14. Insert the inboard end of the driveshaft into the differential or intermediate shaft until the set ring locks in the groove. Make sure to insert the driveshaft(s) straight in to avoid damaging the oil seal.

NOTE: You do not need to apply any grease to the new driveshaft(s), as they come pre-greased.

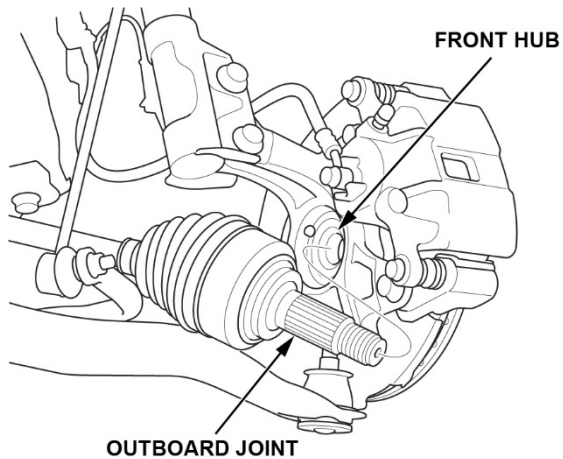
15. Install the outboard joint into the front hub on the knuckle.

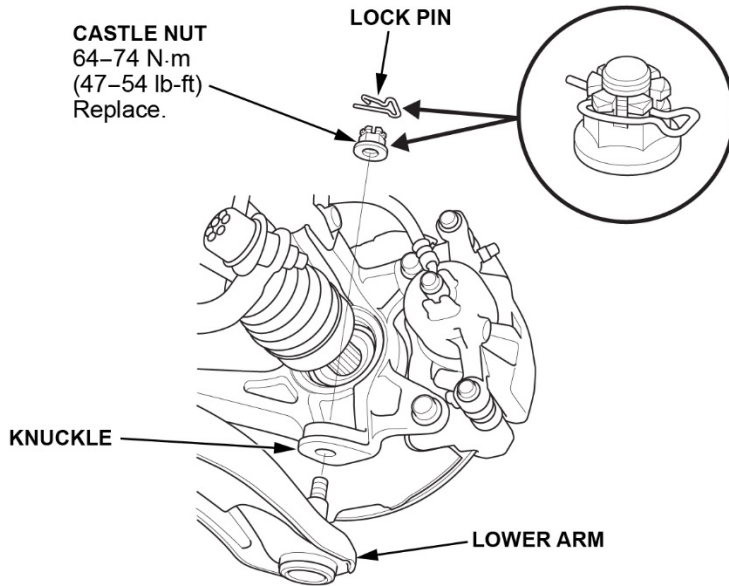
16. Wipe off any grease contamination from the tapered ball joint section and threads, then install the knuckle onto the lower arm. Make sure not to damage the ball joint boot.

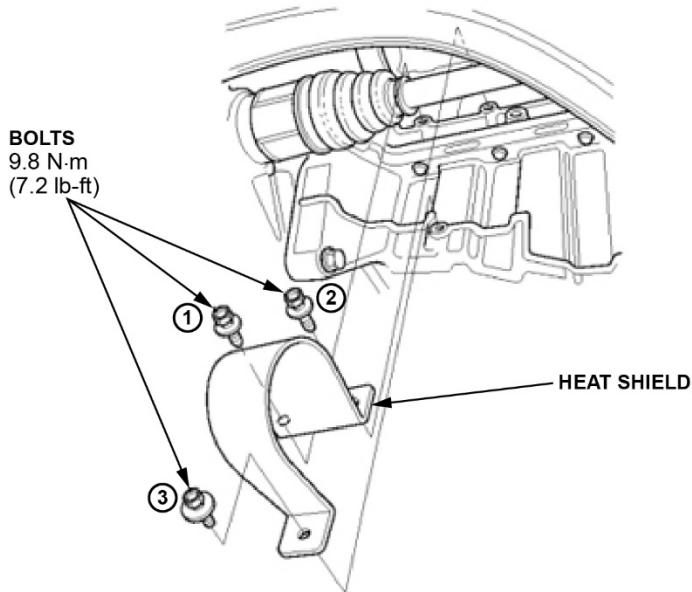
18. *M/T Only*: Install the heat shield and torque the bolts to **9.8 N·m (7.2 lb-ft)** in the sequence shown below.

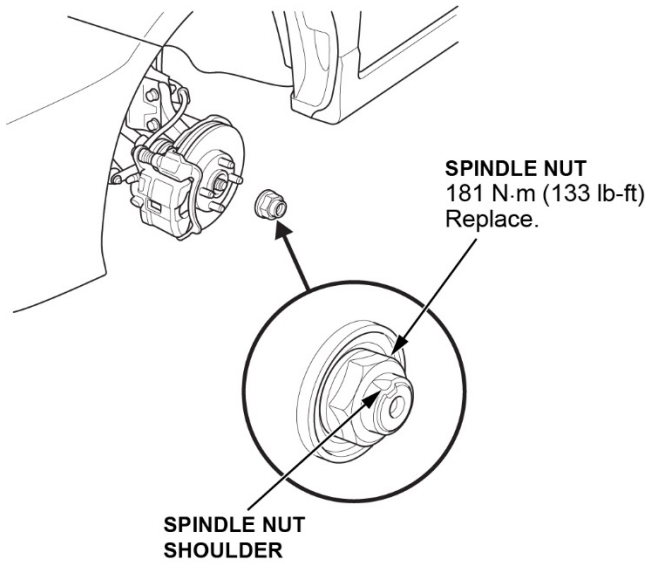
19. Apply a small amount of engine oil to the seating surface of the new spindle nut. Then, install and torque the spindle nut. After torquing it, use a drift punch to stake the spindle nut shoulder against the driveshaft.

NOTE: If you are going to use an air or battery powered impact gun to install the nut, make sure to turn down the air or power so you do not overtighten it, then torque it to specification using a torque wrench.

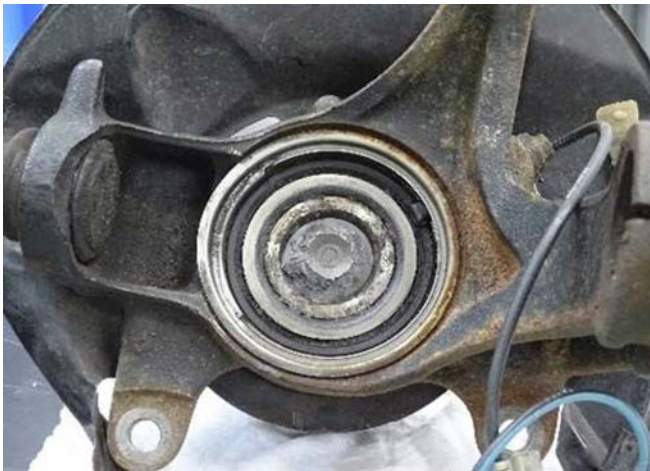
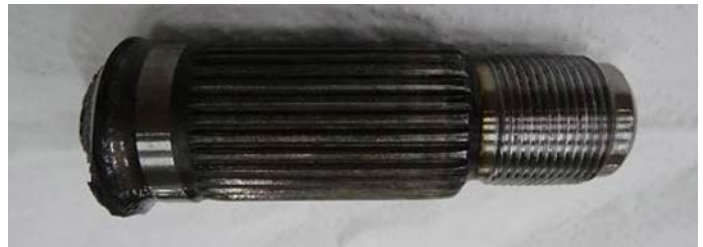
NOTE: It is important to know that many air and battery powered impact guns can achieve 2 or 3 times the axle nuts torque specification. If you severely over-torque an axle nut, it is possible to break a driveshaft as shown below:
