**February 17, 2021**

Version 2

**Safety Recall: 2009-13 Fit Driveshaft Inspection**Supersedes 21-009, dated February 16, 2021, to revise the information highlighted **yellow****AFFECTED VEHICLES**

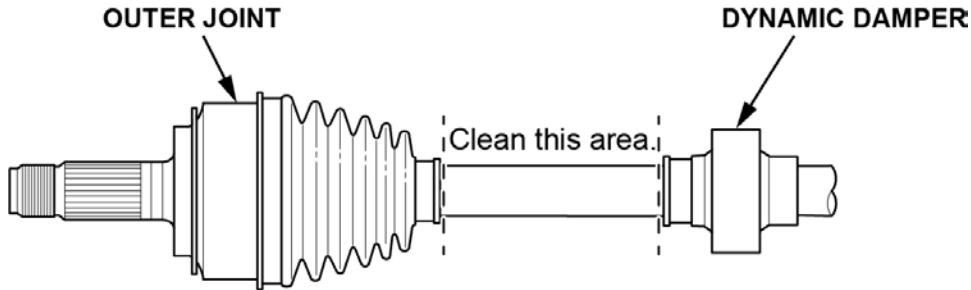
1. Raise and support the vehicle.
2. Use a clean shop towel to wipe any excess dirt and debris from the driveshafts between the outer joint and the dynamic damper.

NOTE: Paint chips may be sharp and could cut bare hands. Use gloves when wiping the driveshaft.

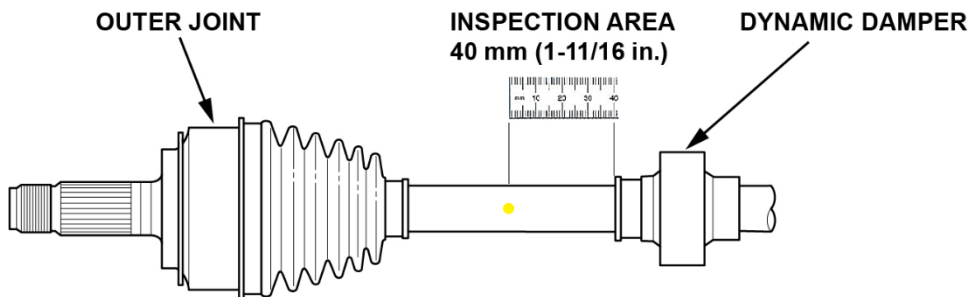
3. Using a ruler and yellow paint marker, measure **40 mm (1-11/16 in)** away from the dynamic damper, and mark the driveshaft with a dot. Click [HERE](#) to view a video on how to do the inspection procedure.

NOTE: Do not scribe or damage the painted surface of the driveshaft. Any replaced driveshafts may be called in for inspection.

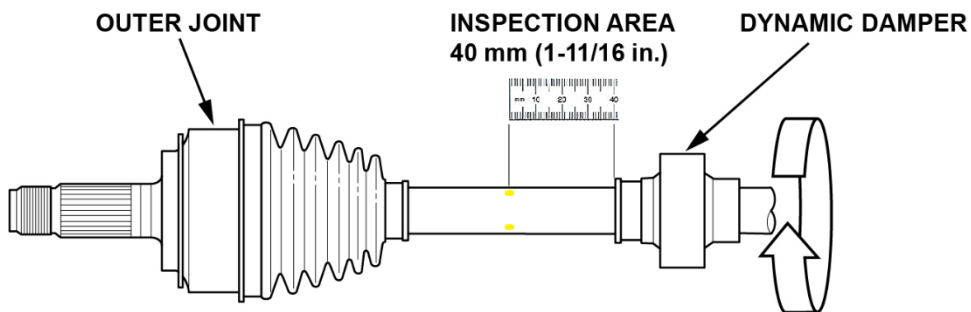
4. Rotate the axle 1/4 turn and repeat the step above **three times** until there are four paint dots on the axle.

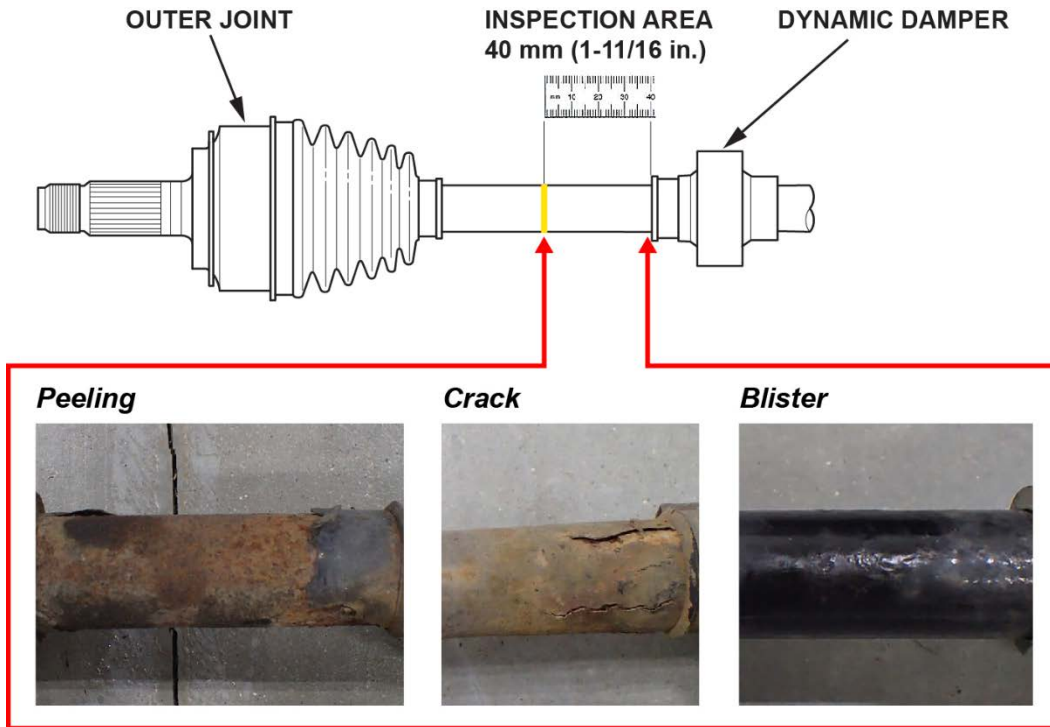
8. Inspect the driveshaft surface between the dynamic damper and the line for peeling paint, cracks, or blisters. Corrosion or paint defects between the outer joint and the yellow line are OK.

Is there peeling paint, cracks, or blisters on either driveshaft within **40 mm (1-11/16 in)** of the dynamic damper?

Yes - Go to REPAIR PROCEDURE.

No - The driveshafts are OK. Return the vehicle to the customer.

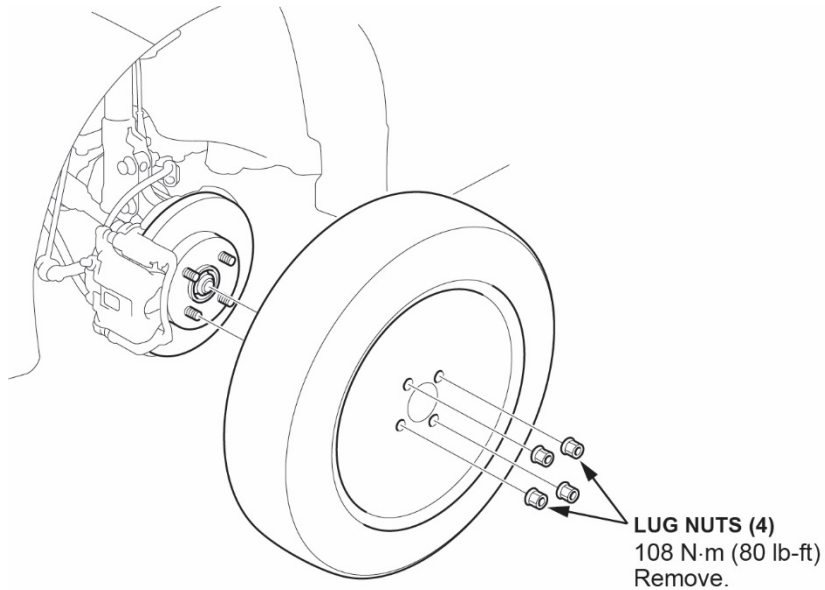
1. Remove the front wheel of the driveshaft you are replacing.

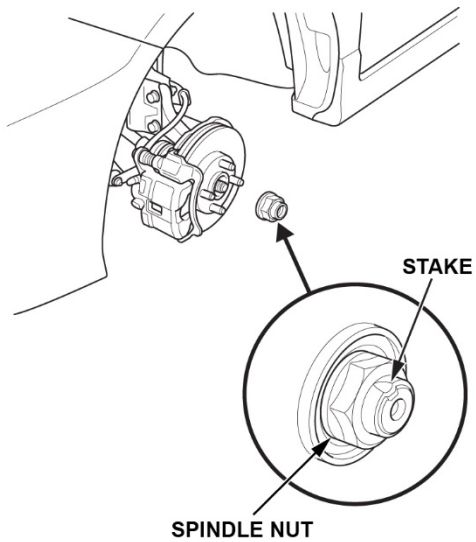
2. Pry up the stake on the spindle nut, then remove it.

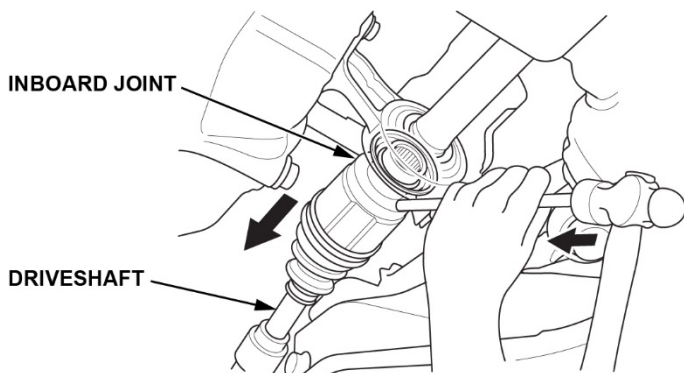
8. *Passenger's side driveshaft only:* Using a punch and hammer, drive the inboard joint off of the intermediate shaft. Then, remove the driveshaft as an assembly.

- Do not pull the assembly by the driveshaft, the inboard joint may come apart.
- Be careful not to damage the transmission oil seal with the pry bar.

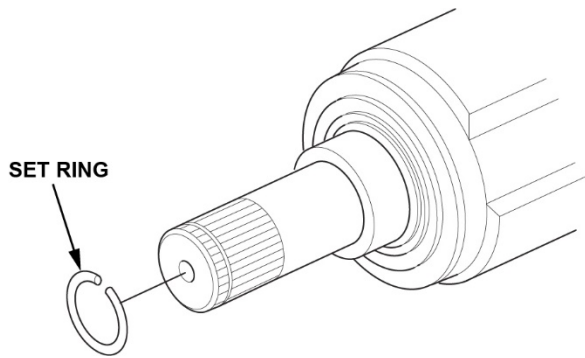
9. *Driver's side driveshaft only:* Replace the set ring on the inboard joint.

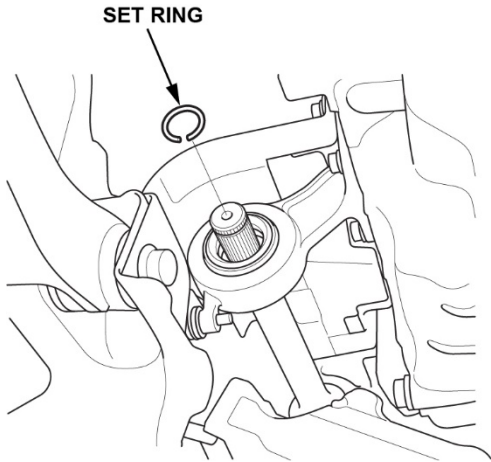
10. *Passenger's side driveshaft only:* Replace the set ring on the intermediate shaft.

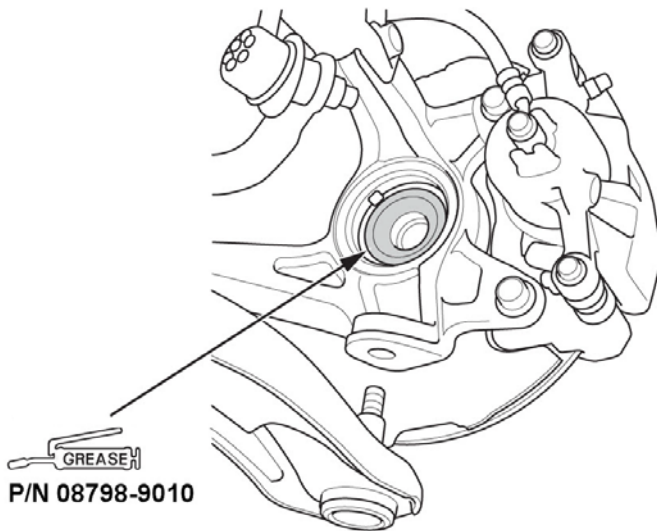
12. Apply about **5 g (0.18 oz)** of M-77 Assembly Paste (P/N 08798-9010) to the contact area of the outboard joint and front wheel bearing.

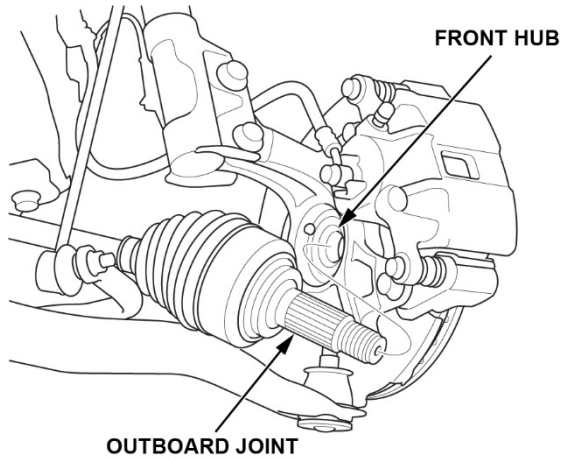
14. Install the outboard joint into the front hub on the knuckle.

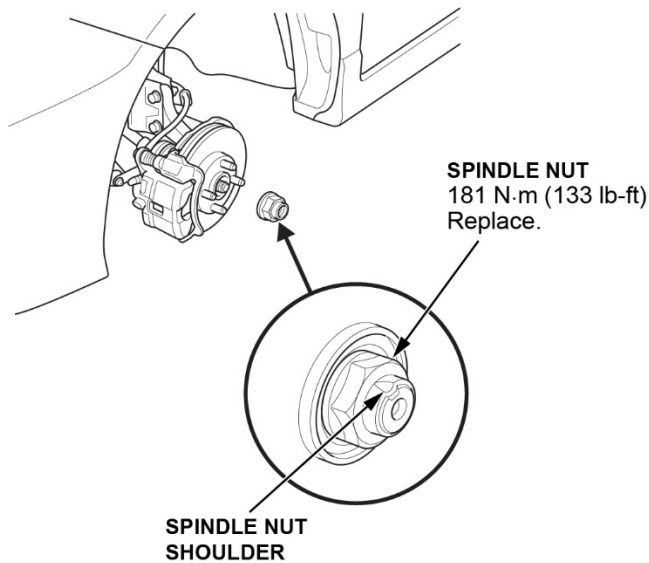
16. Install the new castle nut, and torque it to the lower torque specification. Then, tighten it until the slot on the castle nut aligns with the ball joint pin hole. Install the lock pin into the pin hole as shown.

17. Apply a small amount of engine oil to the seating surface of the new spindle nut. Then, install and torque the spindle nut. After torquing it, use a drift punch to stake the spindle nut shoulder against the driveshaft.
