Safety Recall

Code: 46i7

Subject	Brake Pedal																		
Release Date	December 18, 2020																		
Affected Vehicles

Subject: Safety Recall 46i7 – Brake Pedal

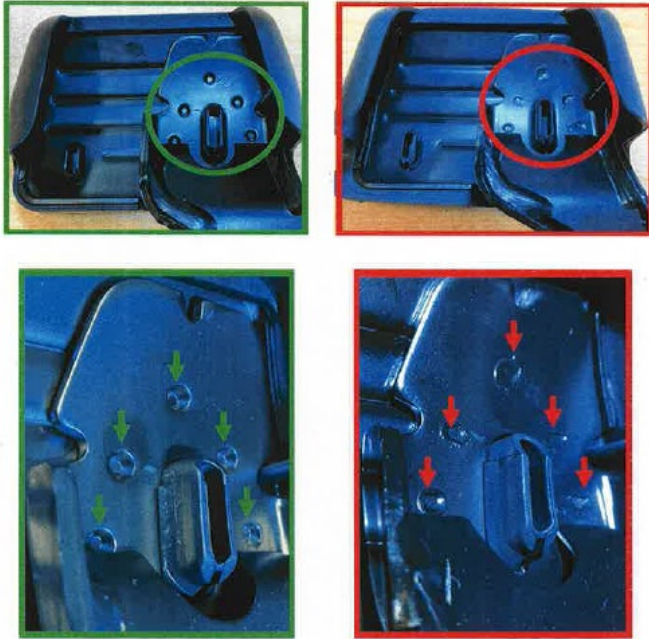
Repair Overview

- Inspect stampings on brake pedal and replace brake pedal if necessary.

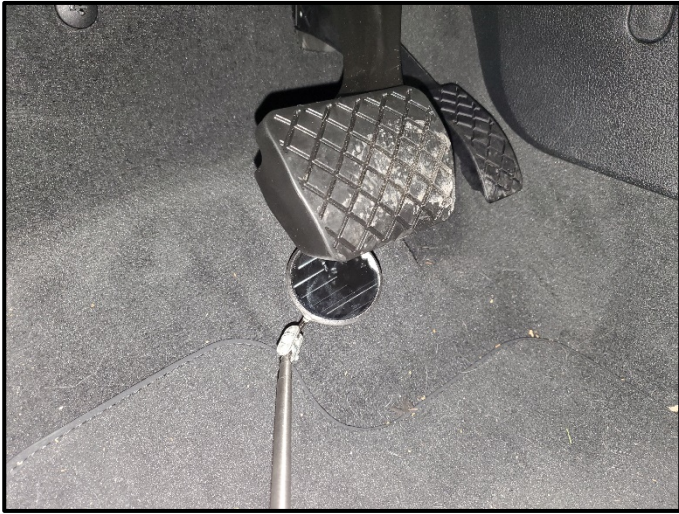
- Inspect the underside of the footpad on the brake pedal using an inspection mirror.

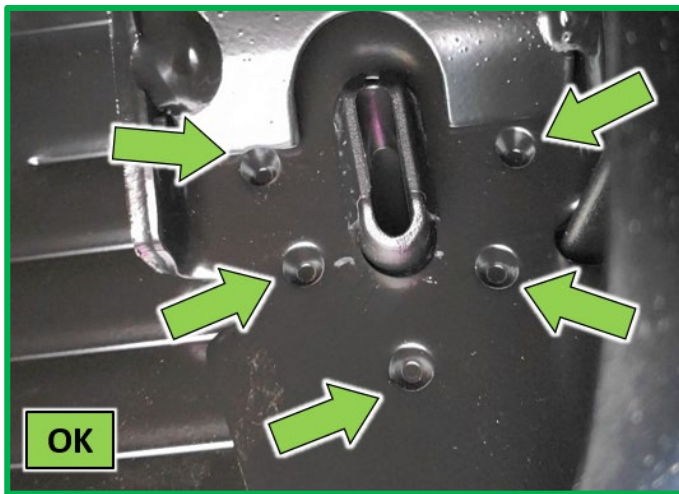
- Inspect the five stampings <arrows> on the brake pedal.
- The stampings should be well defined, deep and complete.
- All five stampings must be complete.

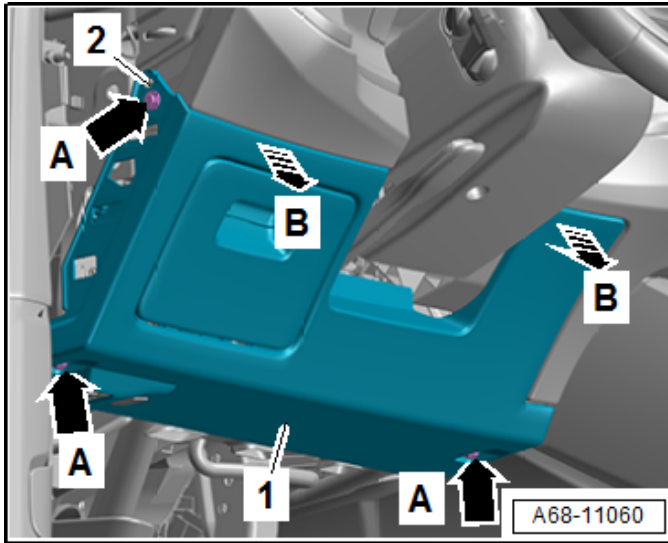
Remove instrument panel cover:

- Remove driver side instrument panel side cover (not shown).
- Remove the screws <A arrows>.
- Disengage the instrument panel cover on the side at the pin <2>.
- Unclip the driver side instrument panel cover <1> by hand from the instrument panel in direction of <B arrows> and remove.
- Disconnect the connector for the footwell lamp (if equipped).

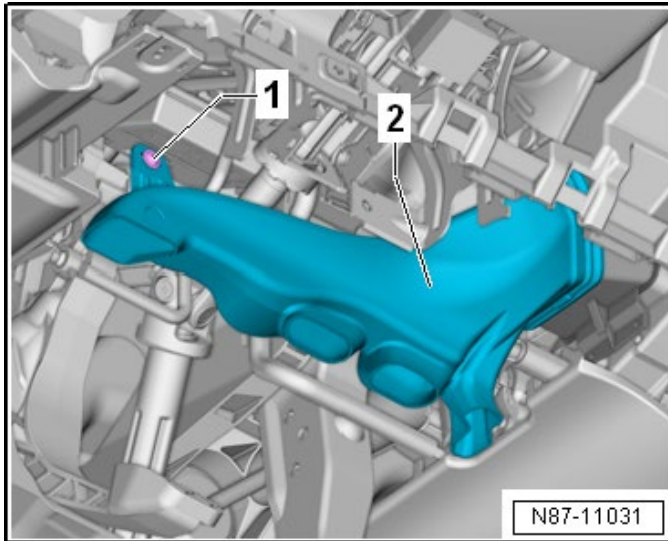
Remove driver side footwell vent:

- Remove the expanding clip <1> and remove the driver side footwell vent <2>.

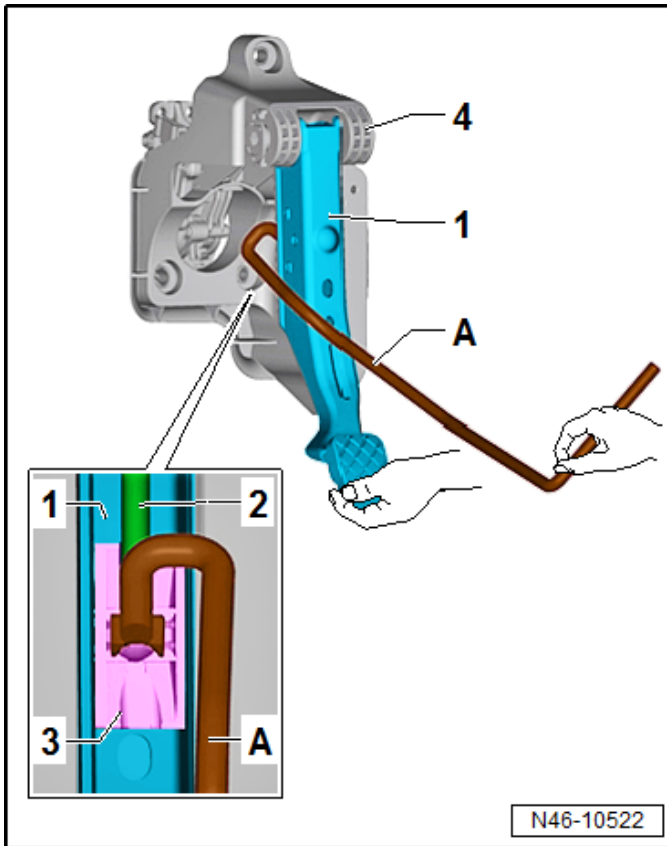
Disconnect the brake pedal from the brake booster:

- Press and hold the brake pedal <1> in the direction of the brake booster.
- Insert the -T10159B- <A> and pull in the direction of the driver seat. While doing so, counterhold at the brake pedal so that it does not move toward the rear. While doing so, the mount retaining tabs <3> will be pushed out of the pushrod ball head <2>.
- Pull the -T10159B- and brake pedal together toward the driver seat. As a result, the brake pedal is removed from the pushrod ball head.

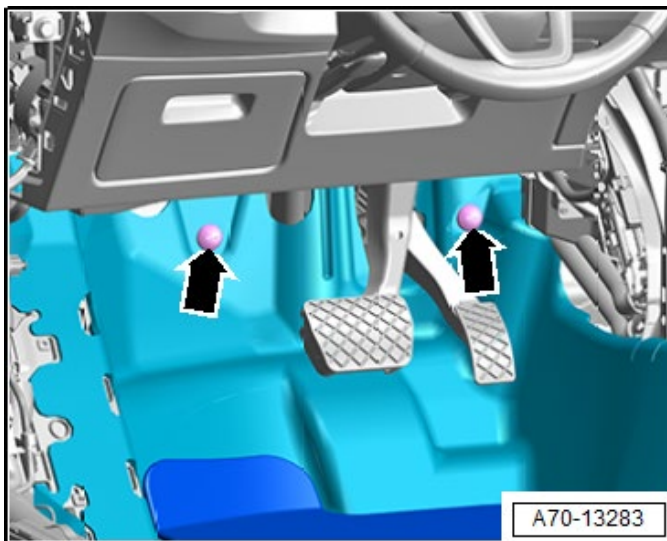
Access steering column bolt:

- Remove the buttons/nuts <arrows>.
- Free up the carpet in the area of the universal joint and push it slightly rearward.

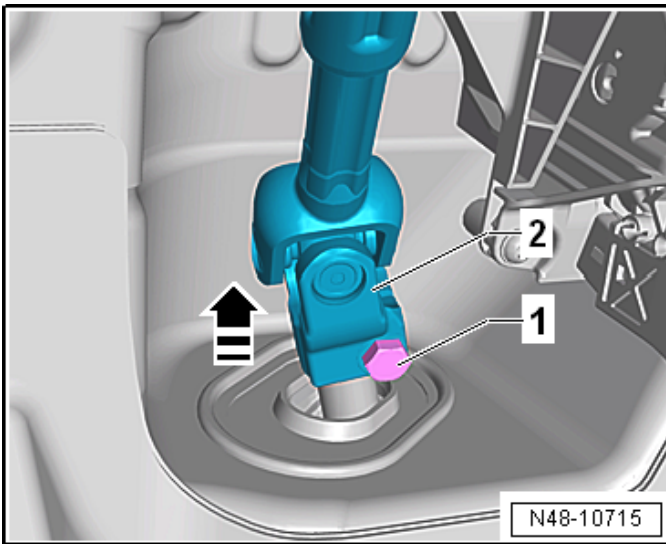
Remove steering column bolt:

- Remove the bolt <1> for the universal joint <2> and then remove the universal joint from the steering gear in direction of <arrow>.

The steering column orientation must remain as it was when the steering column is disconnected from the steering rack.

Disconnecting the steering column allows for complete removal of the brake pedal pin.

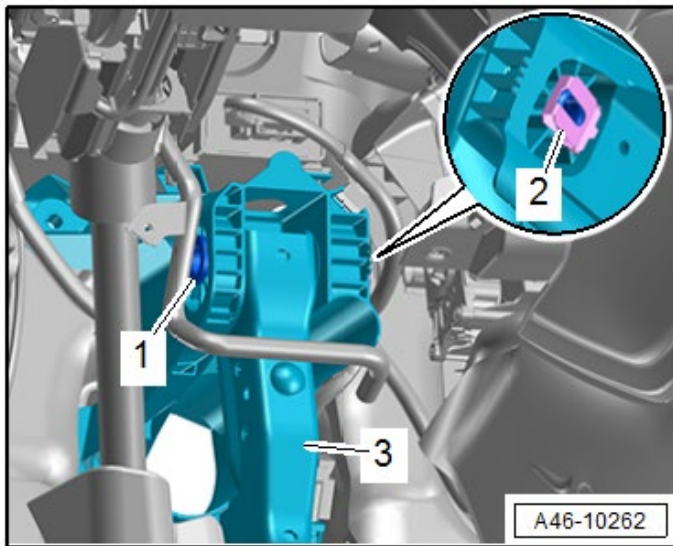
Remove brake pedal:

- Remove the clamp <2>.
- Remove the mounting pin <1> and remove the brake pedal <3> from the mounting bracket.

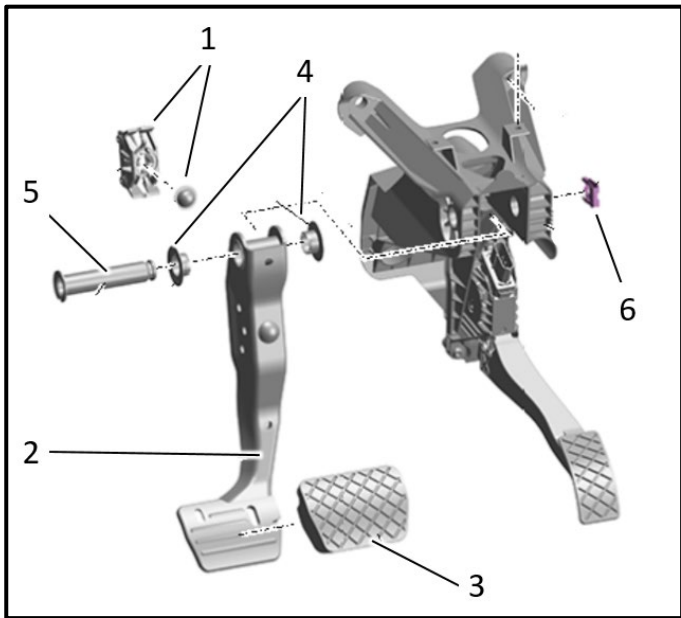
Pos.	Part Number	Part Description
1	5Q0-721-165-C	Mounting Parts
2	5Q1-723-143-C	Brake Pedal
4	5Q0-721-153-B	Bushing (x2)
5	5Q1-721-325-A	Mounting Pin
6	5Q0-721-170-A	Clip

- Install new mounting kit pieces <1> into new brake pedal <2>.
- Transfer rubber pad <3> from old brake pedal to new brake pedal.
- Install new bushings <4> onto brake pedal <2>.
- Install new brake pedal <2> in the reverse order of removal with a new mounting pin <5>:
 - Do not lubricate or grease the mounting pin.
 - Both bearing bushings must be located in the brake pedal bearing so that the brake pedal is securely guided into the mounting bracket.

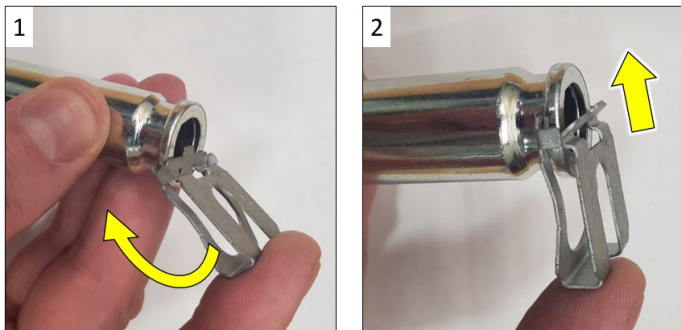
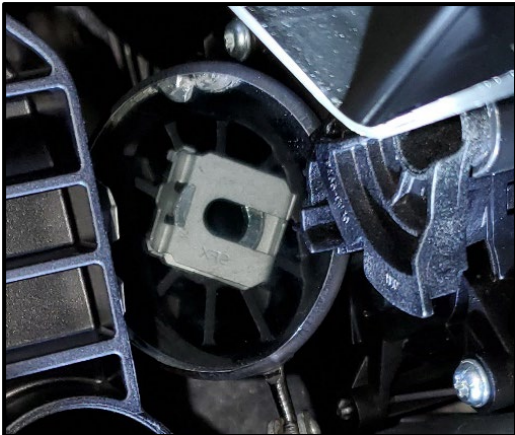
Install clip <6>:

- Pin shown removed for clarity.

- Place clip against the edge of the pin on a 45° angle.
- Keep pressure against the end of the clip and rotate the clip down in direction of <arrow>.

- Once clip is properly aligned, push clip in direction of <arrow> until it is fully seated.

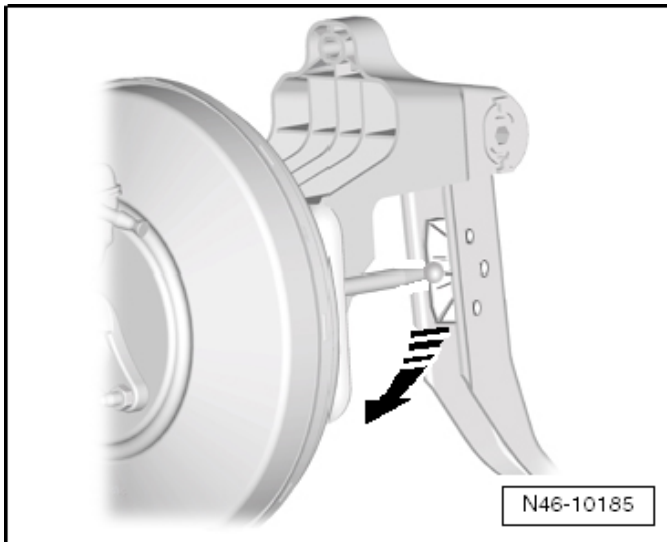
Attach brake pedal to brake booster pushrod:

- Hold the pushrod ball head in front of the mount and push the brake pedal toward the brake booster in direction of <arrow> until the ball head engages audibly.
