SERVICE BULLETIN

FIELD CAMPAIGN SERVICE BULLETIN #: SVC2023-107

BC1200XL Wheel and Tire Assembly Replacement Kit (IK003973)

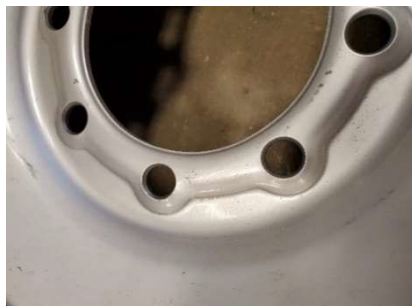
Specific wheels (steel rim) with 8-bolt pattern on 6½ inch (165 mm) circle to be used with 5/8" studs provided by a supplier:

- have an incorrect lug nut contact area causing wheel lug nuts to loosen; and/or can develop possible cracks causing the tire to lose air pressure.

**Defective Supplier Wheel
Improper Lug Nut Seat and
Potential Cracks**

Identified by continuously raised lug nut surface

IK003973 has been created to provide the necessary parts and instructions to inspect the wheels to identify **IF** it was equipped with supplier defective wheels. **This kit must be installed as soon as possible.**

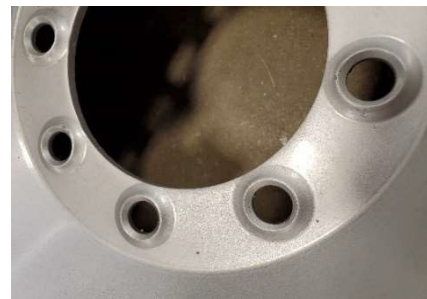
**Properly Manufactured Wheel
Correct Lug Nut Seat**

Identified by raised surface only around lug nut location

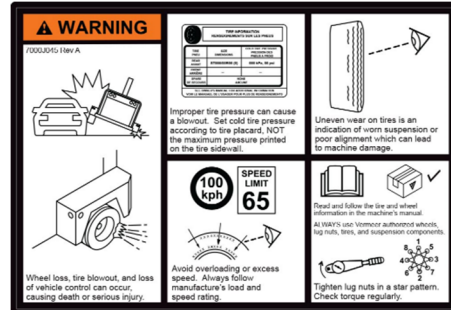
IK003973 contains a new safety sign (shown to the right) and updated operator's manual and maintenance manuals. No wheel/tire assembly is included in IK03- or IK04-3973. See sample owner letter #1 at end of this Bulletin. **This kit must be installed as soon as possible.**
