# SERVICE BULLETIN

FIELD CAMPAIGN SERVICE BULLETIN #: SVC2022-056

BC1800XL Wheel and  
Tire Assembly  
Replacement Kit  
(IK00-3942)

NHTSA SAFETY RECALL NUMBER 20V-085

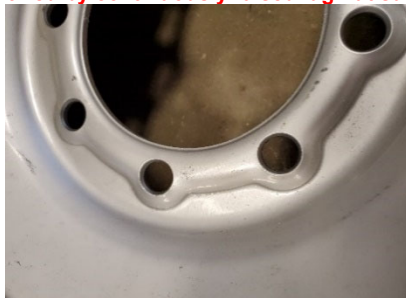
**Defective Supplier Wheel  
Improper Lug Nut Seat  
and Potential Cracks**  
Identified by continuously raised lug nut surface

Specific wheels (steel rim) with bolt pattern 8 on 6½ inch (165 mm) circle to be used with 5/8-in studs provided by a supplier:

- have an incorrect lug nut contact area causing wheel lug nuts to loosen; and/or

- can develop possible cracks causing the tire to lose air pressure.

Both conditions may increase the risk of wheel loss and the risk of a crash. **Death or serious injury** is possible. Property damage may also occur.

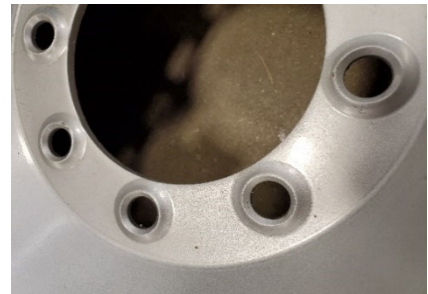
**Properly Manufactured Wheel  
Correct Lug Nut Seat**  
Identified by raised surface only around lug nut location
