R20AR

DATE: September 18, 2023
TO: Blue Bird Owners
Subject: R20AR – Air Conditioner Circuit Breaker Installation

SUBJECT: R20AR – Air Conditioner Circuit Breaker Installation

Issue: Air Conditioner 100-Amp Circuit Breakers May Have Been Installed Incorrectly

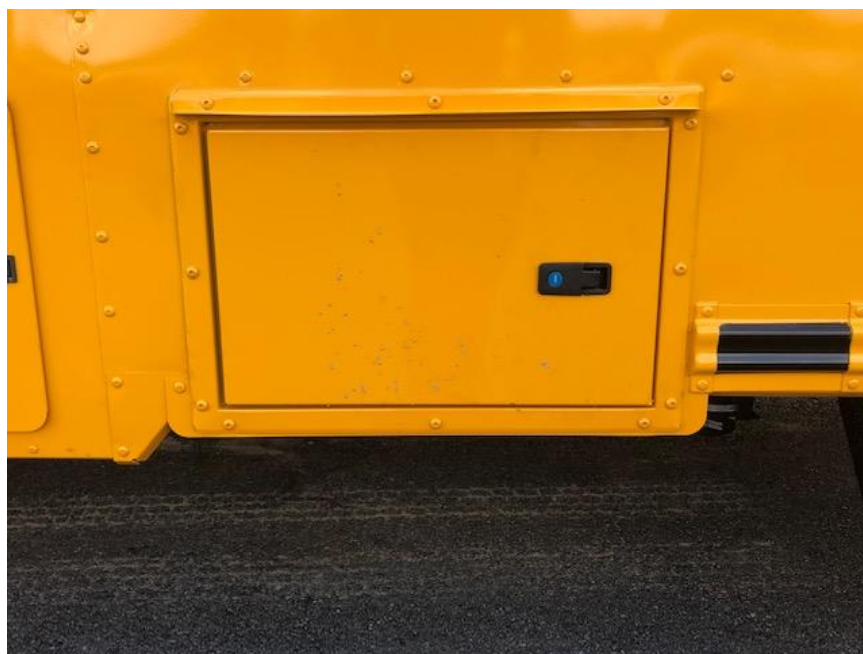
Compartment Door

1. Locate the 100-amp air conditioner circuit breakers. Note: The 100-amp breakers are identified on the decal that is located on the inside of the air conditioner electrical compartment cover.
 - a. For Vision and Front Engine All American, the circuit breakers are in the air conditioner electrical compartment which is on the left-hand skirt panel rear of the battery compartment.
