Product Safety Recall

N192290990 Front Passenger Air Bag Inflator – US Only

Release Date: January 2020

Condition	TK Global LLC ("Takata") has decided that a defect which relates to motor vehicle safety exists in certain 2007-2008 model year Chevrolet Silverado and GMC Sierra 2500/3500 series heavy duty pickup trucks. Takata has determined that some of the front passenger air bag inflators in these vehicles may experience an alteration over time, which could lead to overaggressive combustion in the event of an air bag deployment. This condition could create excessive internal pressure when the air bag is deployed, which could result in the body of the inflator rupturing upon deployment. In the event of an inflator rupture, metal fragments could pass through the air bag cushion material, which may result in injury or death to vehicle occupants.
Correction	Dealers will replace the front passenger air bag inflator module.

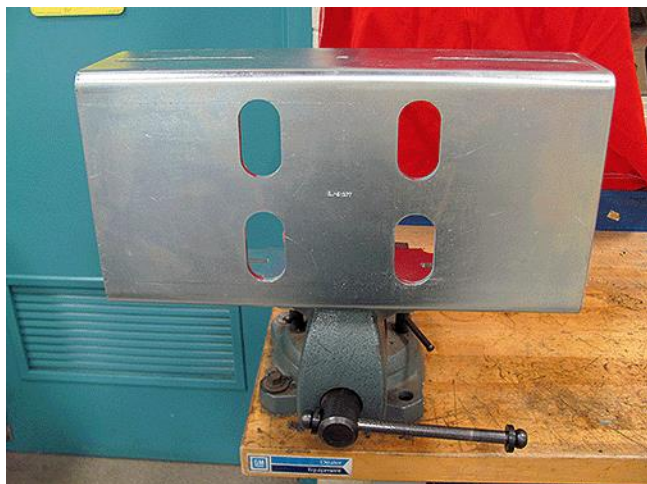
4664047

1. Mount the air bag module bracket securely in a vice.

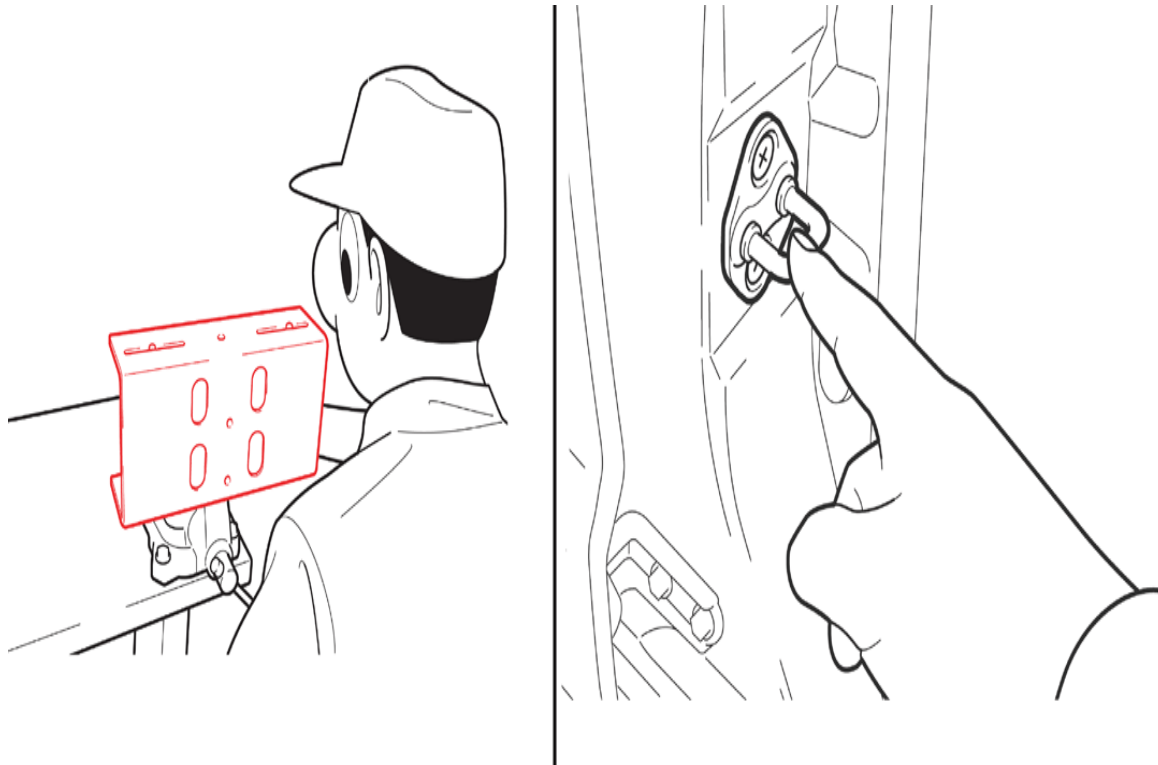
3607909

Danger: To avoid personal injury, **ALWAYS** keep as much of your body as possible in front of the bracket when working on the air bag assembly. Remember to periodically touch a metallic part of the vehicle or work bench to discharge static electricity in the body. **DO NOT** use power tools when performing the inflator removal/reinstallation steps.

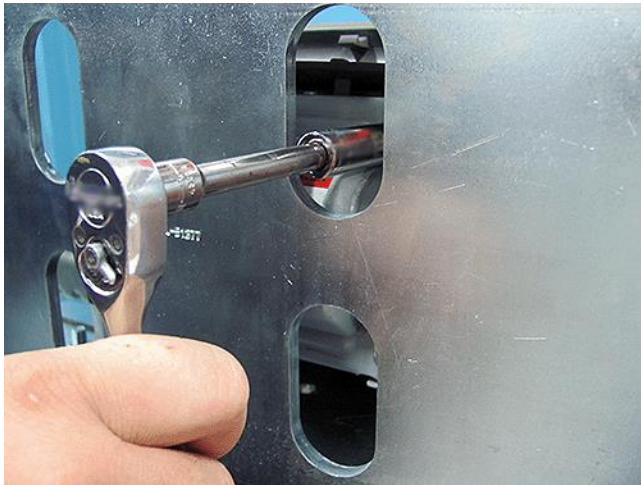
4664052

7. Use the access holes in the bracket to loosen and remove the four self-locking nuts. Discard the nuts, they will not be reused.
8. Remove the two stopper plates.

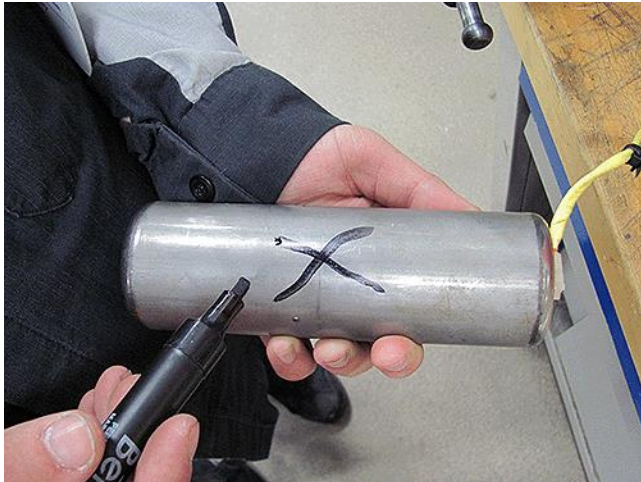
4664063

12. Put a mark on the removed inflator and store it in the provided replacement part box. Refer to the packaging instructions that were included with the new inflator module kit.

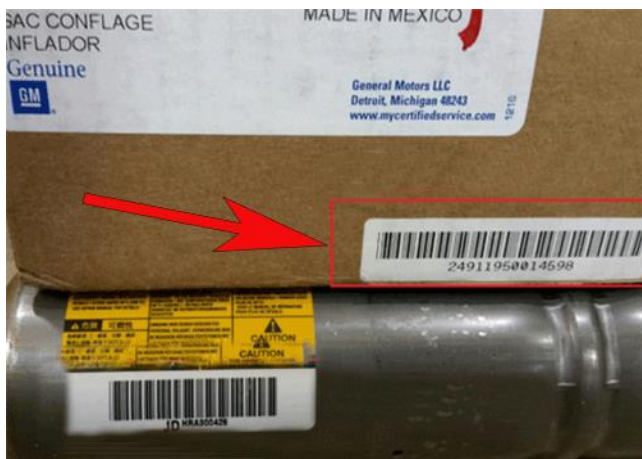
4664074

13. Record the serial number from the service inflator kit on the repair order.

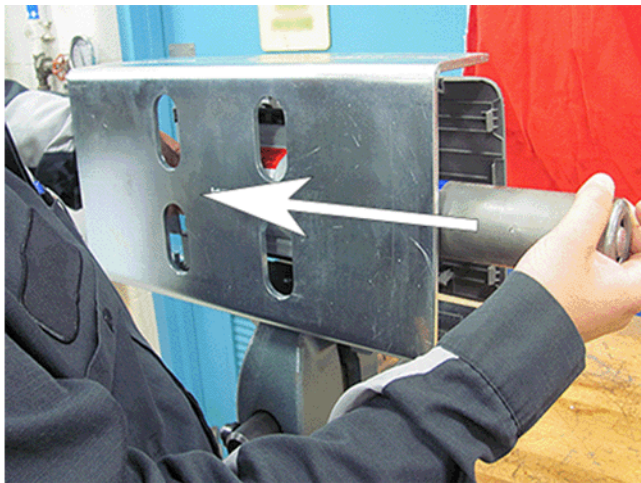
4664064

14. Carefully slide the new inflator into the air bag assembly. Ensure the inflator is installed with the harness end first.
