# SERVICE BULLETIN

SVC2020-096

**BC1800XL Wheel and  
Tire Assembly  
Replacement Kit  
(IK00-3942)**

**Defective Supplier Wheel  
Improper Lug Nut Seat  
and Potential Cracks**

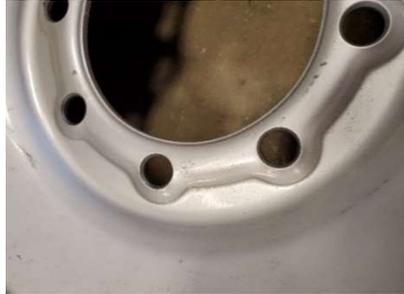
Identified by continuously raised lug nut surface

- have an incorrect lug nut contact area causing wheel lug nuts to loosen; and/or
- can develop possible cracks causing the tire to lose air pressure.

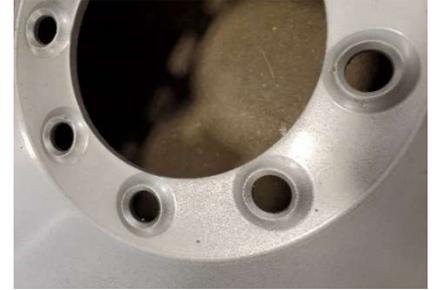
**Properly Manufactured Wheel  
Correct Lug Nut Seat**

Identified by raised surface only around lug nut location

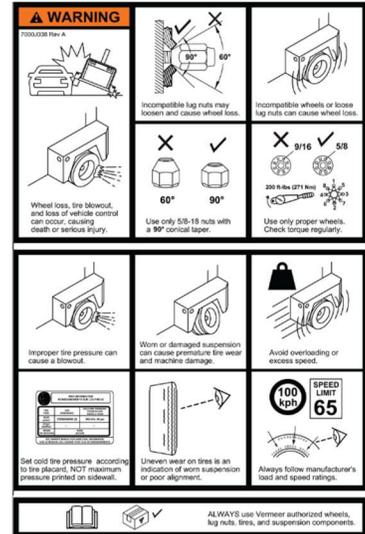
IK00-3942 has been created to provide the necessary parts and instructions to replace the wheel and tire assembly, install a new safety sign (shown at right), install a new wheel/tire specification placard and provide a Supplemental Operator's and Maintenance Manual.

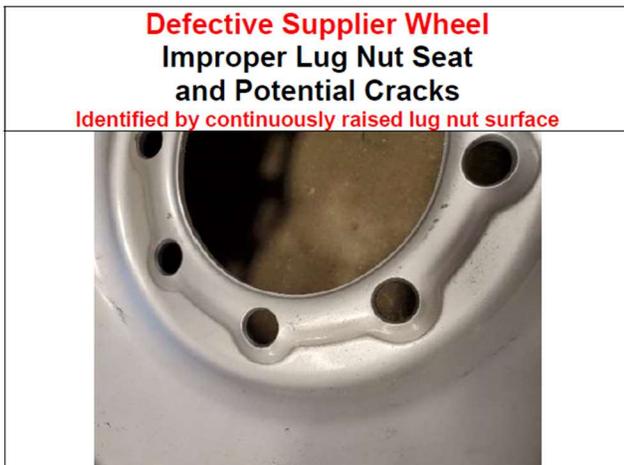
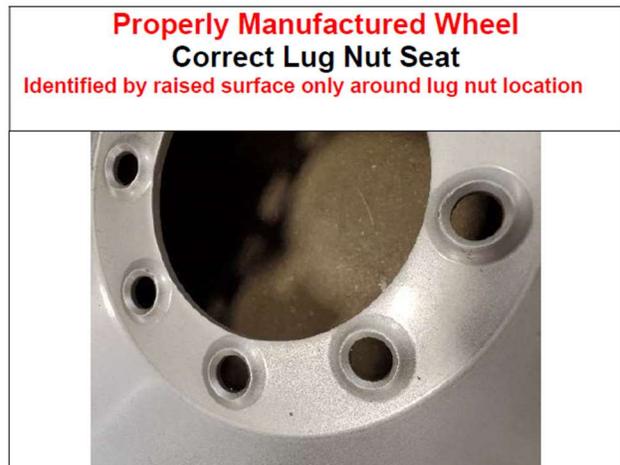
Certain brush chippers with specific wheels (steel rim) with bolt pattern 8 on 6½ inch (165 mm) circle to be used with 5/8-inch studs provided by a supplier:

- have an incorrect lug nut contact area causing the wheel lug nuts to loosen; and/or
- can develop possible cracks causing the tire to lose air pressure.

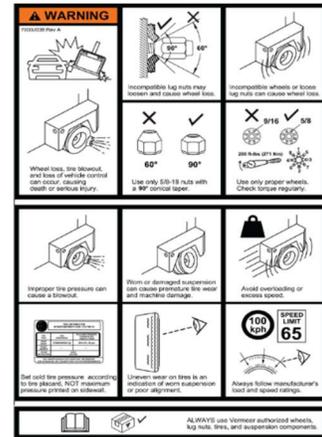
IK00-3942 has been created to provide the necessary parts and instructions to replace the wheel and tire assembly, install a new safety sign (shown below), and provide a Supplemental Operator's and Maintenance Manual. **This kit must be installed as soon as possible.** If your dealer did not install the temporary wheel solution, prior to having this field remedy kit installed, please continue to **verify the torque** of each lug nut [210 ft-lb (285 Nm)] and **tire pressure** [80 psi (550 kPa)] as **part of your pre-trip inspection every day** or at a minimum every 150 miles (250 km) until IK00-3942: Wheel and Tire Assembly Replacement Kit is installed by your dealer.

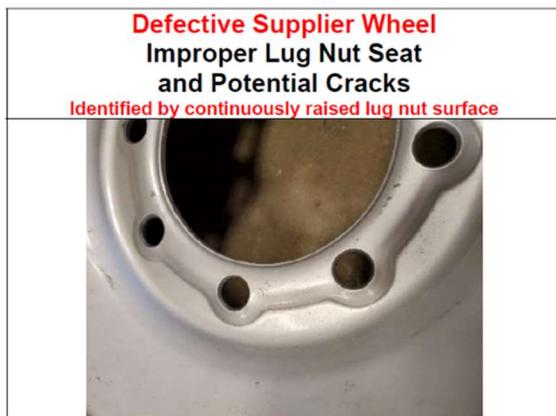
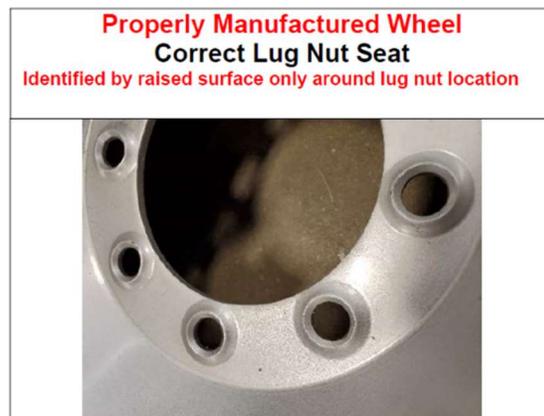
Certain brush chippers with specific wheels (steel rim) with bolt pattern 8 on 6½ inch (165 mm) circle to be used with 5/8-inch studs provided by a supplier:

- have an incorrect lug nut contact area causing the wheel lug nuts to loosen; and/or
- can develop possible cracks causing the tire to lose air pressure.

1. **WHEEL AND LUG NUT INSPECTION.** **Inspect** each brush chipper wheel by referencing the photos to identify if defective supplier wheels are installed. If you own more than one affected brush chipper, you will receive a letter for each machine. The Model and VIN is shown on the top right of this letter and the Wheel

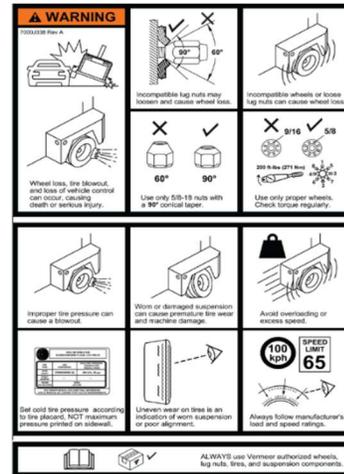
3. **Has defective supplier wheels, contact your local Vermeer Dealer for new wheel and tire assembly.** IK00-3942 has been created to provide the necessary parts and instructions to replace the wheel and tire assembly, install a new safety sign (shown below), install a new wheel/tire specification placard decal and provide a Supplemental Operator's and Maintenance Manual. **This kit must be installed as soon as possible.**

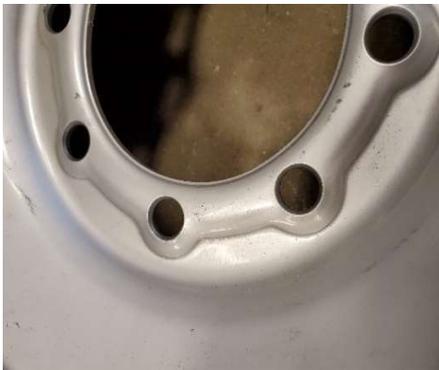
### Defective Supplier Wheel

**Improper Lug Nut Seat  
and Potential Cracks**

Identified by continuously raised lug nut surface

If **defective wheels are installed** (left photo above),

- 1) Contact your local Vermeer dealer immediately to arrange installation of IK00-3942 Wheel and Tire Assembly Replacement Kit.
- 2) Prior to having this field remedy kit installed,
  - a) **If one or more lug nut is missing or loose**, using a calibrated torque wrench, torque to 210 ft-lb (285 Nm).
  - b) **Tire Pressure.** If their pressure is not at 80 psi (550 kPa), the wheel may have a crack. The crack may not be visible
  - c) **Verify torque** on each lug nut [210 ft-lb (285 Nm)] and **tire pressure** [80 psi (550 kPa)] **as part of your pre-trip inspection every day or at a minimum every 150 miles (250 km)** until IK00-3942: Wheel and Tire Assembly Replacement Kit is installed by your Vermeer dealer.
- 3) **Do not** tow the brush chipper without all lug nuts properly installed or with low tire pressure.

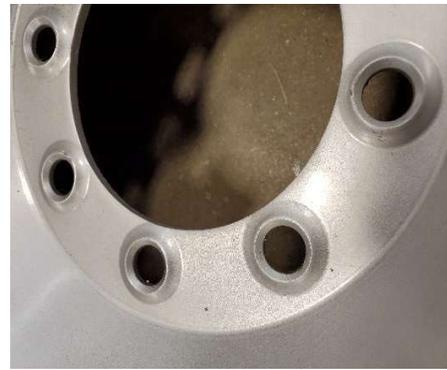
### Properly Manufactured Wheel

**Correct Lug Nut Seat**

Identified by raised surface only around lug nut location

If **properly manufactured wheels are installed** (right photo on above), take photos of **each** wheel, **complete and return Page 2 of this Wheel and Lug Nut Inspection form and photos** to: [safetyform@vermeer.com](mailto:safetyform@vermeer.com). Vermeer Corporation will record in its records that your brush chipper is not affected by this product safety recall and mail a Vermeer Parts Certificate for \$50.00 USD redeemable at your local Vermeer dealer.
