SERVICE BULLETIN

| FIELD CAMPA | - | SVC2021-024 | DATE: | 14 January 2021 |

BC1000XL Wheel and Lug Nut Inspection

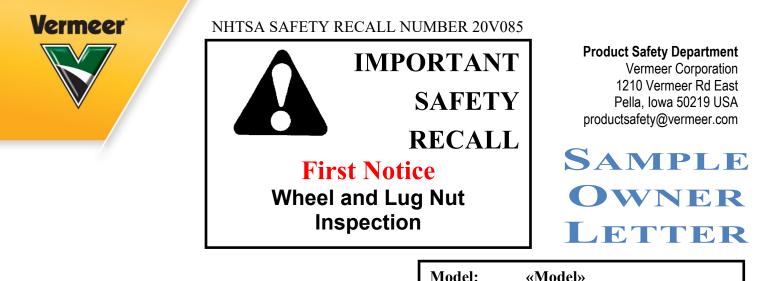
Beginning in August 2016 through early February 2020, specific wheels (steel rim) with **bolt pattern 8 on 61**/₂ **inch (165.1 mm) circle to be used with 5/8**" studs provided by a supplier:

- have an incorrect lug nut contact area, causing wheel lug nuts to loosen; and/or
- can develop possible cracks, causing the tire to lose air pressure.

Defective Supplier Wheel Improper Lug Nut Seat and Potential Cracks Identified by continuously raised lug nut surface

Properly Manufactured Wheel Correct Lug Nut Seat Identified by raised surface around lug nut location only

- 3) **Install kits.** Each of the brush chippers affected by this product safety recall will require the installation of one of the following kits:
 - a) IK00-3940: BC1000XL Wheel and Tire Assembly Replacement Kit if supplier defective "bad" wheels are installed
 - b) IK00-3961: Brush Chipper Wheel and Tire Information Update Kit if properly manufactured "good" wheels are installed

- iii) Check lug nut torque and tire pressure every day or at a minimum every 150 miles (250 km) until the Vermeer dealer has installed IK00-3940 kit remedy.

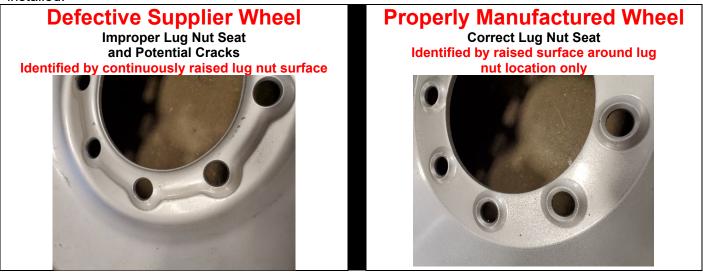
Using photos below, **inspect** <u>each</u> brush chipper wheel to determine if defective supplier wheels are installed.

If defective wheels are installed (left photo above):

If properly manufactured wheels are installed (right photo above),

- 2) **Contact your Vermeer dealer** to arrange for IK00-3940: BC1000XL Wheel and Tire Assembly Replacement Kit to be installed. This kit will be installed free of charge (parts and labor).

- Inspect each brush chipper wheel for these possible conditions until IK00-3940 is installed:
 a. If one or more lug nut is missing or loose, using a calibrated torgue wrench, torgue to 210 ft-

- **Ib (285 Nm)**. If torque value cannot be obtained, contact your local Vermeer dealer.
 - b. If tire pressure is not at 80 psi (550 kPa), the wheel may have a crack. The crack may or may not be visible. If the tire pressure cannot be maintained, contact your local Vermeer dealer.

- c. Verify the torque on each lug nut [210 ft-lb (285 Nm)] and tire pressure [80 psi (550 kPa)] as part of your pre-trip inspection every day or at a minimum every 150 miles (250 km) until IK00-3940 has been installed by your Vermeer dealer.

- d. **DO NOT** tow the brush chipper without all lug nuts properly installed or low tire pressure.

- 1) **Take photos** of <u>each</u> wheel <u>and</u> complete enclosed Wheel and Lug Nut Inspection Form. Email photos and form to: <u>safetyform@vermeer.com</u>.
- 2) **Contact your Vermeer dealer** to arrange for installation of IK00-3961: Brush Chipper Wheel and Tire Information Update Kit. This kit will be installed free of charge (parts and labor).
