# **Federal Recall Information**

20PBE

Watson Chalin Lift Axle Pivot Bolts - NHTSA: 20V506 / TC: 2020-399

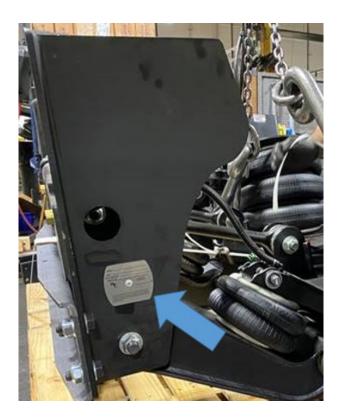
Figure 1

- 1. Review the attached Pivot Bolt Inspection Procedure.
- 2. If the thread engagement of the pivot bolts does not meet the requirements as described in the Pivot Bolt Inspection Procedure, follow the procedure in the attached Pivot Bolt Replacement Procedure.
- 3. It is required that the following are attached to the claim:
  - A clear photo showing the bolt and the nut with insufficient thread engagement.
  - The model of the truck.
  - The serial number for the axle see serial number location in Figure 1.
