# Product Safety Recall

## N202313440 Transmission Accumulator Bolts Missing (Inspection Only)

**Release Date:** October 2020

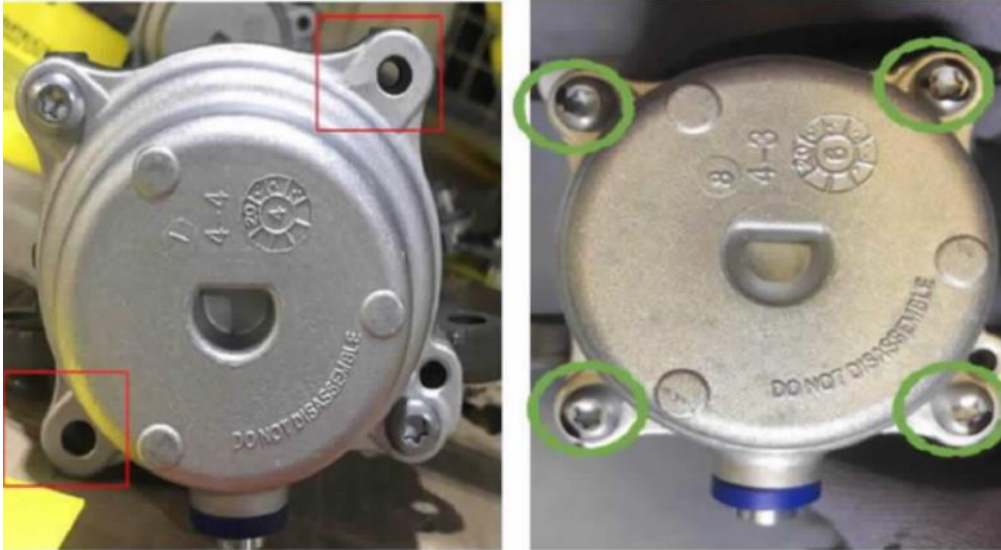
5666156

**Note:** The purpose of this service procedure is to inspect for the presence of missing bolts in the Transmission Auxiliary Fluid Accumulator Cover, an example of which is shown above.

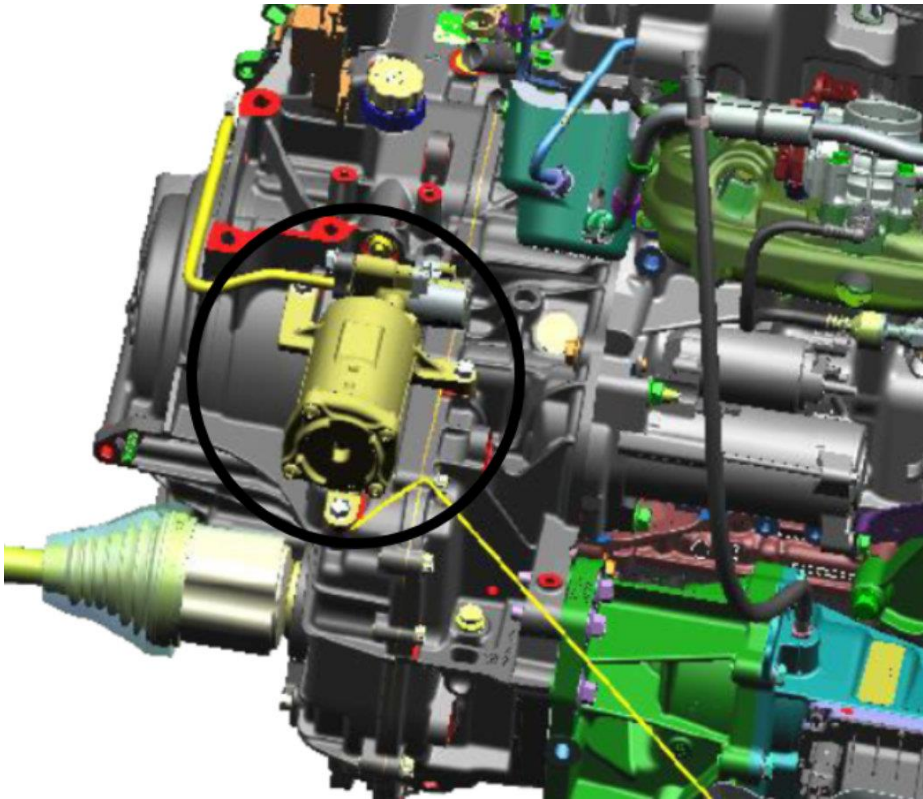
5666157

2. Looking straight up around the rear of the transmission, identify the transmission auxiliary fluid accumulator.

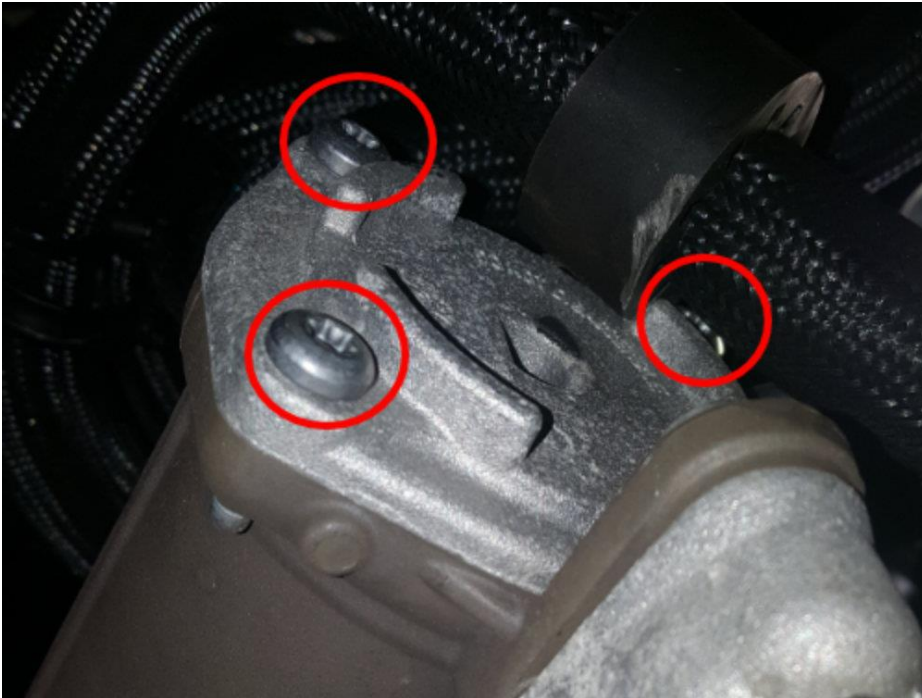
5666158

3. Visually inspect for the presence of the three bolts shown above.
4. Using your hand, feel for the presence of the bottom right bolt in the cover.
  - If NONE of the four cover bolts are missing, no further action is required.
  - If ANY of the four cover bolts are missing, hold the vehicle for future repair.

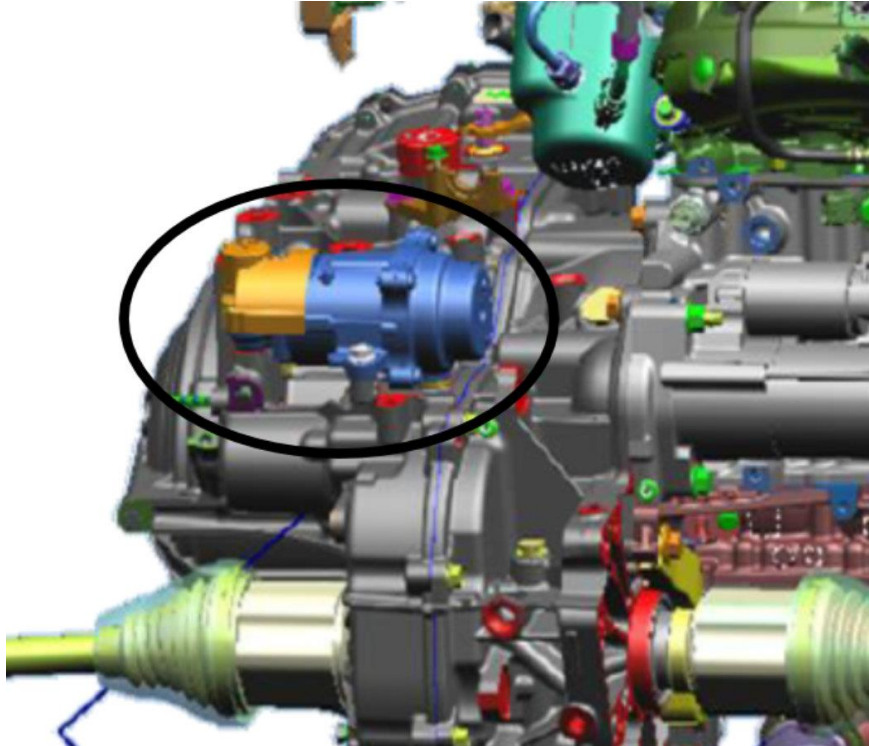
5666159

2. Looking up above the driver's side wheel drive shaft, locate the transmission auxiliary fluid accumulator.

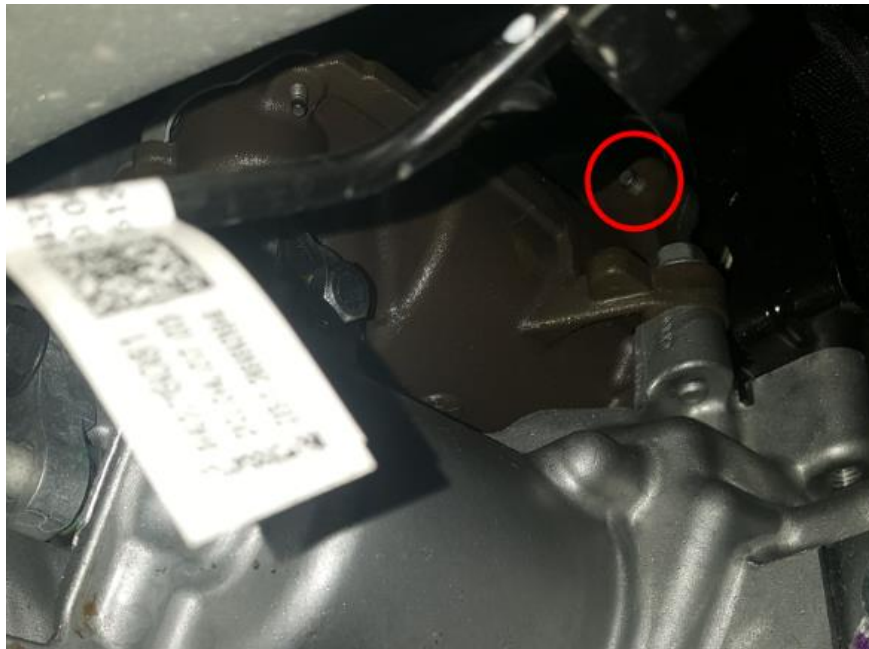
5666160

3. Visually verify the first bolt (circled above) is installed. You will be looking for the threads protruding from the transmission fluid accumulator housing for these vehicles to verify the bolt is installed.

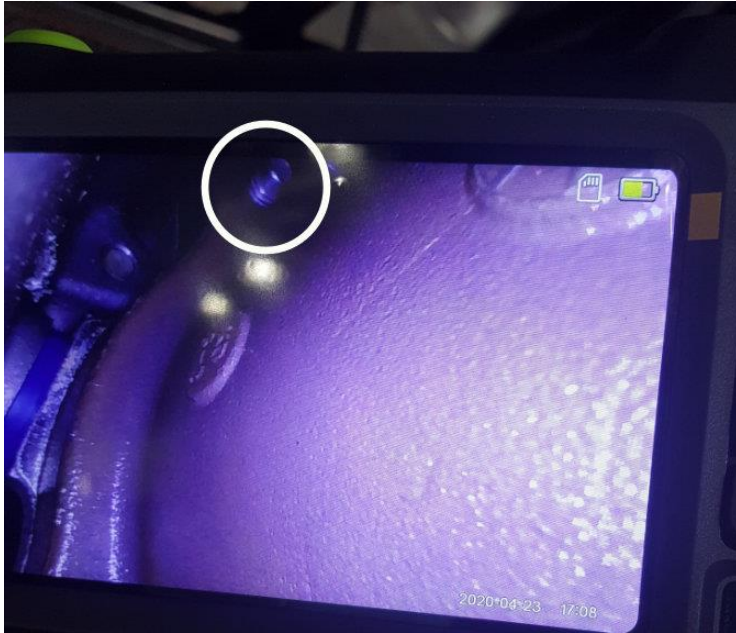
5666161

- Using a borescope, visually verify the next three bolts are installed.

- Top left.

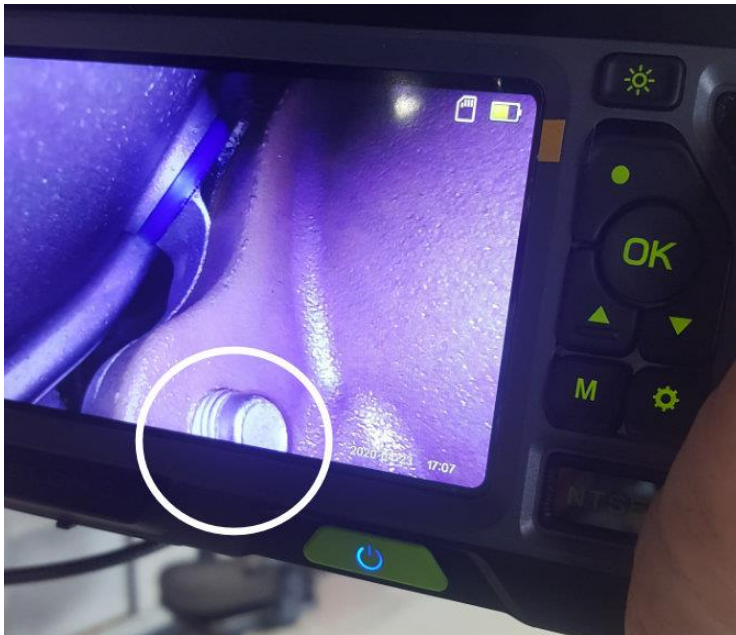
5666162

- Bottom left.

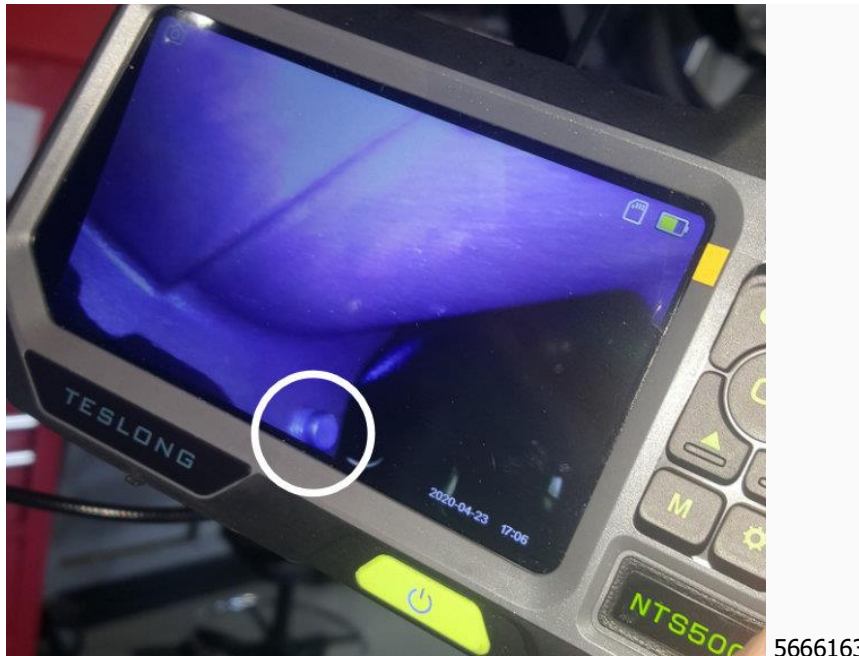
5666163

7. Bottom right.
  - If NONE of the four cover bolts are missing, no further action is required.
  - If ANY of the four cover bolts are missing, hold the vehicle for future repair.
8. Lower the vehicle. Refer to *Lifting and Jacking the Vehicle* in SI.
