SAFETY RECALL

VOLVO Trucks North America
Greensboro, NC USA

Date	Number	Page
09/20	RVXX2004	1 (9)

Pedal Carrier Date Code Inspection

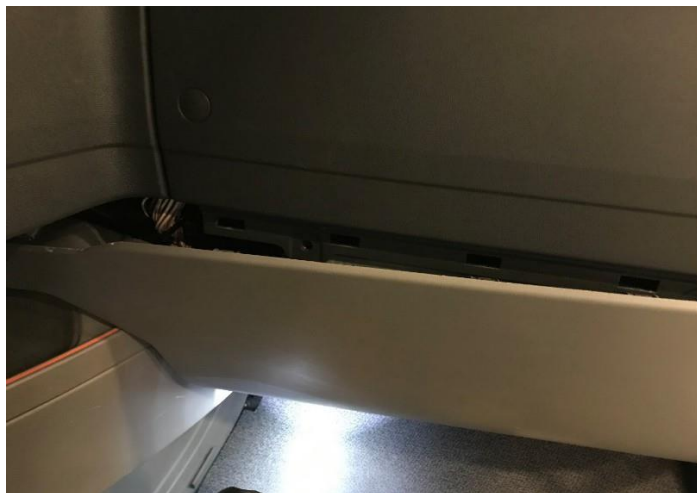
10. Pull back the passenger side panel to gain access for the center panel.

11. Remove the screws.

12. Remove the panel.

Note: Use caution not to damage the panel.

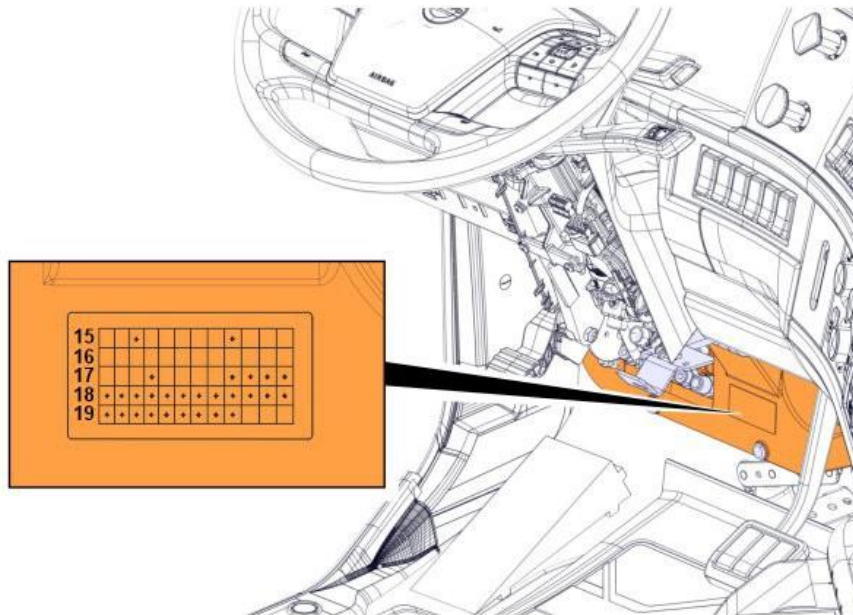
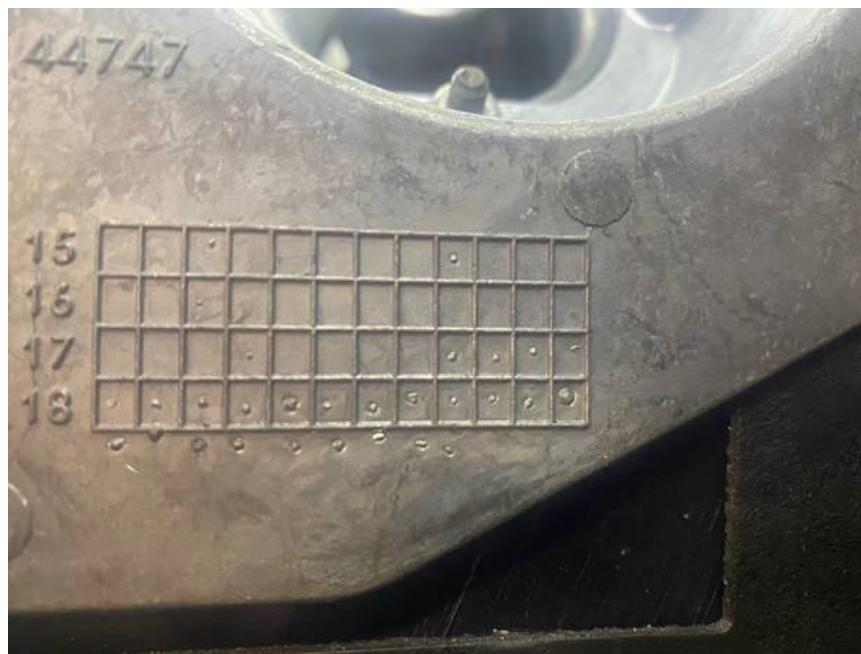
23. Check the date code on the pedal carrier.

Note: A) Find the row which indicates the year.

For example: the row under 18 is 19 and indicates year 2019.

B) Count the number of dots or the position of the dots.

For example: One dot in the first position is January.

Photo shows an example of September, 2019 date code

24. If the date code shows 9 or 10 dots in row 19 this indicates September, 2019 or October, 2019. Then continue to the Test Procedure next.

25. If date code IS **NOT** 9 or 10 dots, then return the truck to service and file claim as Part "A".

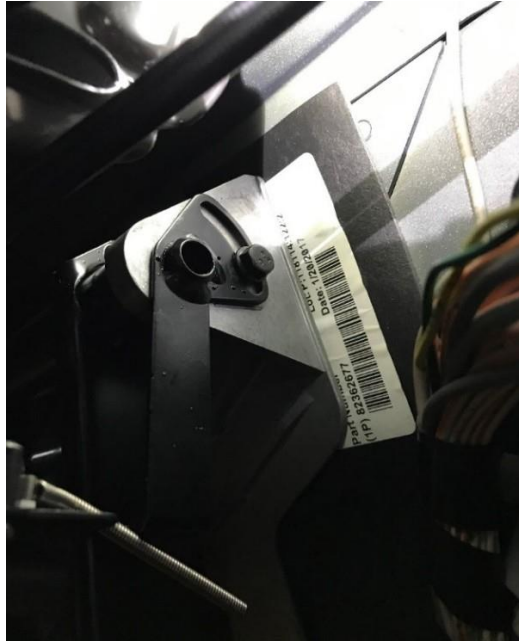
1. Start the vehicle and allow air pressure to build to 120 psi or connect to shop air.
2. Perform 12 simulated emergency stops.
3. Mark the position of the brake switch using the side of the bracket, allowing you to return to original setting.

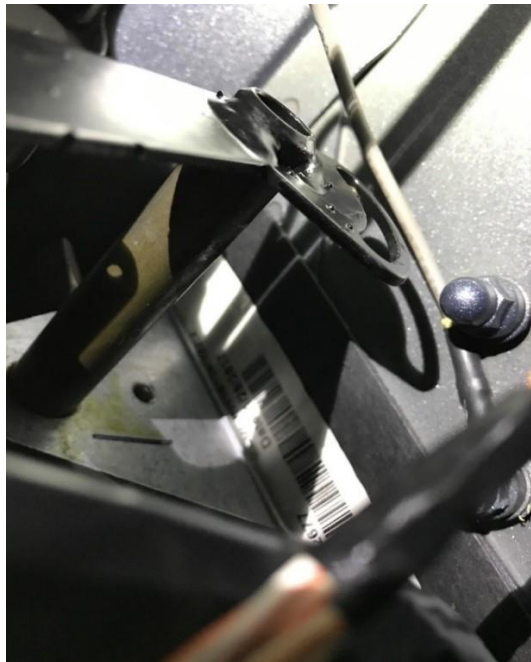
4. Remove the bolt.
5. Pull the brake pedal shaft out enough to inspect casting.

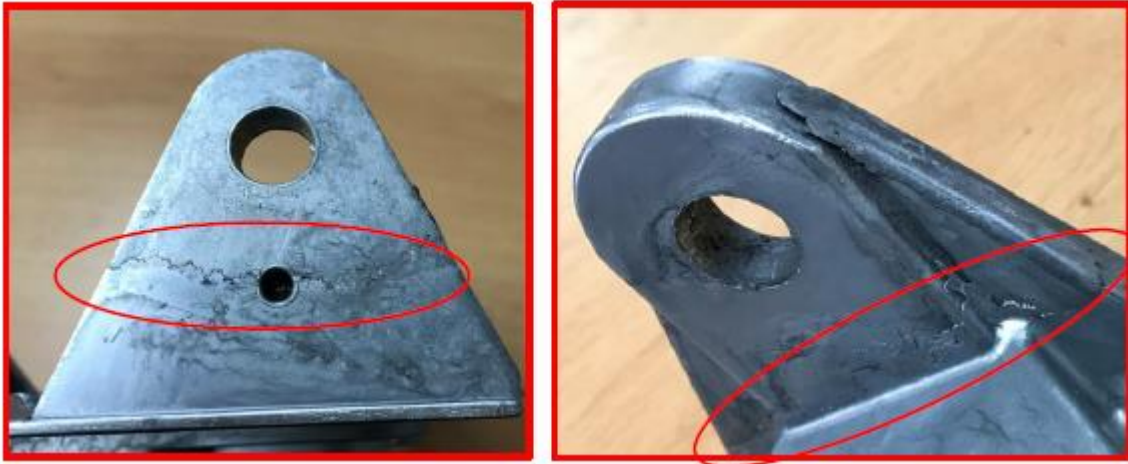
Figure 1

6. From the driver's perspective; thoroughly inspect both sides of the right most ear for possible defects. The defects seem to resemble a crack with some discoloration. Use examples below to determine defective parts See Fig. 1 and Fig. 2 (circled line/cracks show the signs of defective parts)

7. Before continuing, create an ARGUS case with RVXX2004 in the Summary field, choose Reliability in the App/Service field and add photos of the right most, mounting ear from both sides of the ear. In the Description field indicate whether the Pedal Carrier Plate was replaced or there were no defects found.
8. If defects are found, then continue to the Repair Procedure next.
9. If defects are **NOT** found then return truck to service and file claim as Part "A" + Part "B".
