TO: Mercedes-Benz Dealer Principals, General Managers, Sales Managers,	FROM: Gregory Gunther, Department Manager, Vehicle	
Service Managers, Parts Managers	Compliance and Analysis, Engineering Services	
RE: Recall Campaign Notification – Wave 2		
Replace Front Stationary Sunroof Panel	Datas Ostabar 15, 2021	
MY14-20 117,156, 205, 222, and 253 (C-Class, CLA-Class, GLA-	Date: October 15, 2021	
Class, GLC-Class, GLE-Class, and S-Class)

Recall Campaign Bulletin

Campaign No.2021070010, August 2021 Revision A 09/03/2021

Replace Front Stationary Sunroof Panel

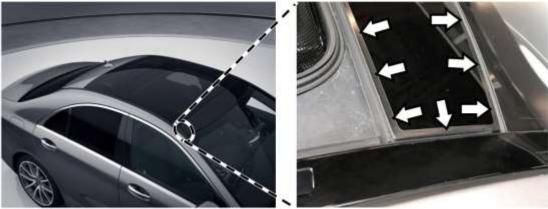
Figure 1

Fixed panel (Figure 1) made from glass.⇒no repair needed
 I The fixed panel made from glass is foam-padded, the padding (arrows, Figure 1) is visible at the edge.

- a. The fixed panel is made from polycarbonate: Perform work procedure.b. The fixed panel is made from glass: End measure.

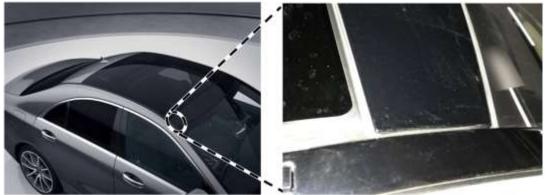
Figure 2

2. Fixed panel (Figure 2) made from polycarbonate (PC). repair is needed **i** The fixed panel made from polycarbonate is **<u>not</u>** foam-padded.
