**SUBJECT: NEW VEHICLE DEMONSTRATION / DELIVERY HOLD
 Safety Recall 21S24 – Supplement #1**
 Certain 2013 through 2022 Model Year Transit Connect Vehicles Equipped with a
 2.5L Engine and 6F35 Transmission
 Shifter Cable Bushing Replacement and Protective Cap

**REF: NEW VEHICLE DEMONSTRATION / DELIVERY HOLD
 Safety Recall 21S24**
 Dated May 25, 2021

CERTAIN 2013-2021 MODEL YEAR TRANSIT CONNECT EQUIPPED WITH A 2.5L ENGINE AND A 6F35 TRANSMISSION — SHIFTER CABLE BUSHING REPLACEMENT AND PROTECTIVE CAP

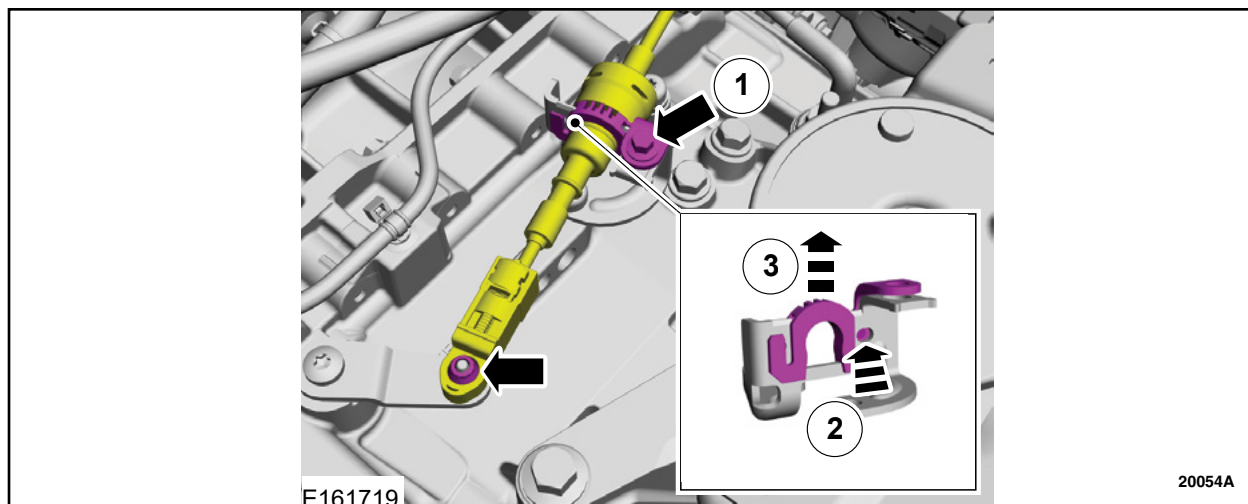
FIGURE 1

1. Apply the parking brake, chock wheels to make sure vehicle does not roll.
2. Position the gear shift lever in Drive (D).
3. Remove the air cleaner assembly. Please follow the Workshop Manual (WSM) procedures in Section 303-12.
4. Remove the air cleaner outlet pipe. Please follow the Workshop Manual (WSM) procedures in Section 303-12.
5. Disconnect the selector lever cable from the transmission manual lever and the bracket. See Figure 1.
 1. Remove the selector lever cable bracket bolt.
 2. Disengage the selector lever cable holding clip.
 - Use caution when removing hold down bracket to avoid damage. Hold down bracket is available separate of shift cable.
 3. Disconnect the selector lever cable.
 - Torque to 62 lb.in (7 Nm).

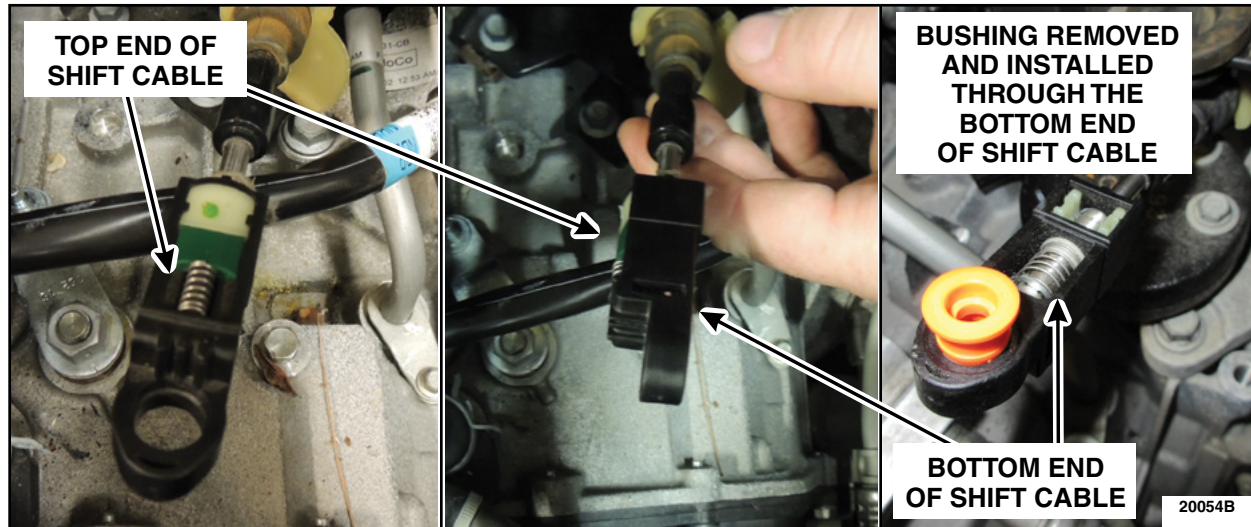
FIGURE 2

NOTE: Selector Lever Cable Bushing Replacement/Orientation. See Figure 2.

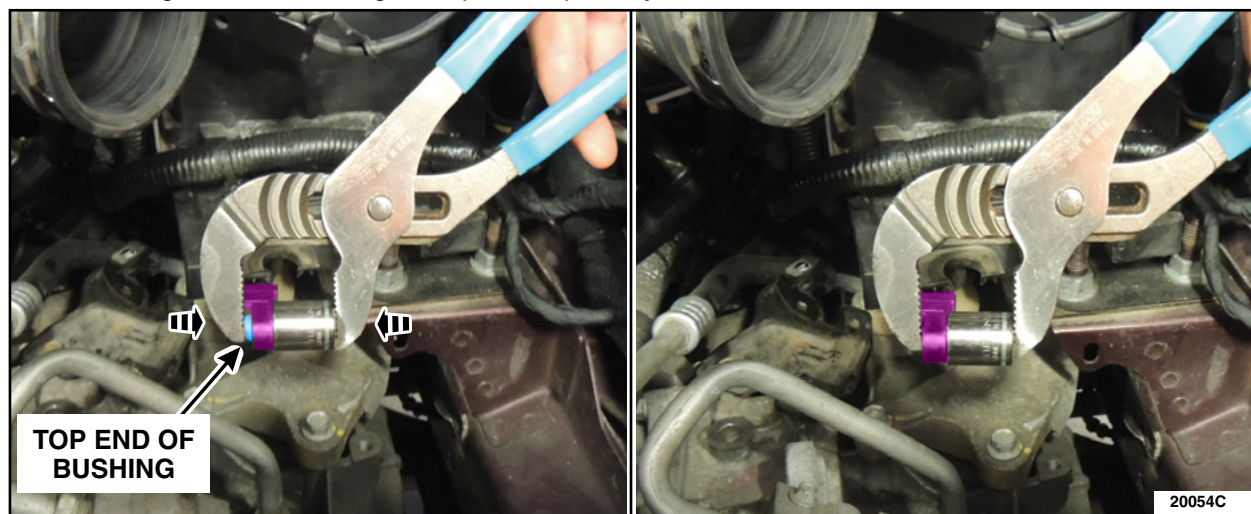
FIGURE 3

6. Using a pair of Straight Jaw Adjustable pliers and a 15mm shallow socket push the bushing partially out of the selector lever cable end. See Figure 3.

NOTE: For all 2013 Transit Connect vehicles equipped with original shift cable, the bushing maybe taller than the replacement bushing.

NOTE: The 15mm socket will rest against the hard plastic bottom end of shift cable, and will be large enough to allow bushing to be pressed partially out.

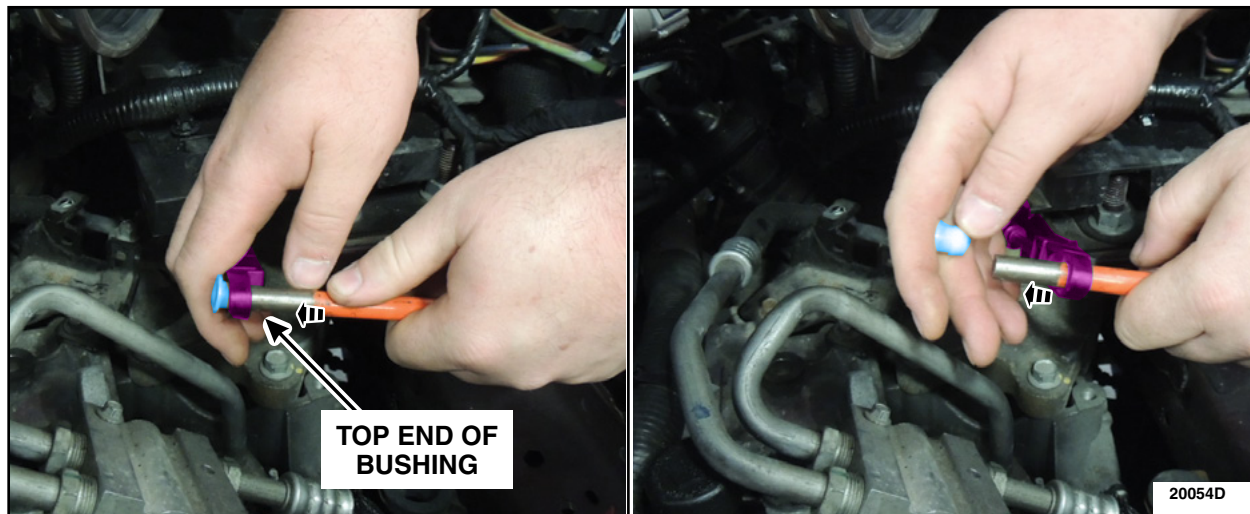
FIGURE 4

7. Turn the selector lever cable end over and using a punch push the bushing the rest of the way out of the selector lever cable end. See Figure 4. Proceed to Step 9.

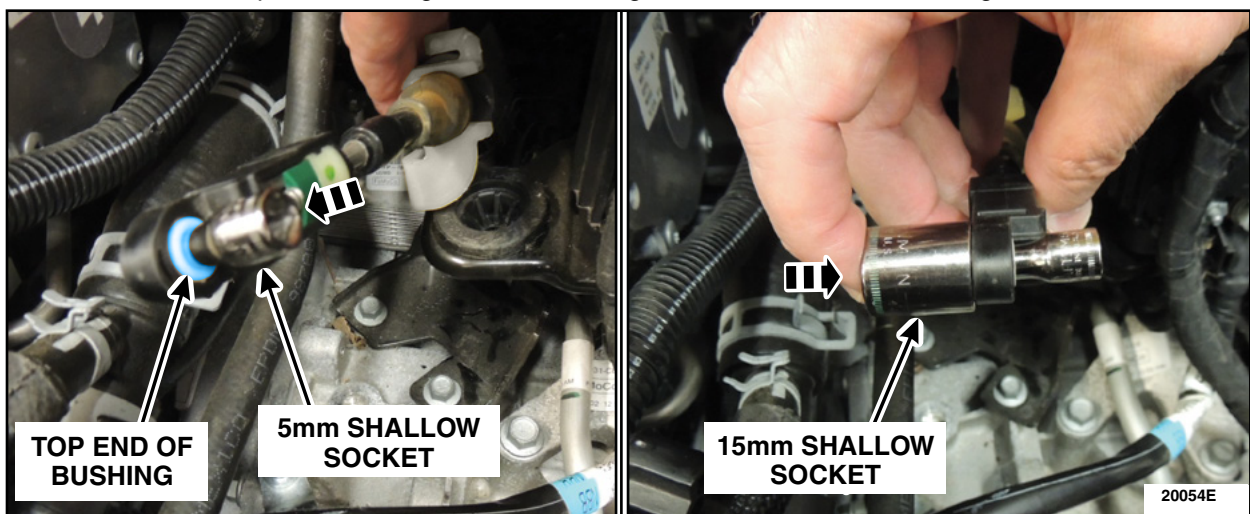
FIGURE 5

8. Press out the shifter cable bushing using one of the two methods below.
- Using a 5mm and a 15mm socket with Straight Jaw Adjustable pliers the bushing can be pressed out of the shifter cable end. The 5mm socket will fit into the small part of the bushing on top, the 15mm will go against the bottom of the shifter cable end, make sure to have socket centered with the bushing to allow clearance of the bushing shoulder as it is being pressed out. See Figures 5 and 6.
 - Using a tool such as a Lisle 38350 - Exhaust Hanger Removal plier to press bushing out. By viewing Figure 7 the shoulder of bushing is positioned upward, small end of plier is pressing bushing out. Proceed to Step 9.
- Use caution not to damage the shifter cable during this procedure.
 - Inspect for damage before installing the new shifter cable bushing.

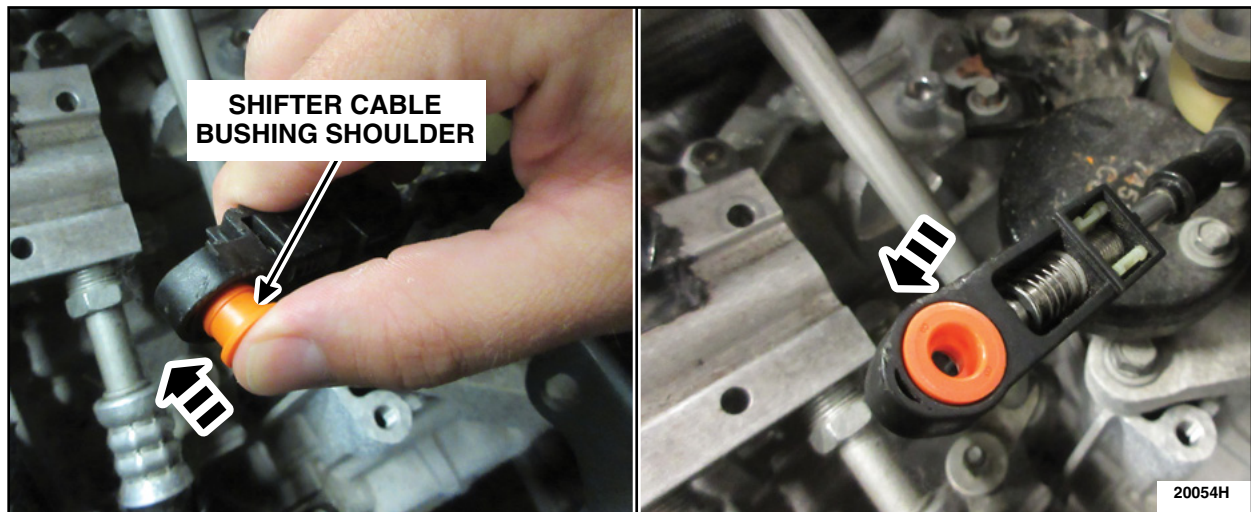
FIGURE 8

9. Using your hands only, install the new selector lever cable bushing. Do not use any grease to install, the bushing and cable end should be dry. See Figure 8.

- Visually check shifter cable end for any signs of damage. If damage to the shifter cable end is found, please call the Special Service Support Center (SSSC).

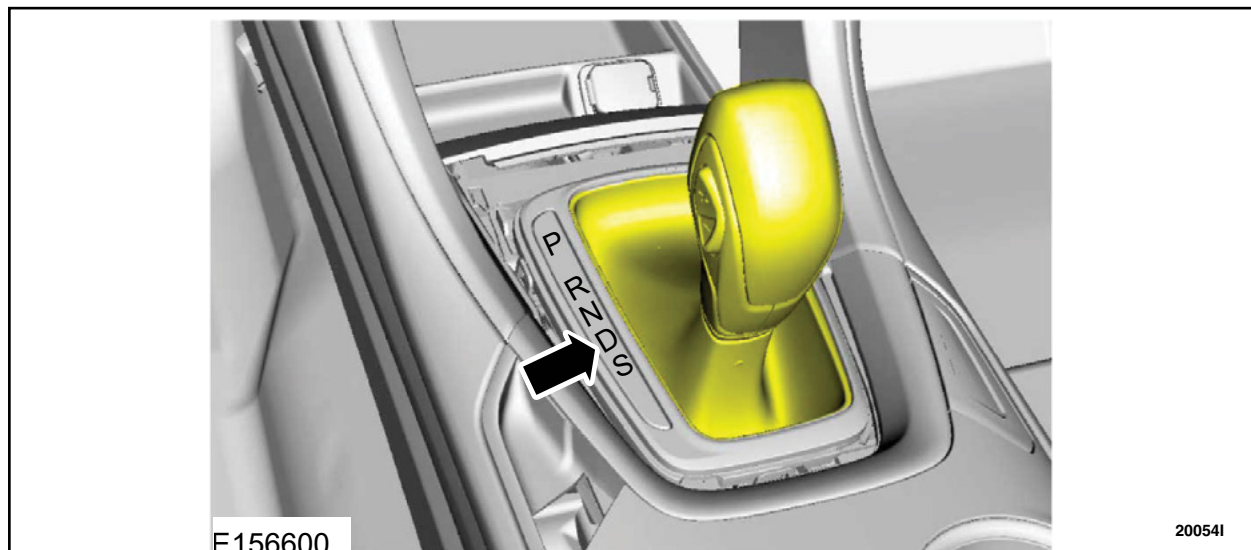
FIGURE 9

10. The vehicle's transmission gear selector lever should be in Drive position from Step 2, if not, position the selector lever to Drive (D). See Figure 9.

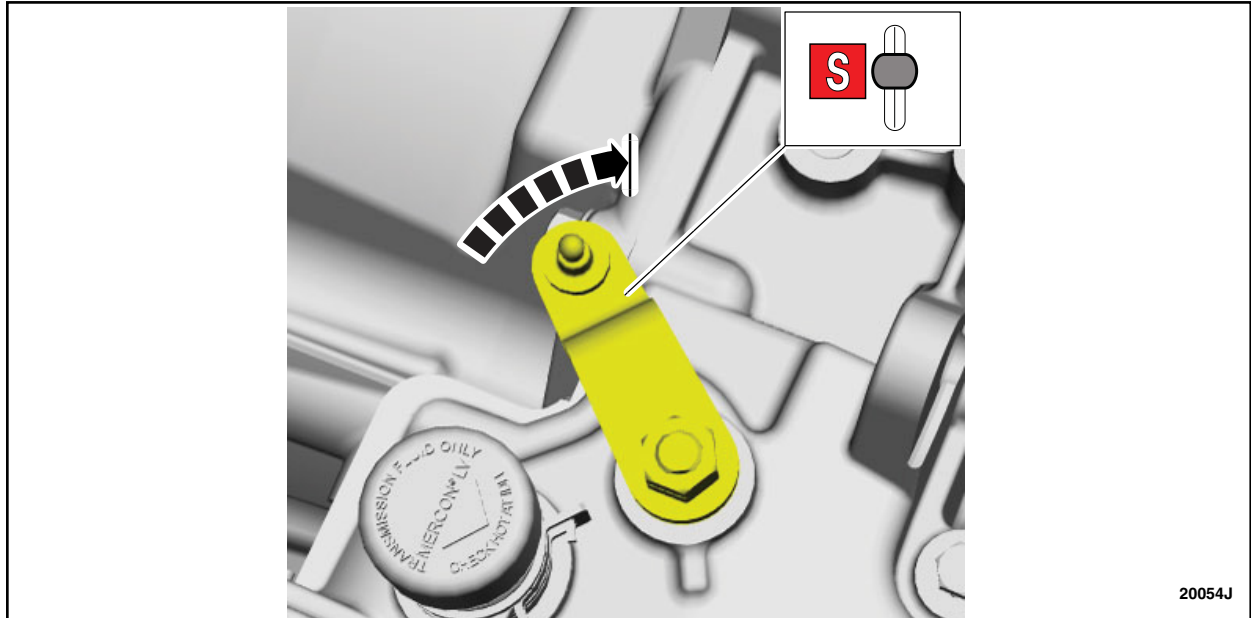
FIGURE 10

11. Rotate the manual control lever clockwise until it stops. See Figure 10.

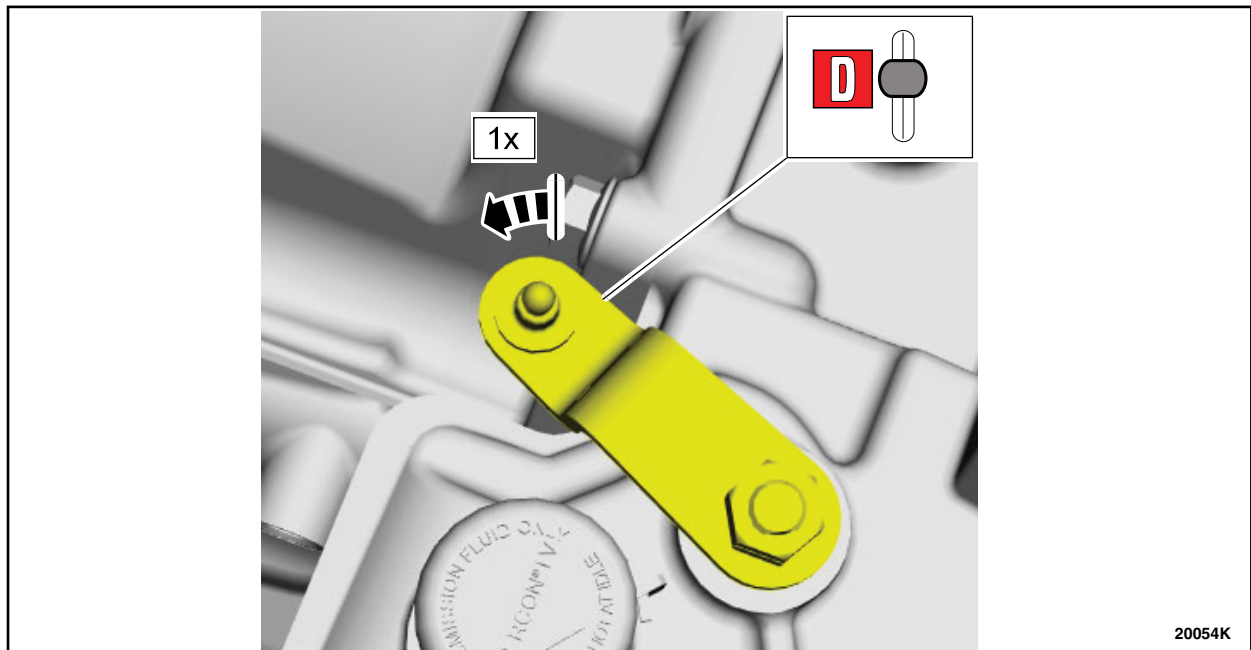
FIGURE 11

12. Rotate the manual control lever counterclockwise 1 detent into Drive (D). See Figure 11.

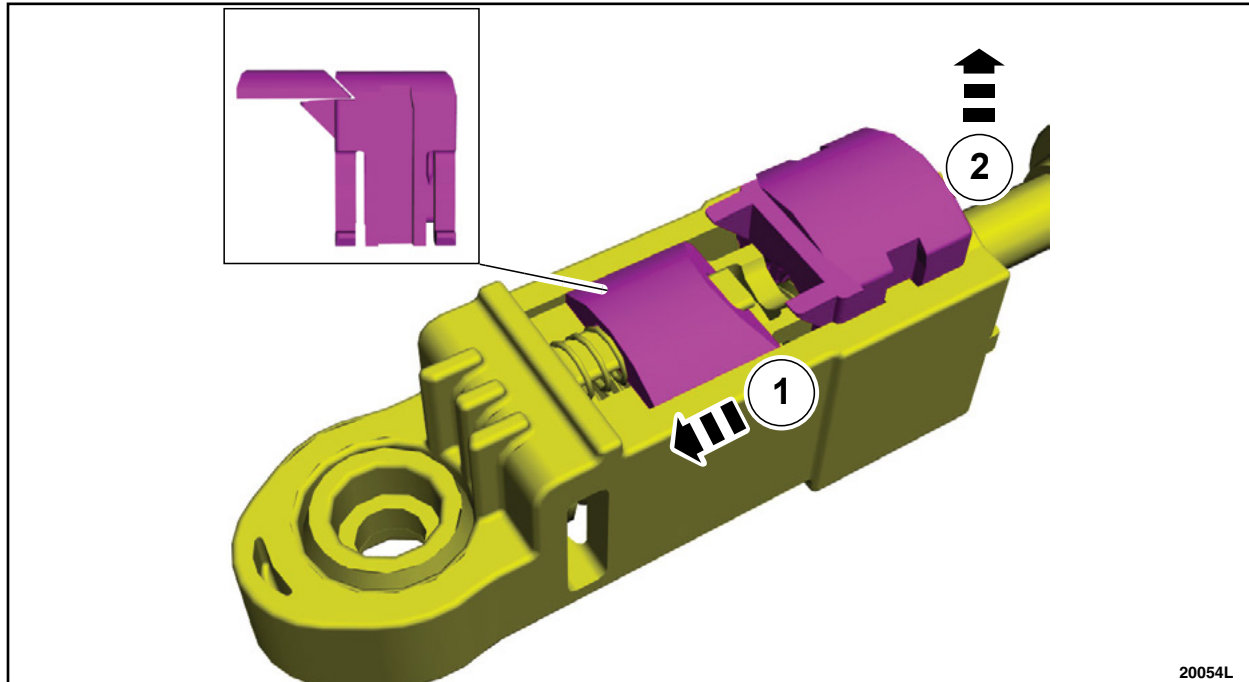
FIGURE 12

13. Release the selector lever cable adjuster lock. See Figure 12.

1. Carefully pry the adjuster lock tabs outward.
2. While holding the adjuster lock tabs outward, slide the lock out to unlock the selector lever cable.

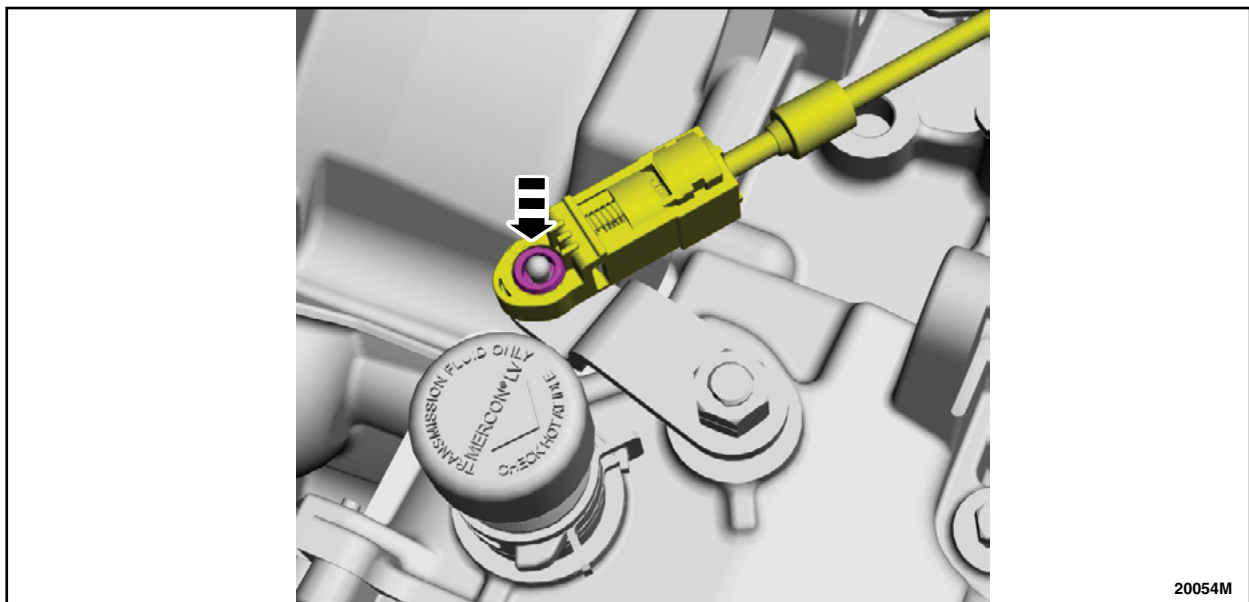
FIGURE 13

14. Connect the selector lever cable to the manual control lever. See Figure 13.

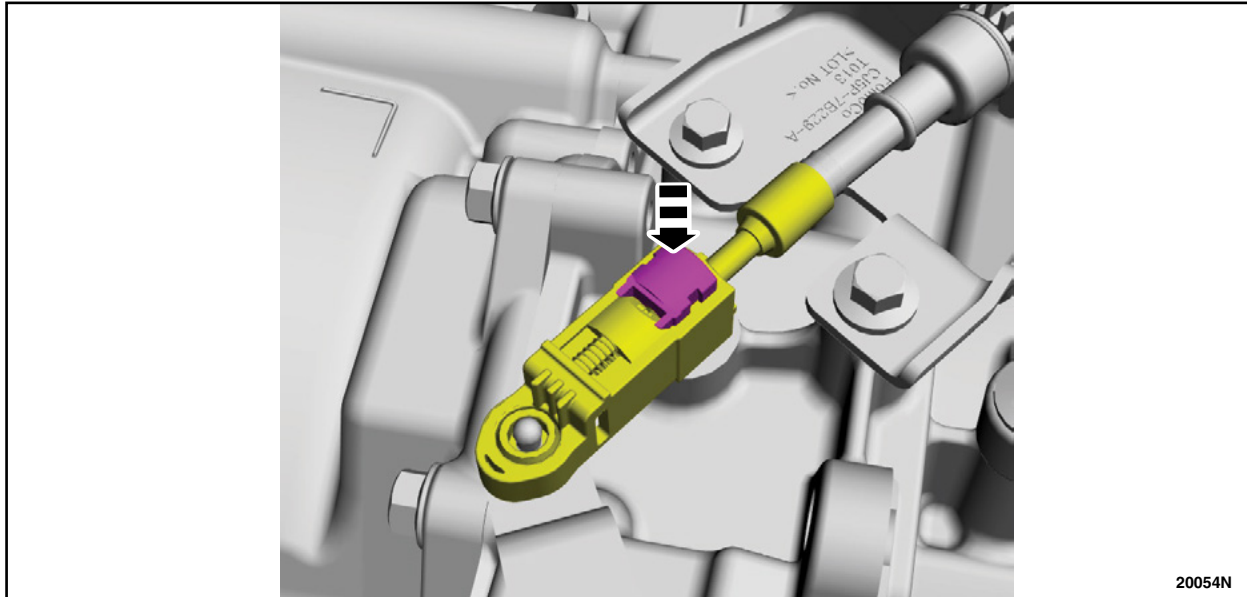
FIGURE 14

15. Slide the adjuster tab in place to lock the selector lever cable. See Figure 14.

NOTE: Visually inspect cable end and give a slight pull up to verify the bushing is fully seated.

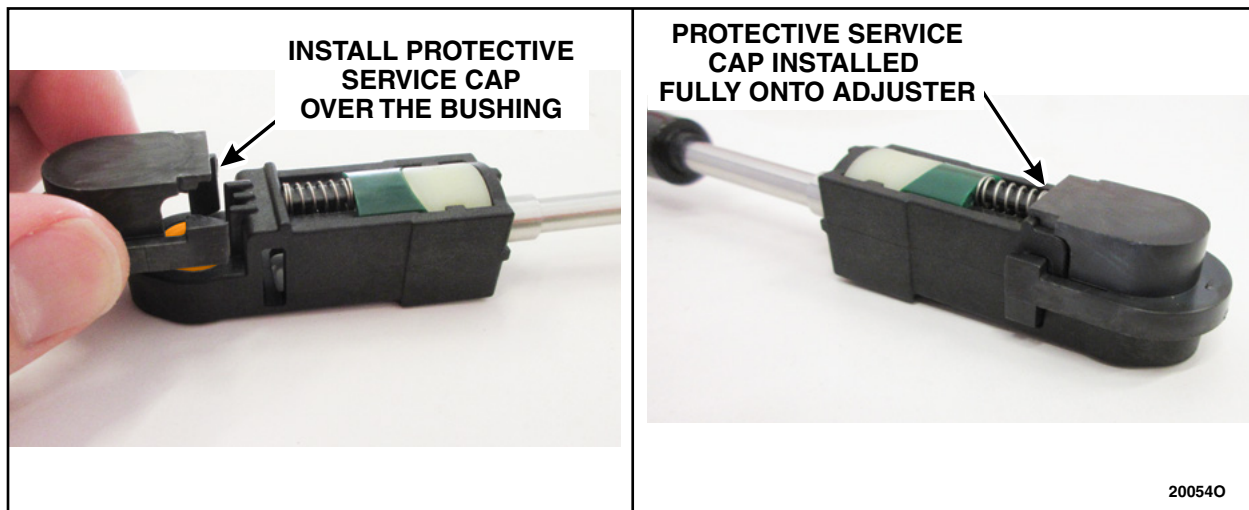
FIGURE 15

16. Install the new cap onto the selector lever cable adjuster. Clip one side into the adjuster body and then slide the other onto the housing until it snaps into place. The protective cap should cover the bushing and the terminal end of the adjuster. See Figure 15.

17. Verify installation by checking the cap is retained by the adjuster body.

NOTE: Selector lever cable removed for clarity.
