SUBJECT: NEW VEHICLE DEMONSTRATION / DELIVERY HOLD
Safety Recall 21S24 – Supplement #2
 Certain 2013 through 2021 Model Year Transit Connect Vehicles Equipped with a 2.5L Engine and 6F35 Transmission
 Shifter Cable Bushing Replacement and Protective Cap

NEW VEHICLE DEMONSTRATION / DELIVERY HOLD**Safety Recall 21S24 – Supplement #2**

CERTAIN 2013-2021 MODEL YEAR TRANSIT CONNECT EQUIPPED WITH A 2.5L ENGINE AND A 6F35 TRANSMISSION — SHIFTER CABLE BUSHING REPLACEMENT AND PROTECTIVE CAP

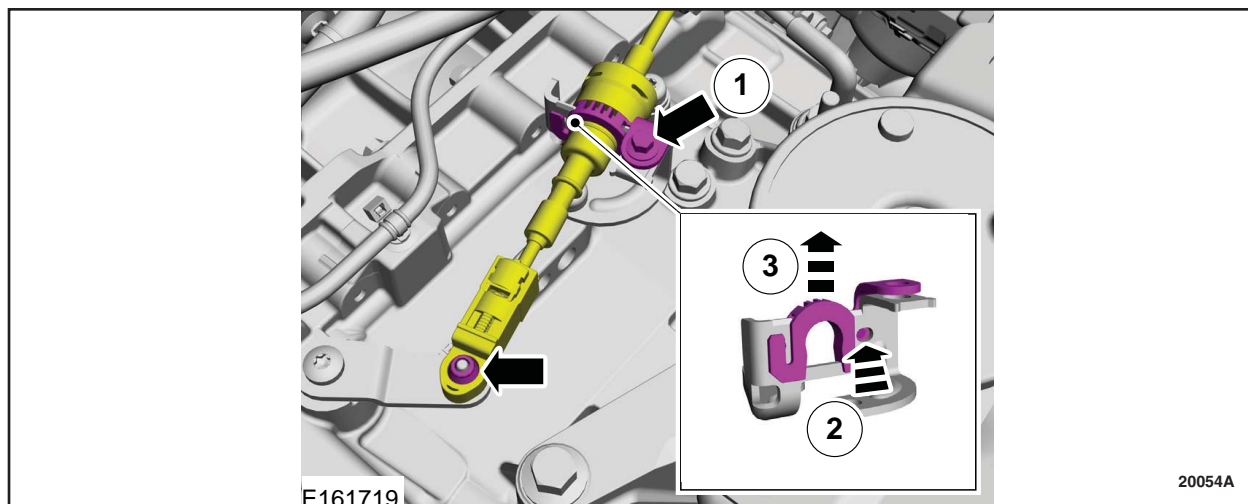
FIGURE 1

1. Apply the parking brake, chock wheels to make sure vehicle does not roll.
2. Position the gear shift lever in Drive (D).
3. Remove the air cleaner assembly. Please follow the Workshop Manual (WSM) procedures in Section 303-12.
4. Remove the air cleaner outlet pipe. Please follow the Workshop Manual (WSM) procedures in Section 303-12.
5. Disconnect the selector lever cable from the transmission manual lever and the bracket. See Figure 1.
 1. Remove the selector lever cable bracket bolt.
 2. Disengage the selector lever cable holding clip.
 - Use caution when removing hold down bracket to avoid damage. Hold down bracket is available separate of shift cable.
 3. Disconnect the selector lever cable.
 - Torque to 62 lb.in (7 Nm).

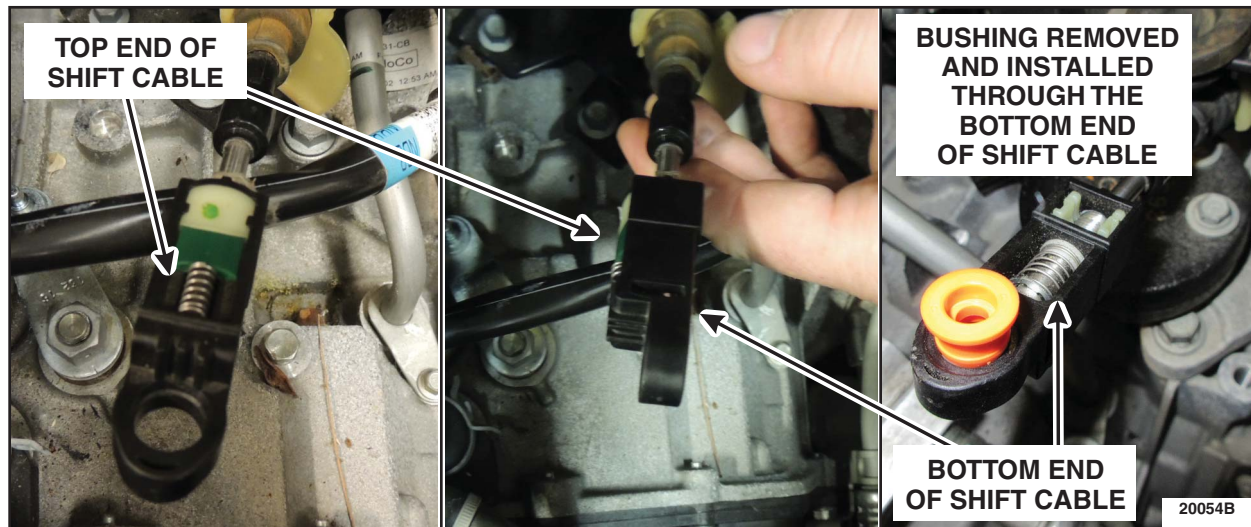
FIGURE 2

NOTE: Selector Lever Cable Bushing Replacement/Orientation. See Figure 2.

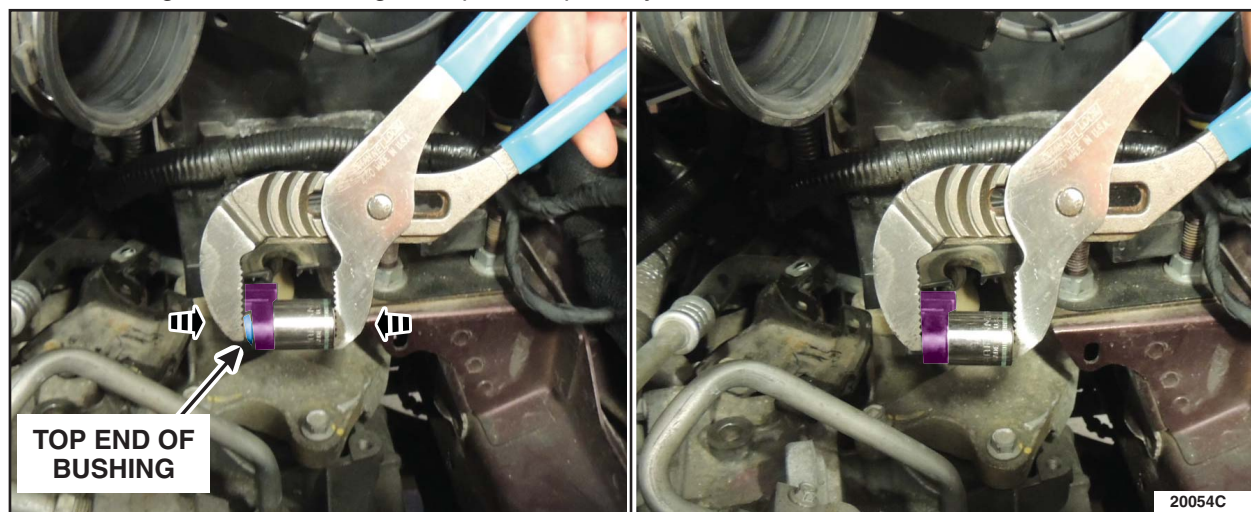
FIGURE 3

6. Using a pair of Straight Jaw Adjustable pliers and a 15mm shallow socket push the bushing partially out of the selector lever cable end. See Figure 3.

NOTE: For all 2013 Transit Connect vehicles equipped with original shift cable, the bushing maybe taller than the replacement bushing.

NOTE: The 15mm socket will rest against the hard plastic bottom end of shift cable, and will be large enough to allow bushing to be pressed partially out.

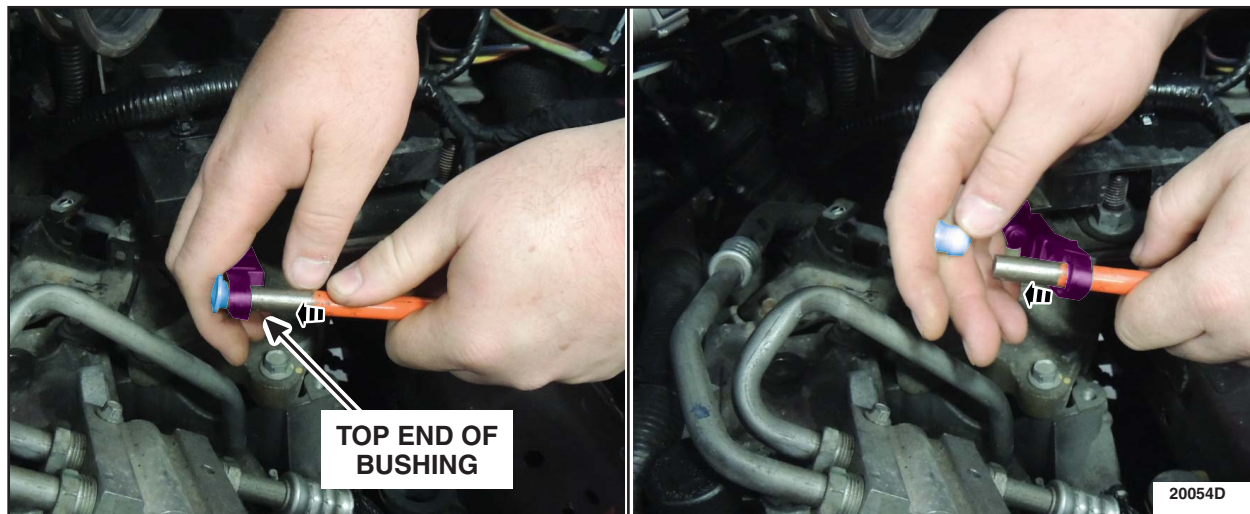
FIGURE 4

7. Turn the selector lever cable end over and using a punch push the bushing the rest of the way out of the selector lever cable end. See Figure 4. Proceed to Step 9.

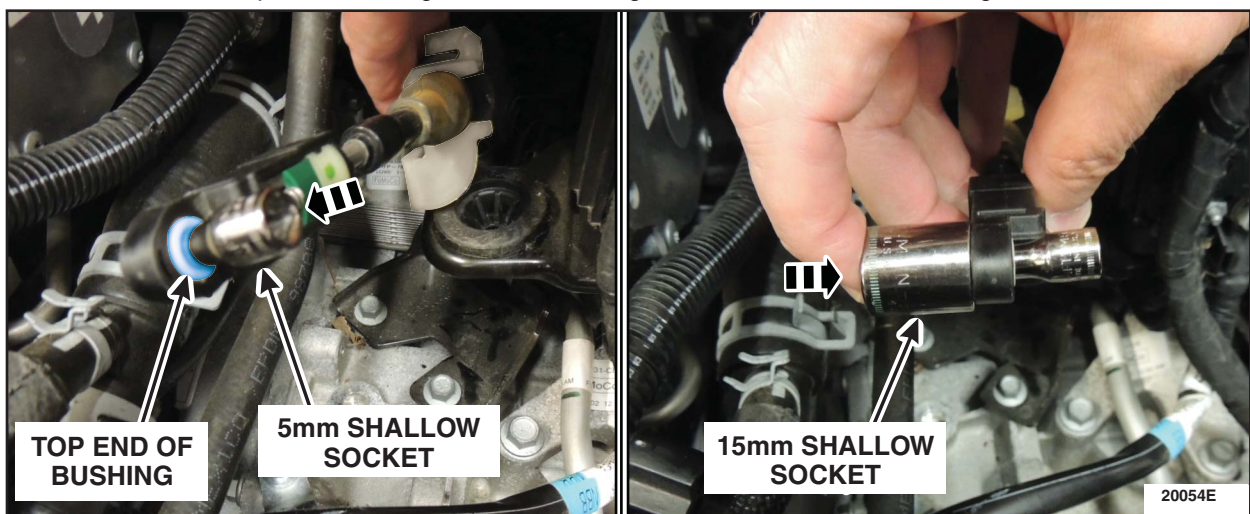
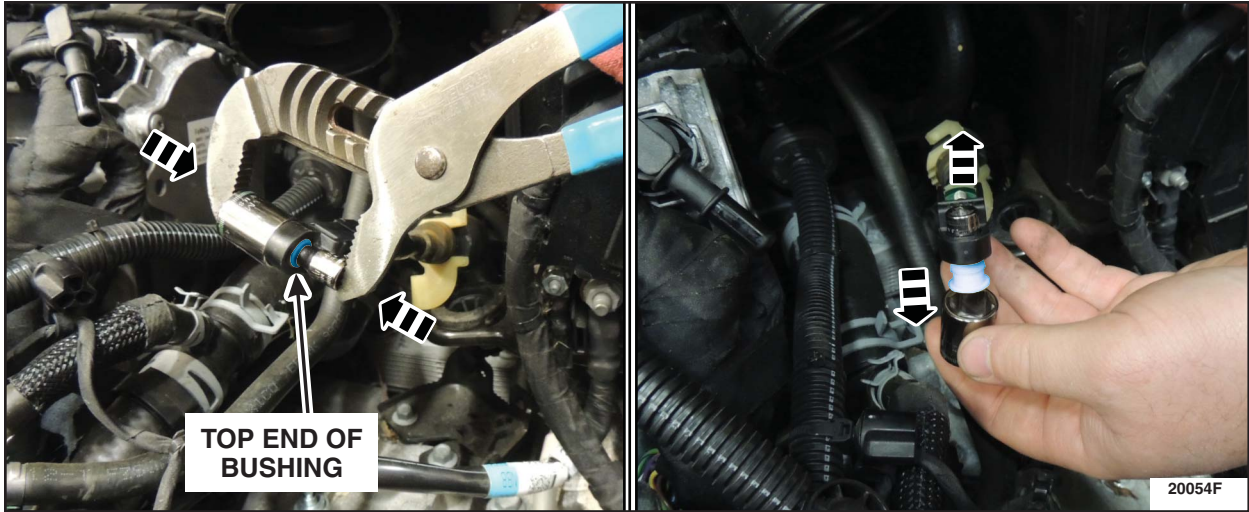
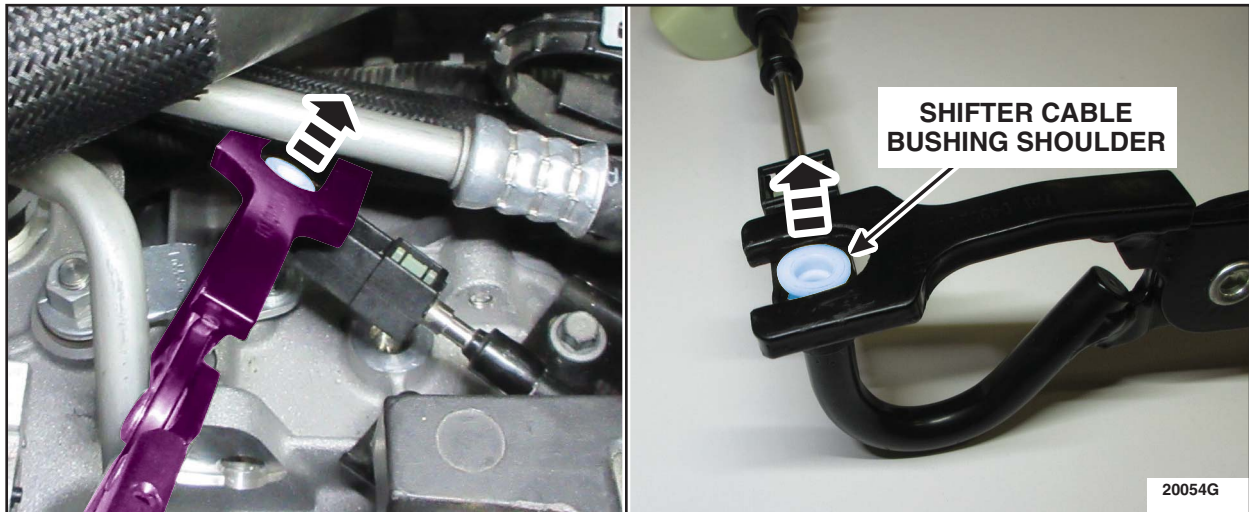
8. Press out the shifter cable bushing using one of the two methods below.
- Using a 5mm and a 15mm socket with Straight Jaw Adjustable pliers the bushing can be pressed out of the shifter cable end. The 5mm socket will fit into the small part of the bushing on top, the 15mm will go against the bottom of the shifter cable end, make sure to have socket centered with the bushing to allow clearance of the bushing shoulder as it is being pressed out. See Figures 5 and 6.
 - Using a tool such as a Lisle 38350 - Exhaust Hanger Removal plier to press bushing out. By viewing Figure 7 the shoulder of bushing is positioned upward, small end of plier is pressing bushing out. Proceed to Step 9.
- Use caution not to damage the shifter cable during this procedure.
 - Inspect for damage before installing the new shifter cable bushing.

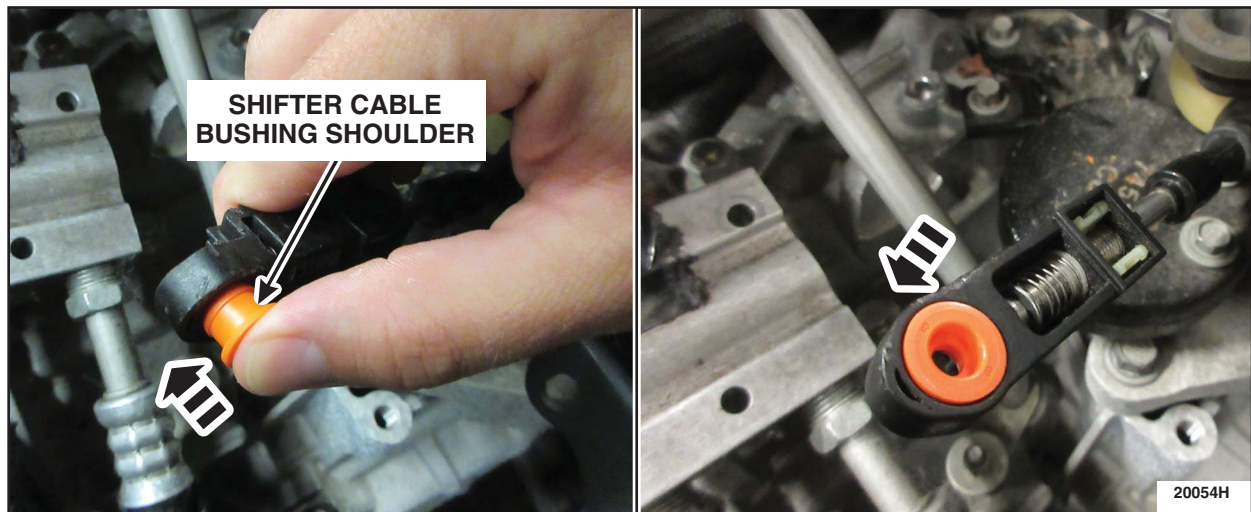
FIGURE 8

9. Using your hands only, install the new selector lever cable bushing. Do not use any grease to install, the bushing and cable end should be dry. See Figure 8.

- Visually check shifter cable end for any signs of damage. If damage to the shifter cable end is found, please call the Special Service Support Center (SSSC).

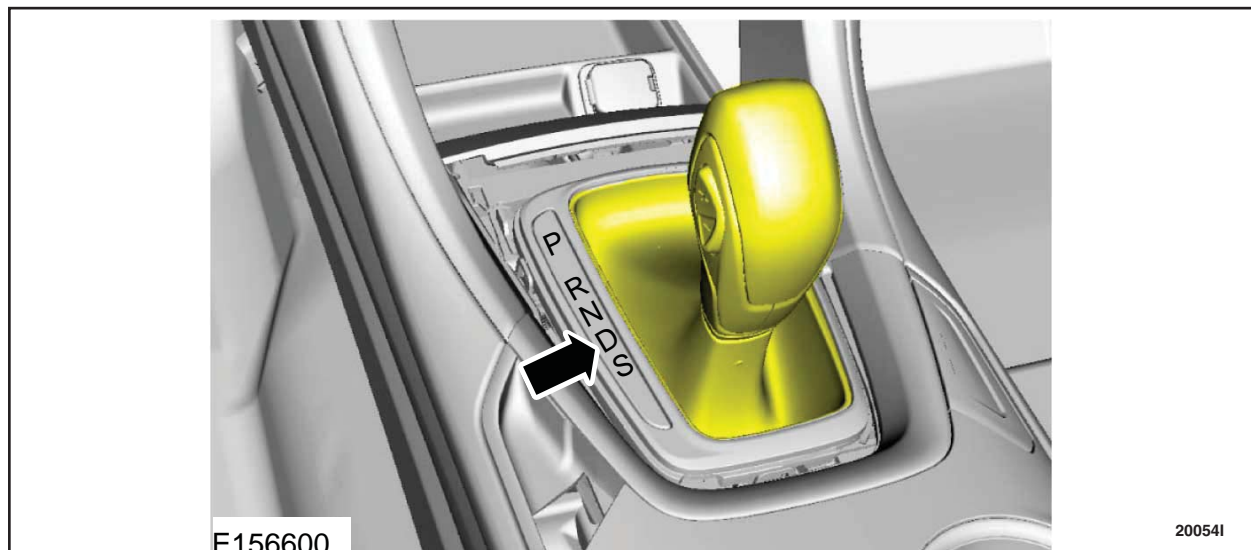
FIGURE 9

10. The vehicle's transmission gear selector lever should be in Drive position from Step 2, if not, position the selector lever to Drive (D). See Figure 9.

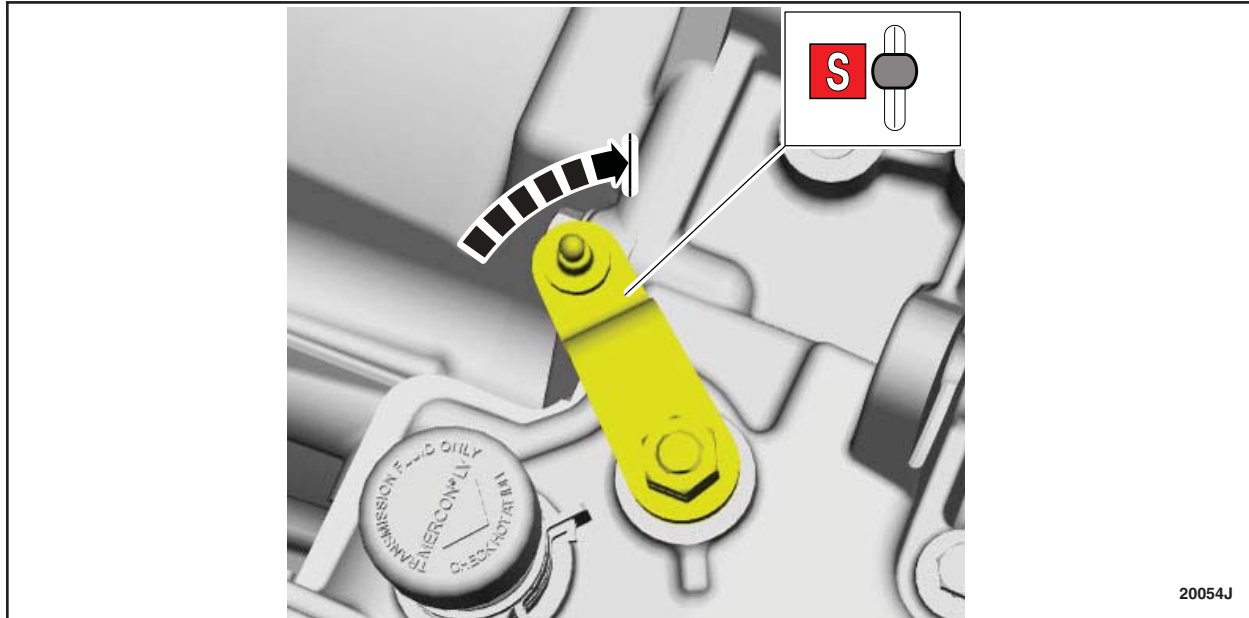
FIGURE 10

11. Rotate the manual control lever clockwise until it stops. See Figure 10.

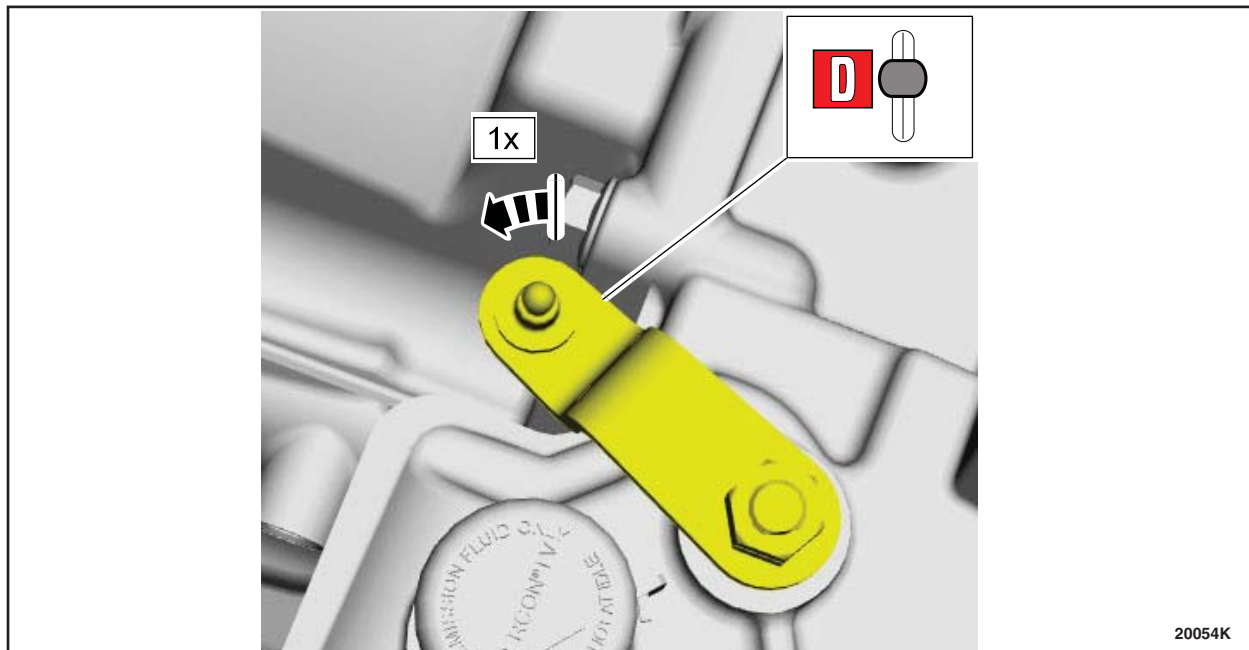
FIGURE 11

12. Rotate the manual control lever counterclockwise 1 detent into Drive (D). See Figure 11.

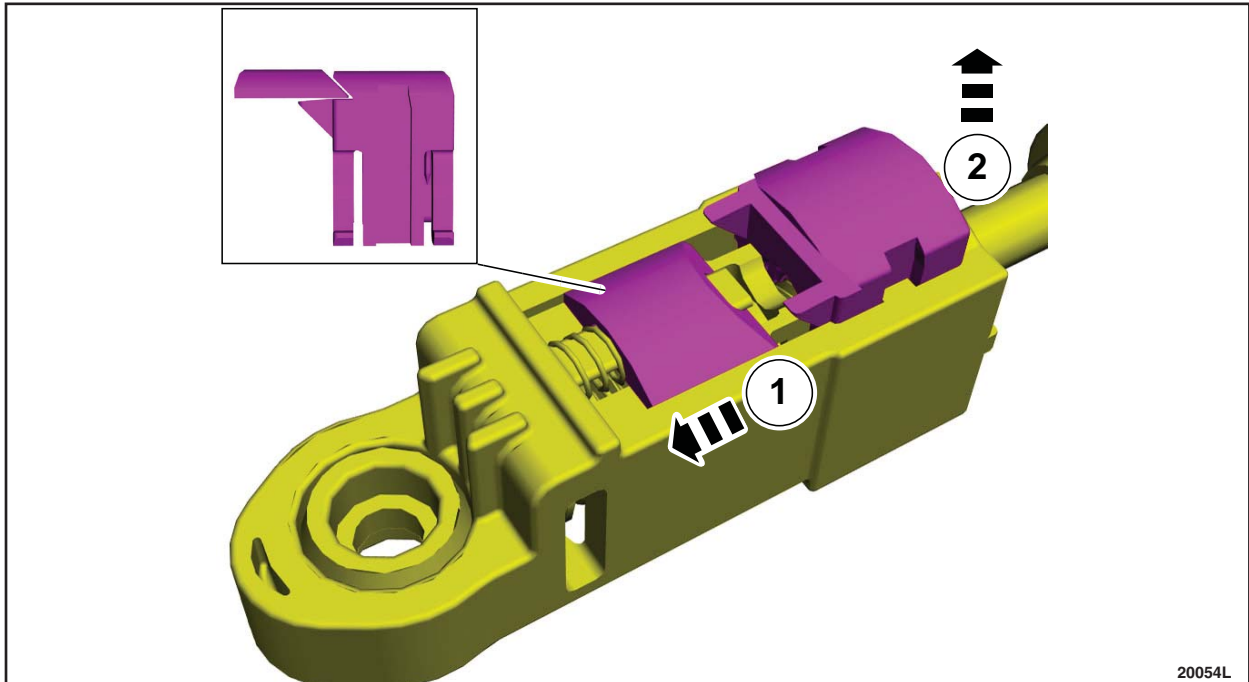
FIGURE 12

13. Release the selector lever cable adjuster lock. See Figure 12.

1. Carefully pry the adjuster lock tabs outward.
2. While holding the adjuster lock tabs outward, slide the lock out to unlock the selector lever cable.

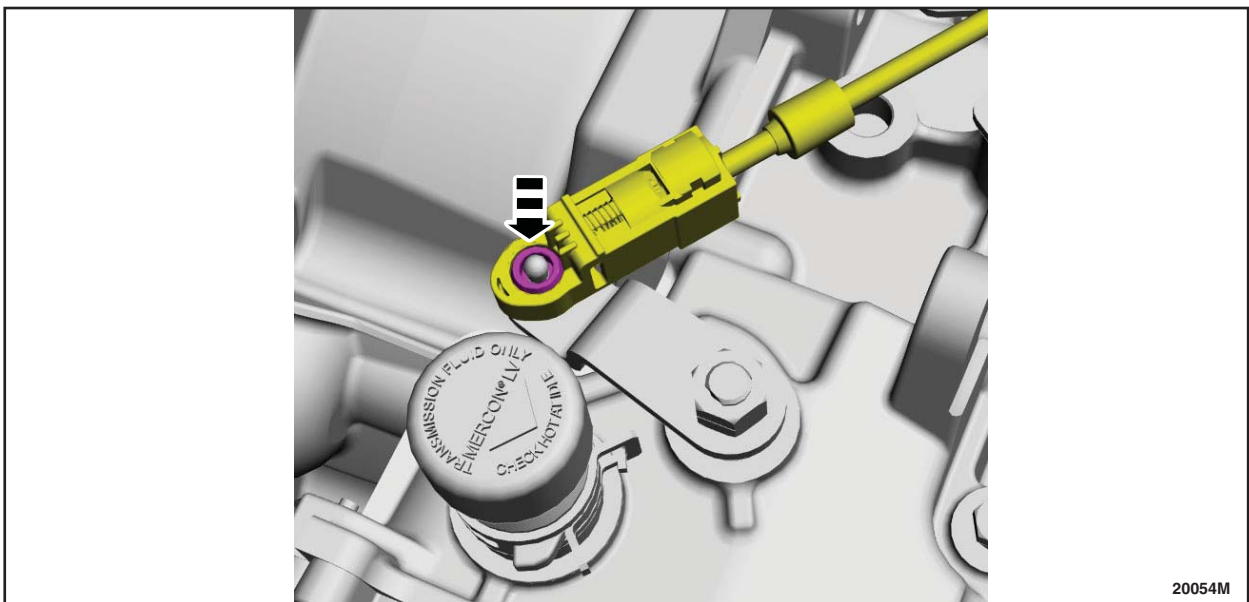
FIGURE 13

14. Connect the selector lever cable to the manual control lever. See Figure 13.

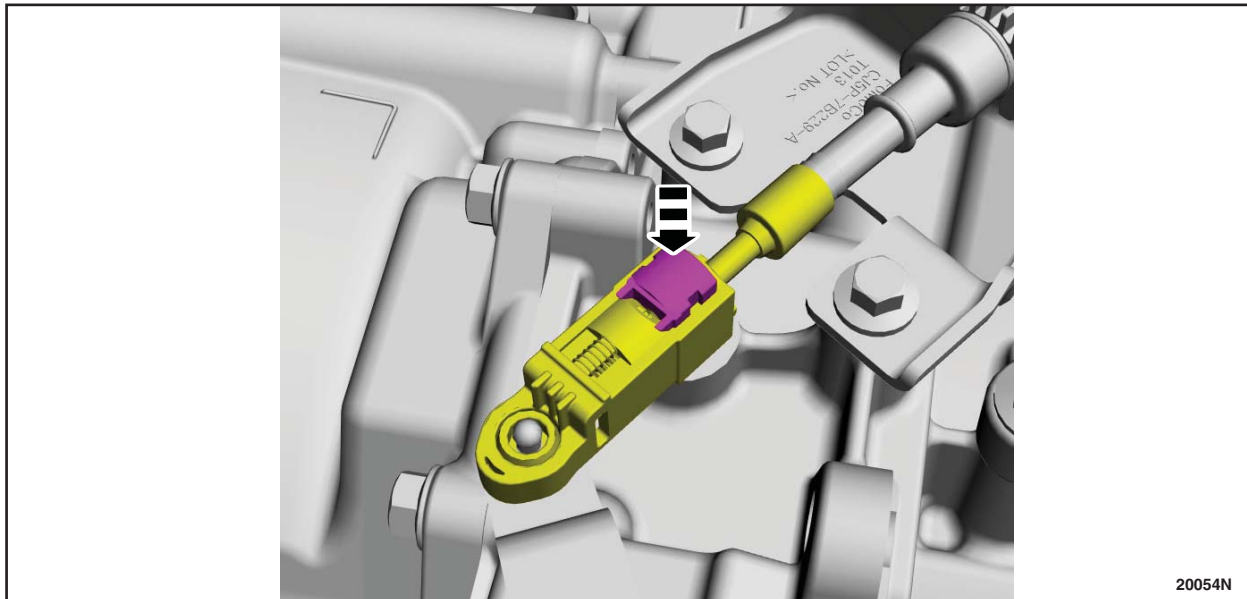
FIGURE 14

15. Slide the adjuster tab in place to lock the selector lever cable. See Figure 14.

NOTE: Visually inspect cable end and give a slight pull up to verify the bushing is fully seated.

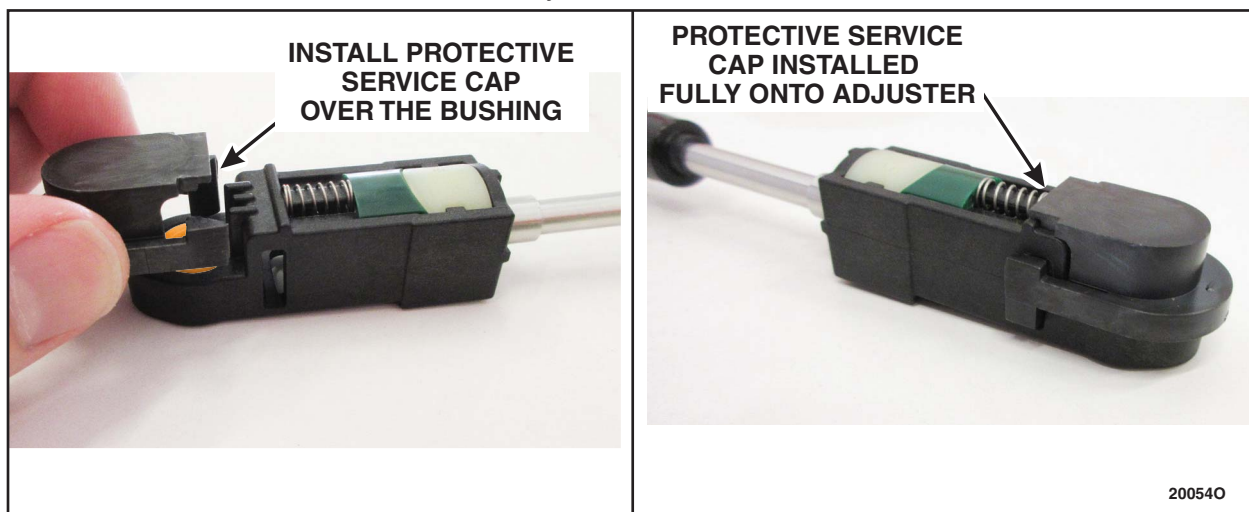
FIGURE 15

16. Install the new cap onto the selector lever cable adjuster. Clip one side into the adjuster body and then slide the other onto the housing until it snaps into place. The protective cap should cover the bushing and the terminal end of the adjuster. See Figure 15.

17. Verify installation by checking the cap is retained by the adjuster body.

NOTE: Selector lever cable removed for clarity.
