# Safety Recall 21KWE: T680, T880, and W990 HVAC Control Head Not Functional

21KWE / 21V546 / 2021-686

Recall 21KWE: HVAC Control Head Not Functional

Kenworth Truck Company has determined that a defect, which relates to motor vehicle safety, exists in certain Model Year 2022 T680, T880, and W990 chassis. Certain Mahle HVAC control heads may have a soldering defect which may result in inoperative HVAC controls.

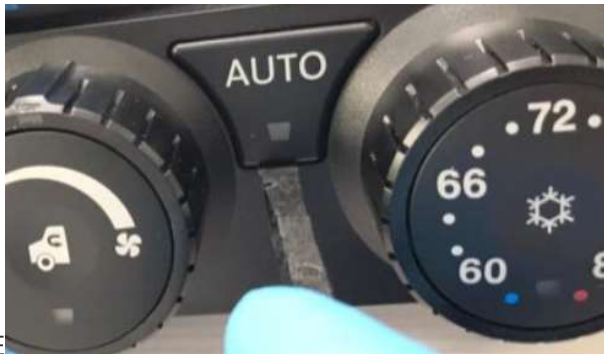
1. Using the non-marring tool, remove the cover from the AUTO button cap.
  - The control head does NOT need to be removed from the dash for inspection.
  - **DO NOT** damage or discard the button cap during inspection.

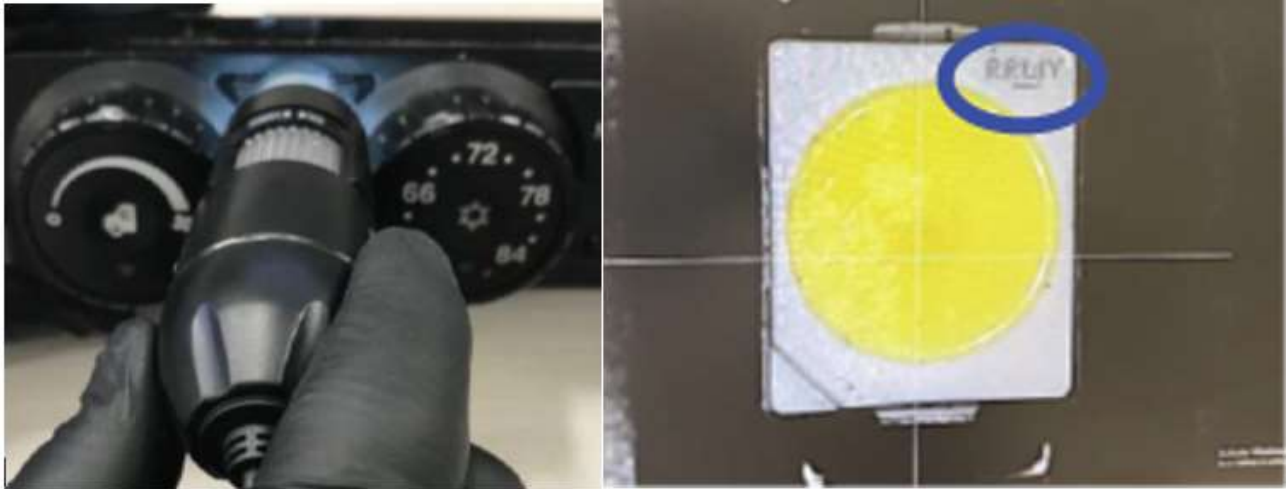
2. Inspect the LED date code with the microscope. Capture an in-focus image of the LED date code.
  - Hold the microscope as close as possible to the button opening.
  - Adjust the focus and brightness to obtain a clear picture of the date code at the corner of the LED module on the circuit board.

- If the LED date code is RRWY, replace HVAC control head and continue with this procedure.
- If the LED date code is anything else, reinstall the AUTO button cap and press the button 5 times to confirm operation. No additional action is required.
- Rename the image file with the chassis number and submit the image with the warranty claim.
